Davis-Besse Reactor Vessel Head Damage NRC UPDATE

October 2002

This is the second periodic update on the NRC response to the reactor vessel head damage at the Davis-Besse Nuclear Power Station. The updates will be available at public meetings of the NRC Davis-Besse Oversight Panel which is coordinating the agency's activities related to the damage. Each update will include background information to assist the reader in understanding issues associated with the corrosion damage.

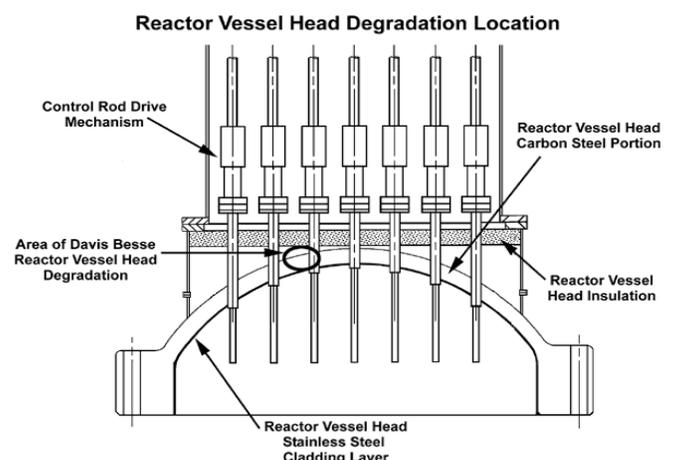
In March 2002 plant workers discovered a cavity in the head or top of the reactor vessel while they were repairing control rod tubes which pass through the head.

The tubes which pass through the reactor vessel head are called control rod drive mechanism nozzles. Cracks were detected in 5 of the 69 nozzles. In three of those nozzles, the cracks were all the way through the nozzle, allowing leakage of reactor cooling water, which contains boric acid.

Corrosion, caused by the boric acid, damaged the vessel head next to Nozzle No. 3, creating an irregular cavity about 4 inches by 5 inches and approximately 6 inches deep. The cavity penetrated the carbon steel portion of the vessel head, leaving only the stainless steel lining. The liner thickness varies somewhat with a minimum design thickness of 1/8 inch.
