Subject: 10CFR21 Reporting of Defects and Non-Compliance -
Engine Systems, Inc. Report No. 10CFR21-0085, Rev. 0

EMD Engine-Driven Water Pump Assemblies

Report No. 10CFR21-0085
Rev. 0: October 04, 2002

**10CFR21 REPORTING OF DEFECTS
AND NON-COMPLIANCE**

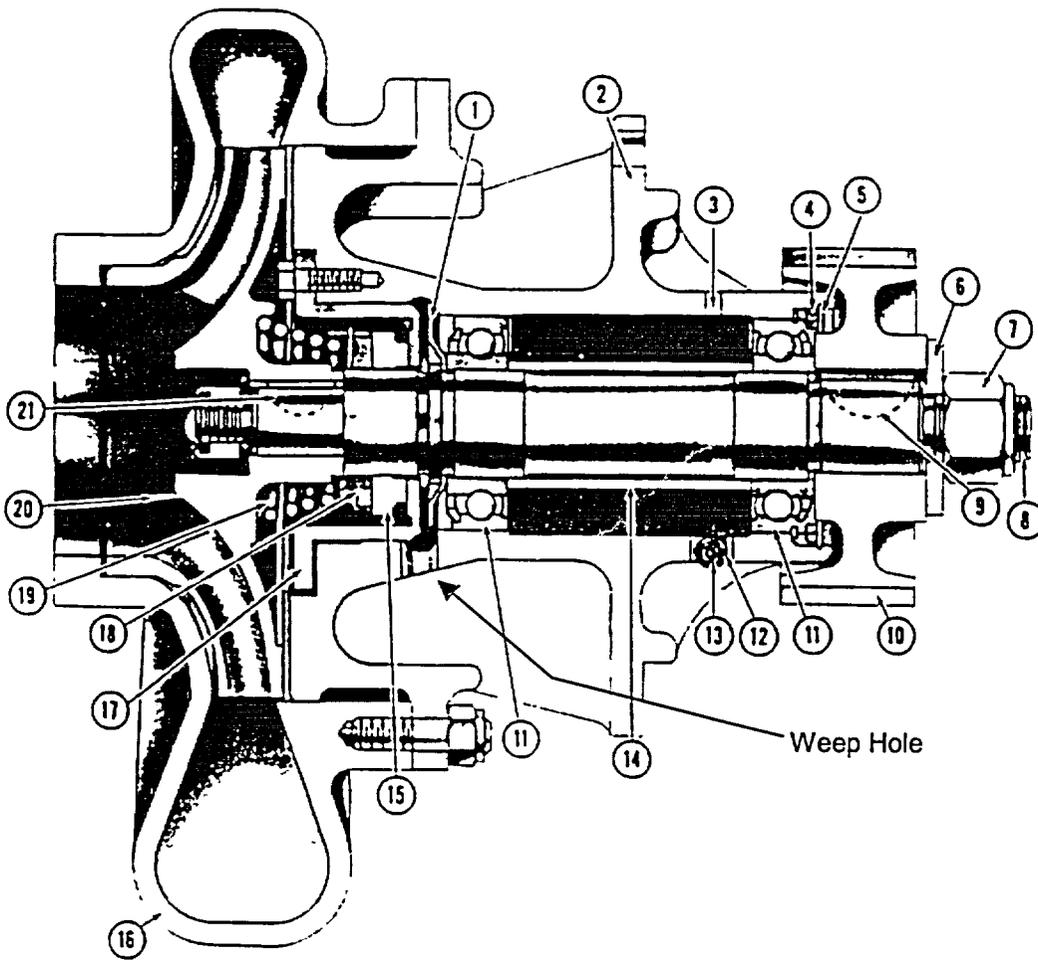
FIGURE 1
Water Pump Cross Section

A cross-sectional view of the EMD standard water pump is shown in Figure 1 of this report.

The water pump impeller and shaft assembly is supported in the housing by two roller bearing assemblies, item 11. The bearings are lubricated by splashed engine lube oil entering through the inlet hole, item 3, located in the top of the drive end of the support housing. Oil exits the bearing cavity through the oil outlet hole, item 12, located in the bottom of the drive end of the support housing. The cooling water is sealed through a mechanical seal assembly located at the impeller end of the shaft assembly, items 15, 17, 18 & 19. The cavity between the bearings and mechanical seal contains a drilled passage (weep hole) to provide an external visual indication of leakage of water from the mechanical seal as well as to prevent water from contaminating the bearings and engine oil system.

In an effort to extend the service life of the water pump assemblies, EMD redesigned the bearings, shaft and support housing to utilize tapered roller bearings in lieu of spherical roller bearings. The tapered roller bearings were mounted as opposed pairs in a back-to-back arrangement. A seal was installed at the opposite-drive end of the shaft to prevent oil leakage into the cavity and out the weep hole. This modification was incorporated on all water pumps applicable to 16 & 20 cylinder EMD engines. The earlier design pumps utilizing spherical bearings were discontinued in April, 2000.

Through the locomotive and marine industry, EMD has found that the redesigned pumps are experiencing premature failures of the internal seals resulting in leakage via the weep hole. The primary leaking fluid is engine cooling water, however, leakage of lubricating oil from the bearing side is a possibility. The seals are failing as a result of an insufficient preload on the tapered roller bearings. Without adequate preload, there exists excessive clearance between the rollers and race. This clearance results in chattering of the rolling elements and relative movement of the shaft within the pump. The issue applies to the design of the pump assembly relating to establishing and maintaining adequate preload on the bearings during operation. The problem is not a result of incorrect assembly.

No method is available to indicate the condition of the seals within the water pump assembly. The service history of the pumps with tapered bearings has indicated the seal failures occur either immediately or prematurely after a low number of operating hours. It is for this reason that it is recommended to replace the tapered bearing pumps with the previous design units using standard roller bearings.

Replace the tapered roller bearing water pump assemblies with standard roller bearing water pumps as identified below. Use the leakage rate (if present) as an indicator of the urgency of pump replacement. If no leakage is present, continue with monthly leak inspections and replace the pumps at the next available opportunity.
