ANO-1

TO DISCUSS THE ARKANSAS NUCLEAR ONE, UNIT 1, REACTOR PRESSURE VESSEL HEAD WELD REPAIRS

# **ANO-1 Reactor Vessel Nozzle Repair**

**Entergy Operations Inc.  
October 16, 2002**

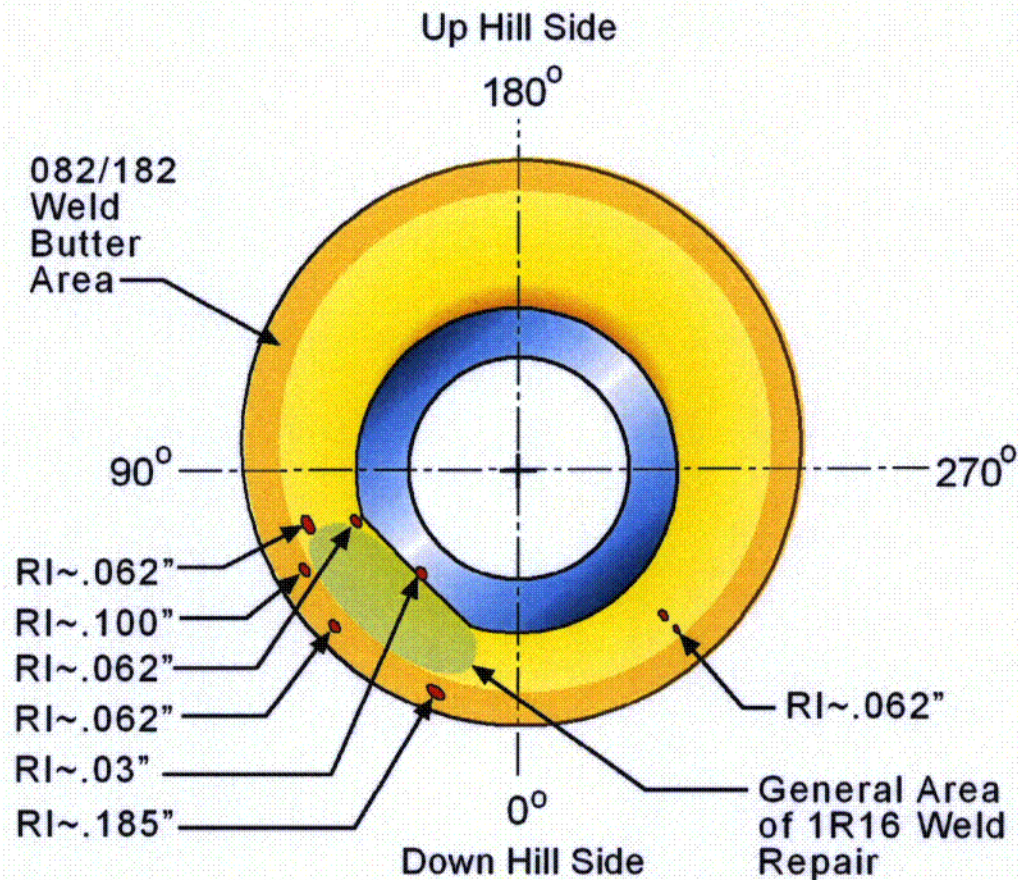
# PT Layout of Nozzle 56 (General Representation)

- ❖ Four Indications Adjacent to 1R16 Weld Repair
- ❖ Two Indications on Hill Side of Nozzle

Flaw #	Depth	Length	Az.	Above	Below
1A	0.177	0.56	20°	.16	---
2A	0.145	0.44	37 °	.12	---
4A	0.177	0.28	175 °	.16	---
5A	0.125	0.6	164 °	0	.12
1C	0.266	0.4	24 °	--	*
2C	0.180	0.68	39 °	.32	--

- ❖ No Indications Identified to Have Circumferential Extent
