Subject: Supplementary Information Associated with the
2002 Steam Generator Inservice Inspection
Rochester Gas and Electric Corporation
R.E. Ginna Nuclear Power Plant
Docket No. 50-244

Attachment I
R.E. Ginna Nuclear Power Plant

Steam Generator Degradation Assessment
2002 Outage

Attachment II
R.E. Ginna Nuclear Power Plant
2002 Steam Generator Inspection Summary

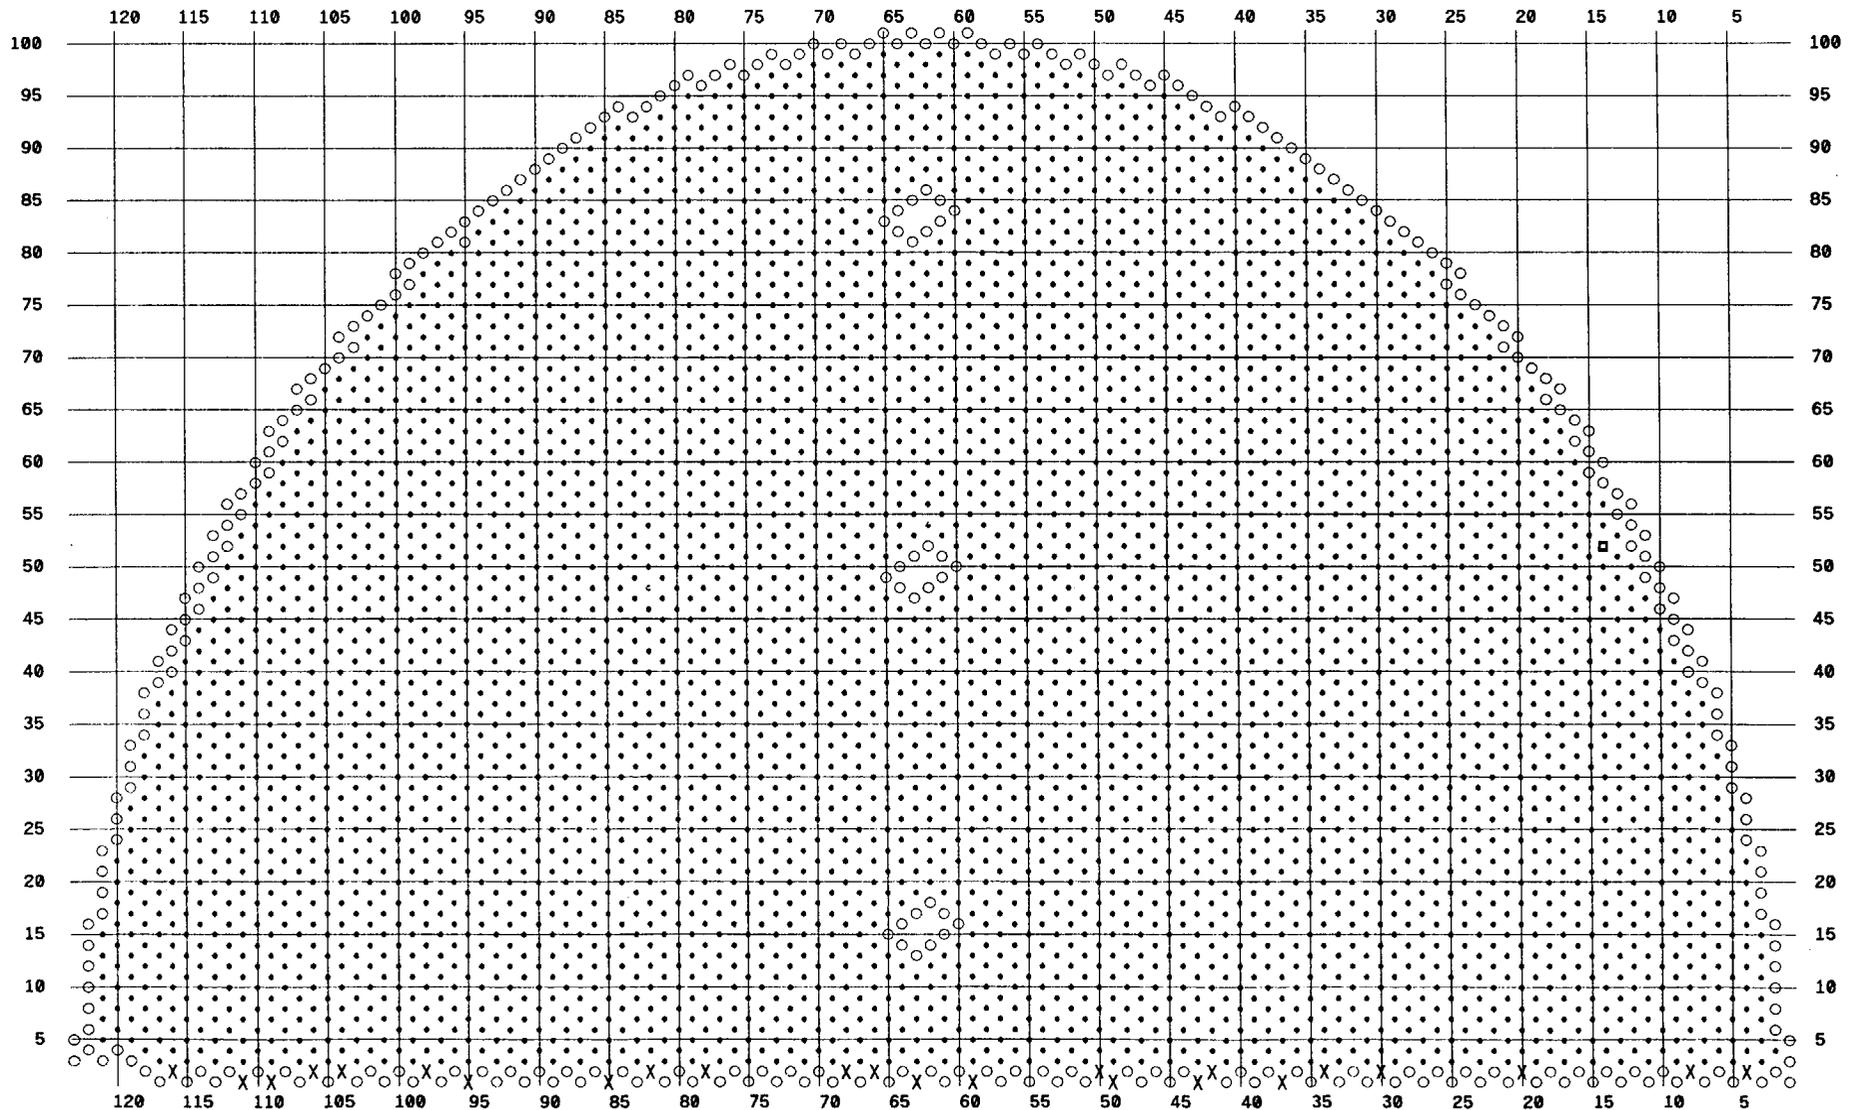
SG - A U-BEND INSPECTION PROGRAM

X 24 TESTED U-BEND 08C - 08H

■ 1 PLUGGED TUBE

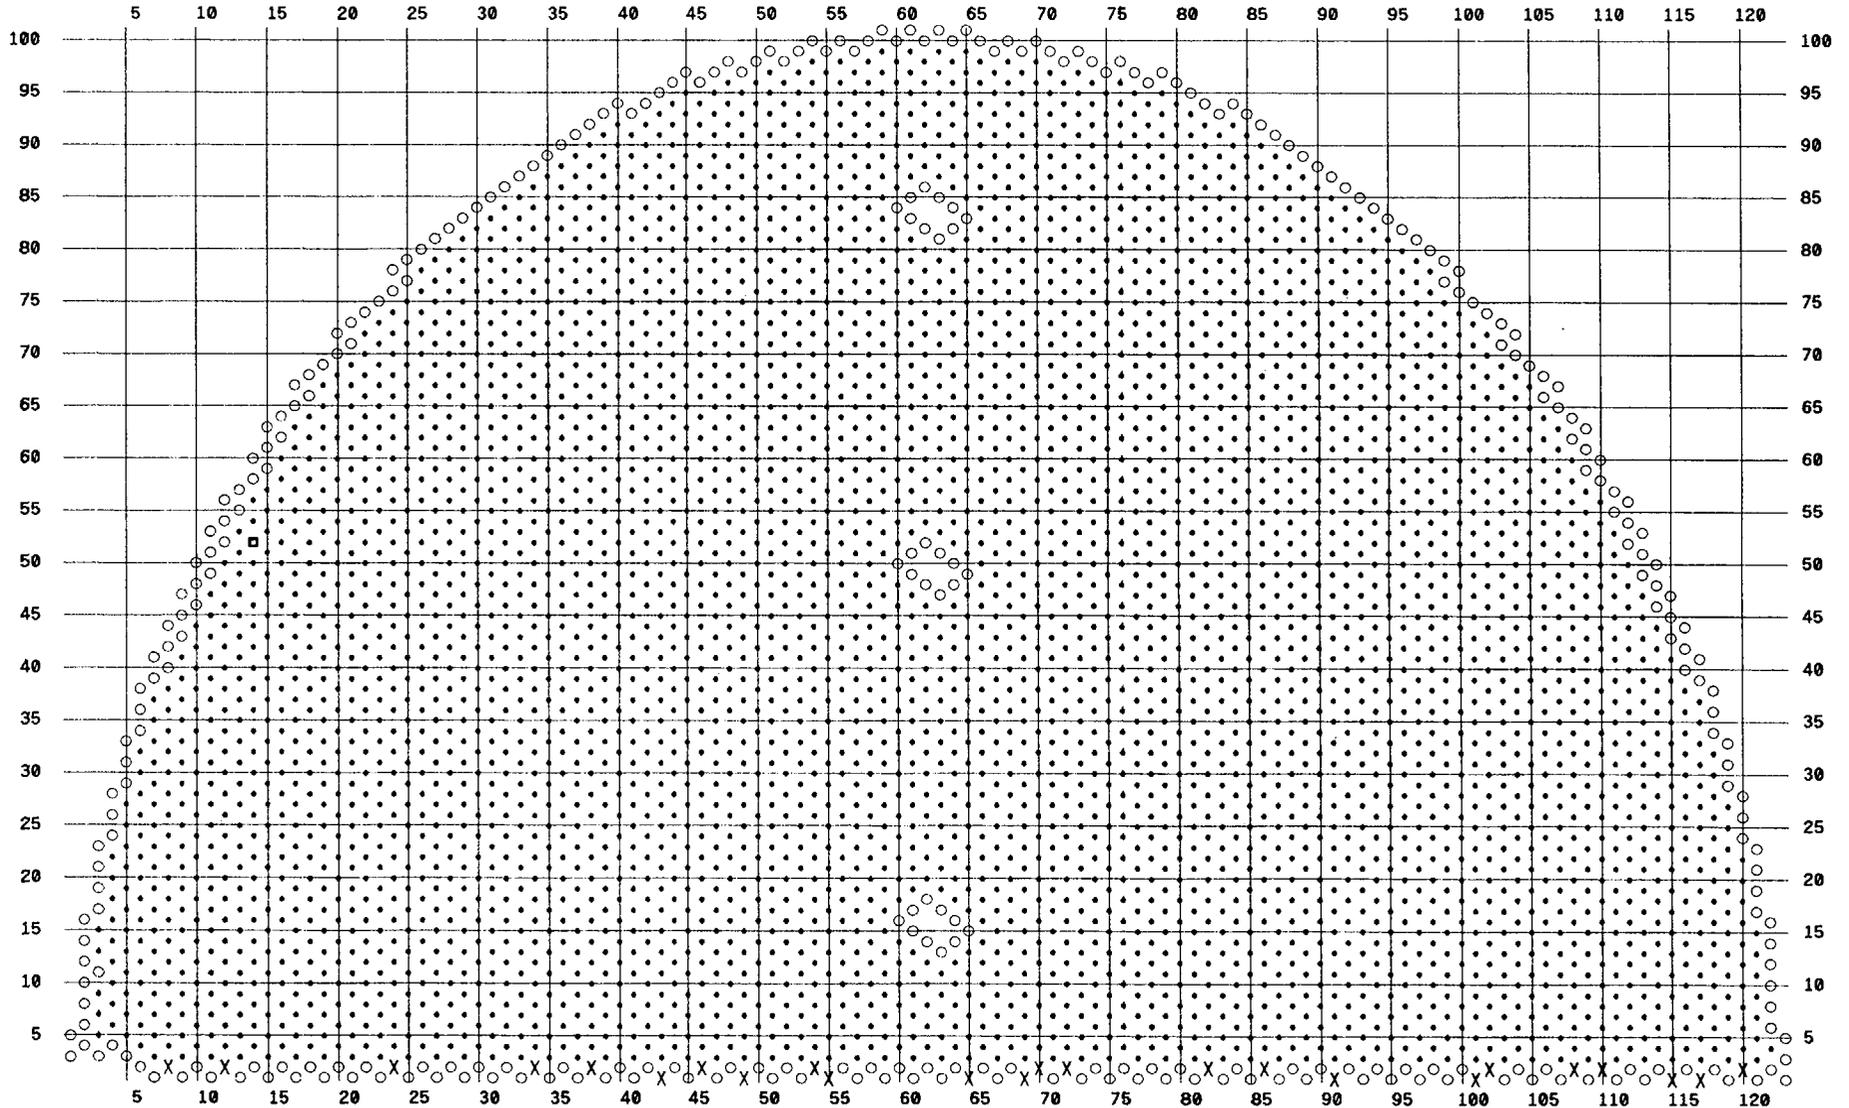
SG-A U-BEND PLUS POINT PROGRAM

X 24 TESTED U-BEND 08C - 08H

▣ 1 PLUGGED TUBE

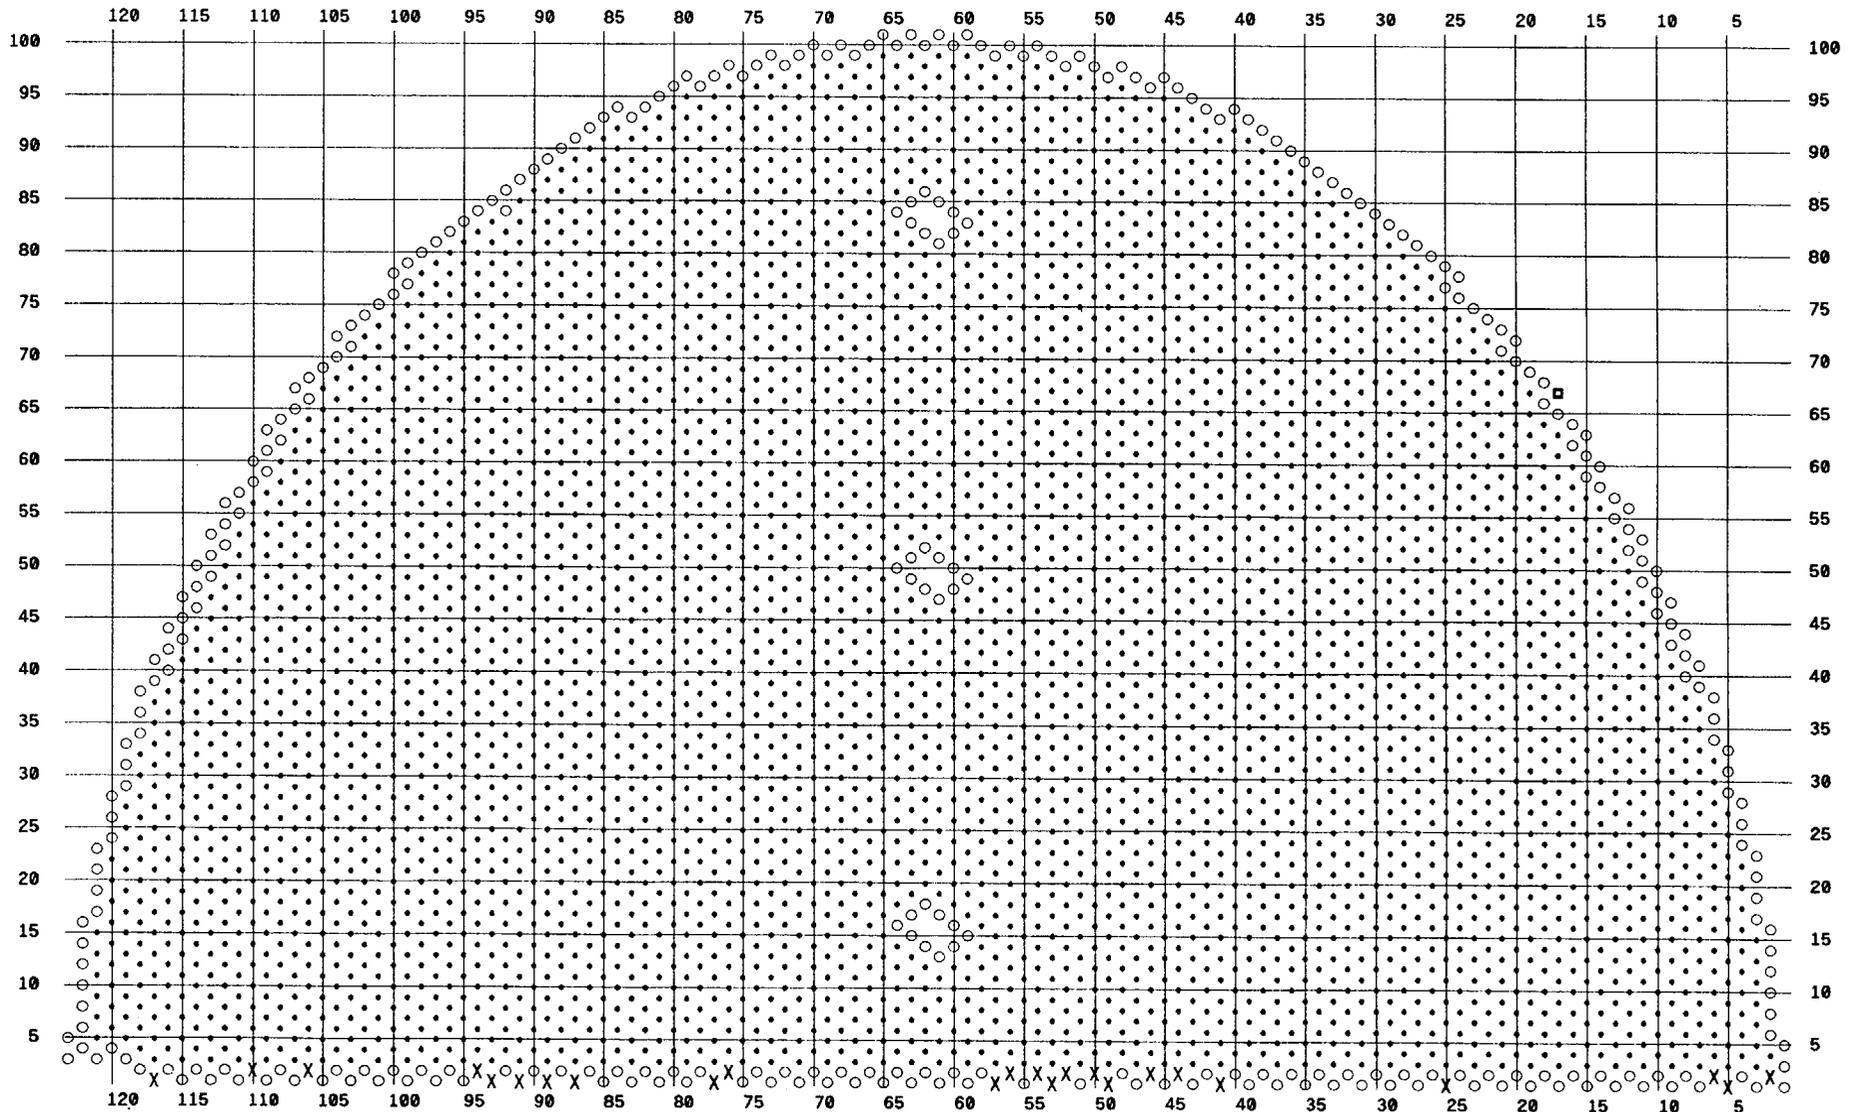
SG - B U-BEND INSPECTION PROGRAM

X 24 TESTED U-BEND 08C - 08H

□ 1 PLUGGED TUBE

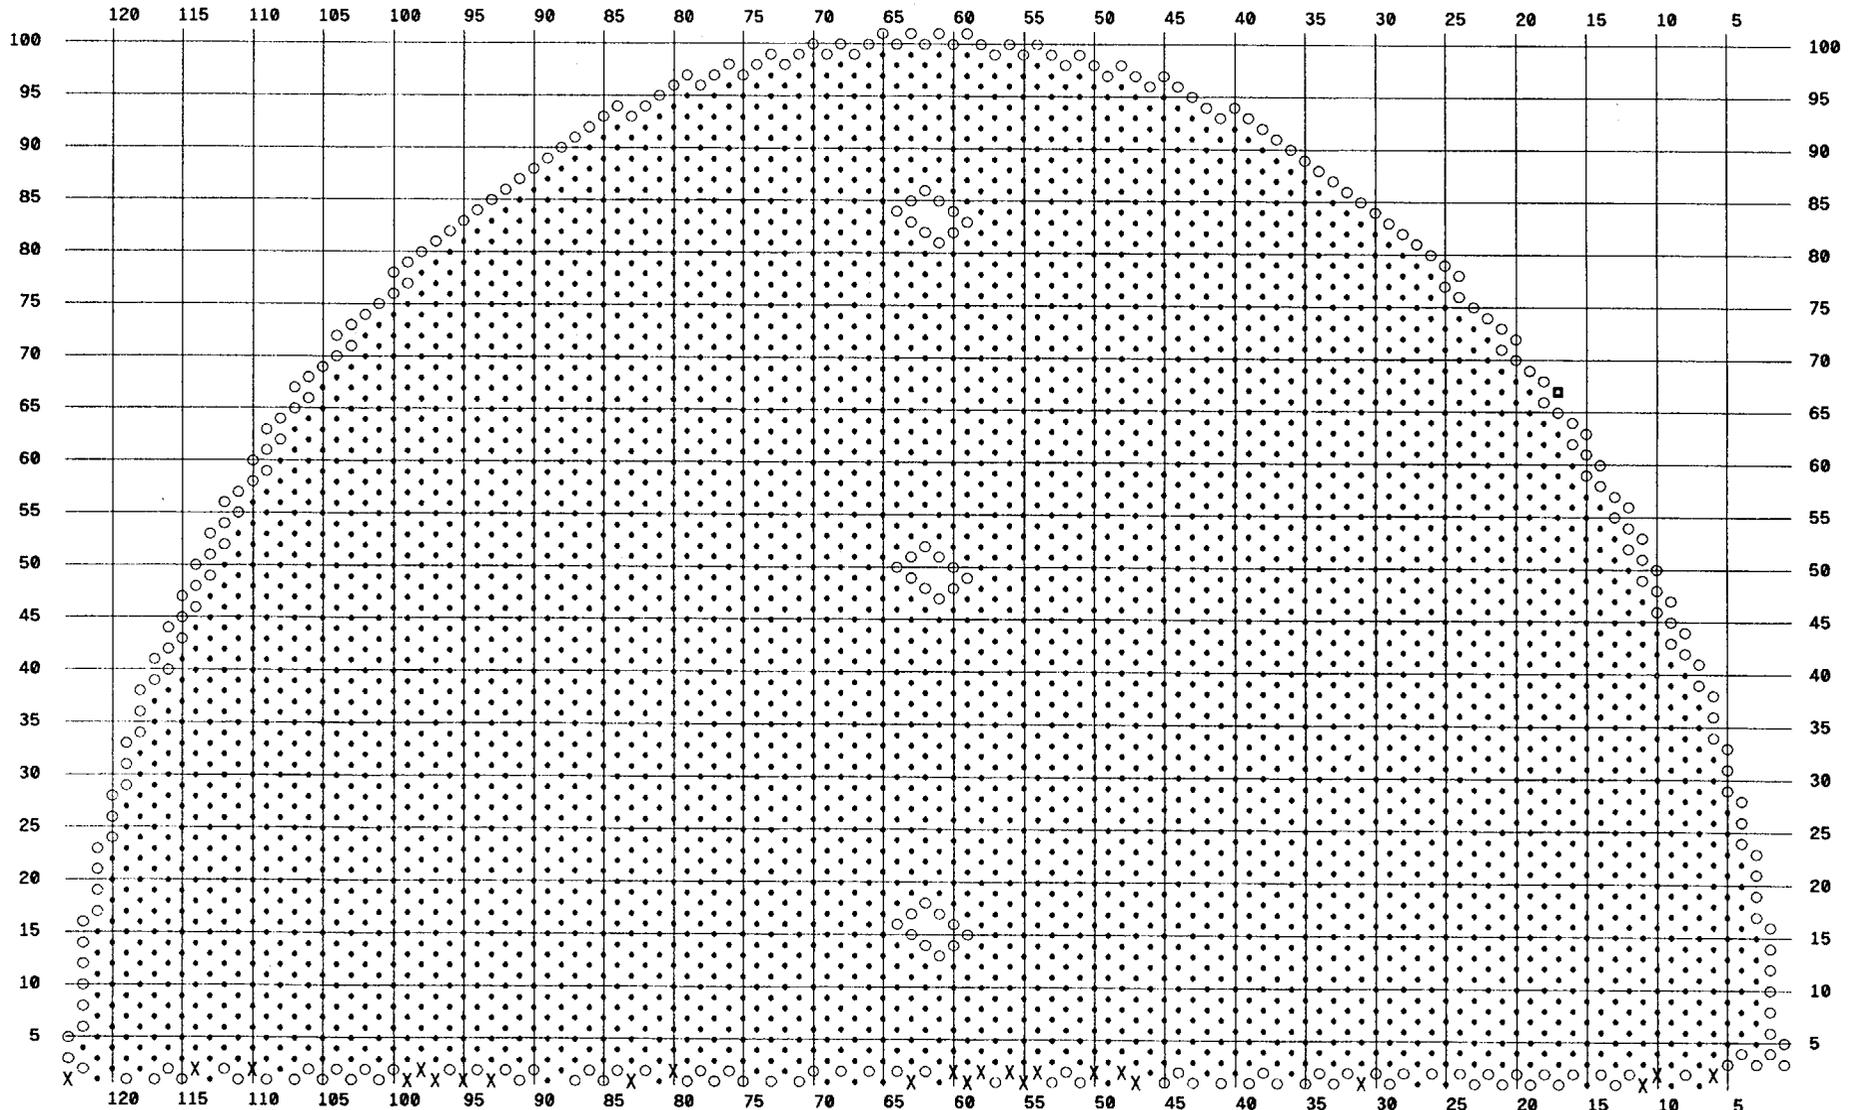
SG-B U-BEND PLUS POINT PROGRAM

X 24 TESTED U-BEND 08C - 08H

▣ 1 PLUGGED TUBE
