Subject: Oyster Creek Generating Station
Docket 50-219
Non - Routine Environmental Operating Report

**OYSTER CREEK GENERATING STATION
FISH KILL MONITORING REPORT**

AmerGen Energy Company, LLC

September 2002

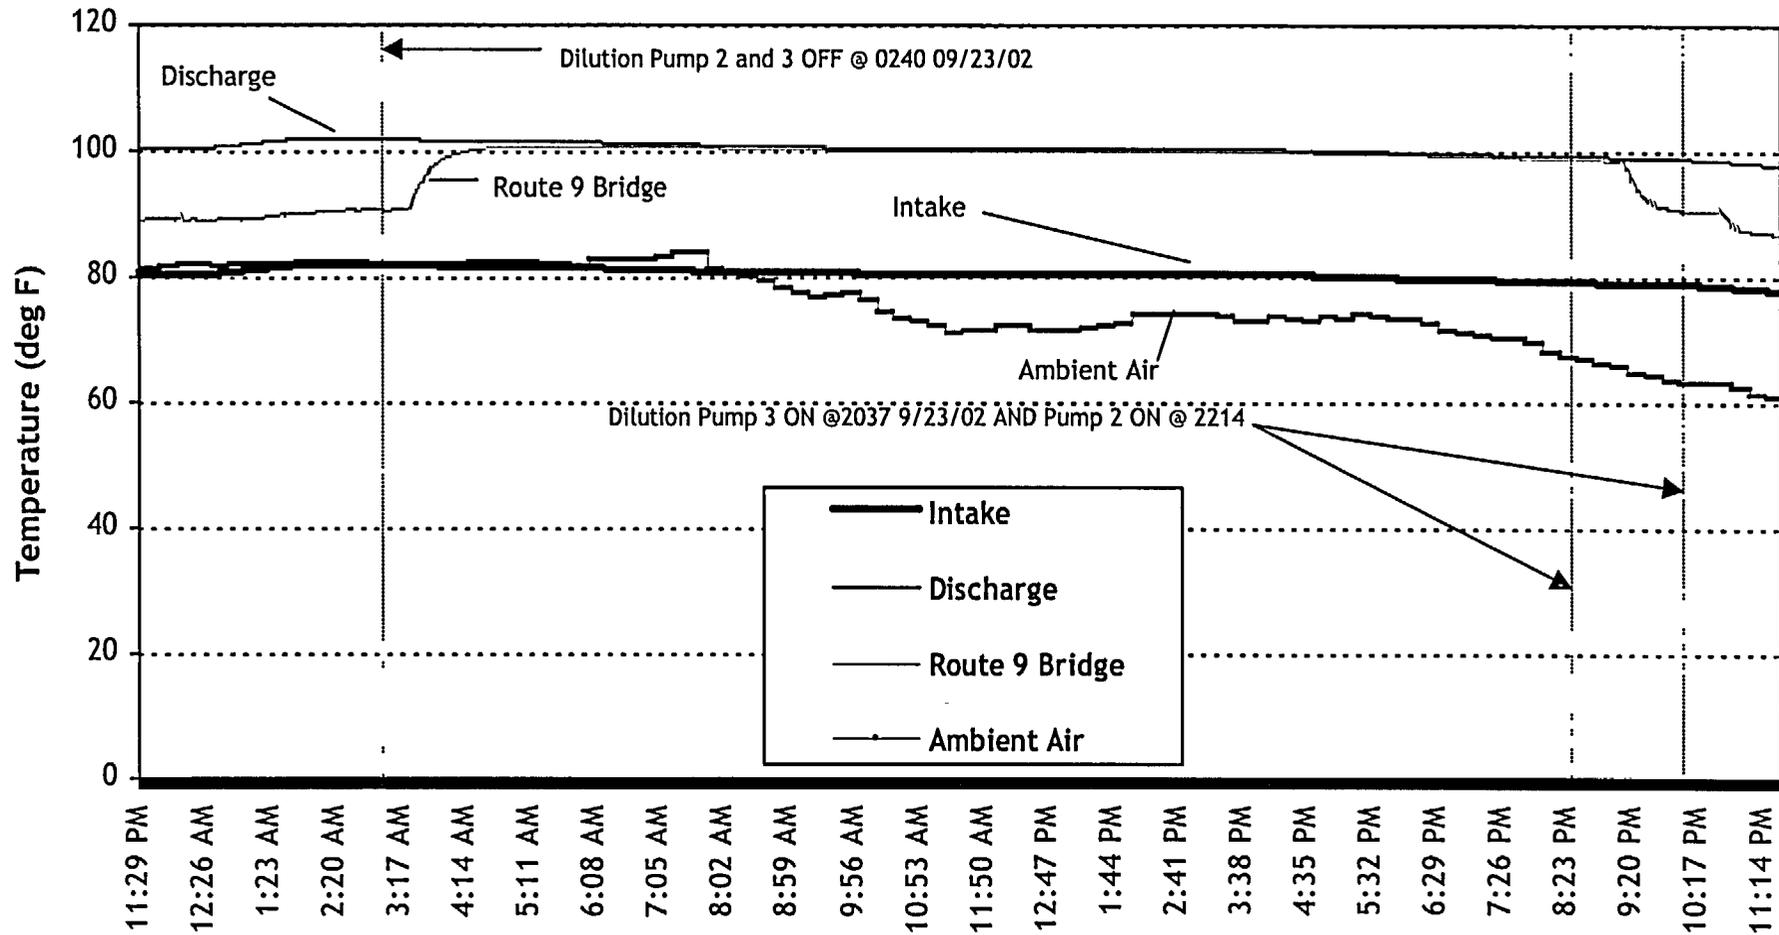
Figure 1

Prior to the shutdown of the dilution pumps, Main Condenser Discharge temperatures were approximately 38.9 °C (102 °F) and Route 9 Bridge surface water temperatures were approximately 32.7 °C (90.9 °F). Subsequently, in the absence of thermal mixing from dilution pump operation, downstream water temperatures within the discharge canal began rising. Water temperatures at the Route 9 Bridge surface water remained at about 32.8 °C (91 °F) for 45 minutes after the dilution pumps were secured. At 3:25 AM, Route 9 Bridge surface water temperatures began rising rapidly, reaching 36.1 °C (97 °F) by 3:43 AM, and 37.8 °C (100 °F) by 4:13 AM. The maximum water temperature observed at the Route 9 Bridge was 38.3 °C (101.0 °F) which occurred at 5:38 AM, approximately three hours after shutdown of the dilution pumps. Route 9 Bridge surface water temperatures remained about 37.8 °C (100 °F) for much of the day until dilution pump operation was restored, which later reduced temperatures at Route 9 Bridge surface water to under 30.6 °C (87 °F).

Oyster Creek Generating Station Water and Air Temperatures - 23Sep2002

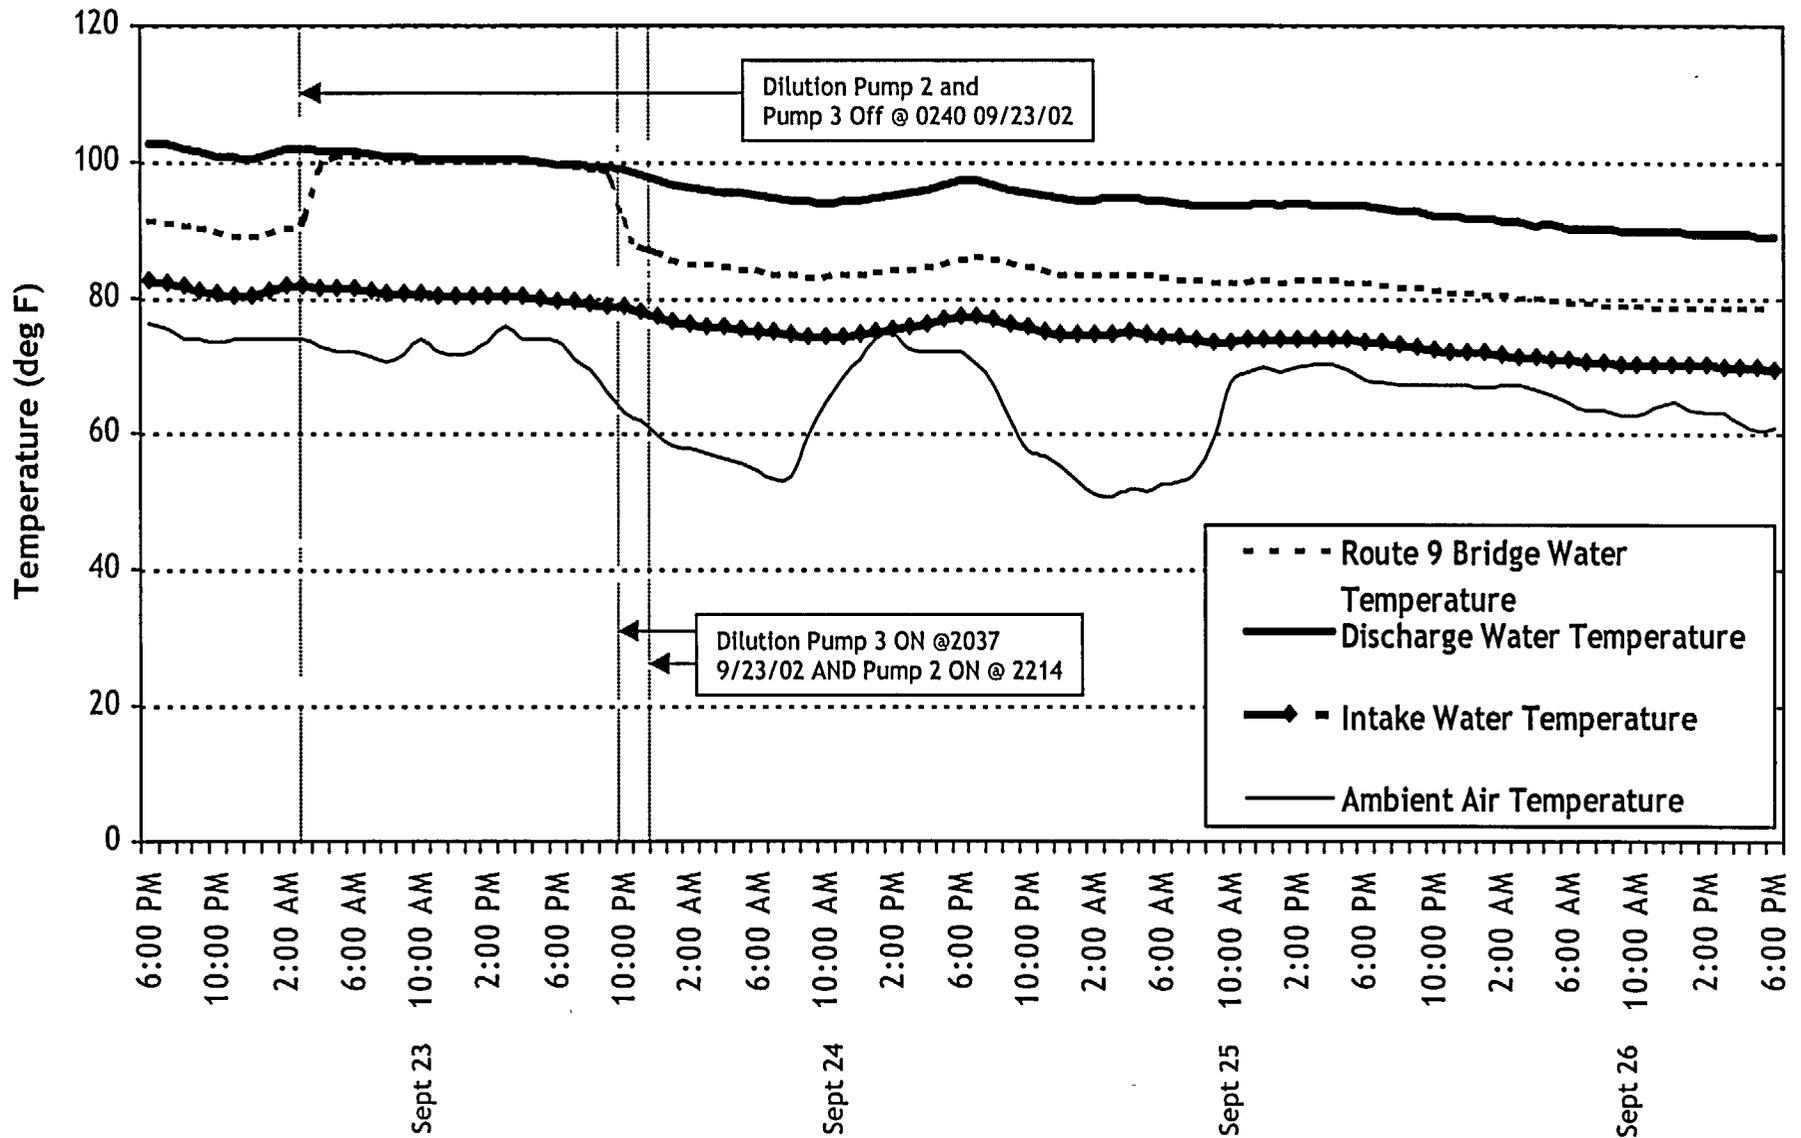
Figure 2
Oyster Creek Generating Station
Water and Air Temperatures
22Sep2002 Through 26Sep2002

The September 23, 2002 fish kill event resulted from the inability of many of the fish and invertebrate species inhabiting the OCGS discharge canal to tolerate the relatively high water temperatures they encountered in the discharge canal subsequent to shutdown of the dilution pumps. Intake canal temperatures were about 27.8 °C (82 °F), at the time of the dilution pump shutdown on September 23 (Figure 1). The Main Condenser discharge temperature at the time of the shutdown was approximately 38.9 °C (102 °F), resulting in a delta T of about 11.1 °C (20 °F). The rapid increase in discharge canal temperature as measured at the Route 9 Bridge surface water (from about 32.7 °C / 90.9 °F to over 37.7 °C / 100 °F in 95 minutes), which occurred following the dilution pump shutdown (Figure 1), appears to have induced heat shock relatively rapidly. The discharge canal temperature increased to about 38.3 °C (101 °F) at the Route 9 Bridge surface water about three hours after the dilution pump shutdown, then remained between 37.2 °C and 38.3 °C (99 °F to 101 °F) until after the first dilution pump was restarted at 8:37 PM (Figure 2).
