INVESTIGATION OF THE IMPACT OF IN-REACTOR SHORT-TERM DRY-OUT INCIDENTS ON FRESH AND PRE-IRRADIATED FUEL CLADDING

M.A. McGrath¹, B.C. Oberlander², T. Anegawa³ and T. Hara³

OECD Halden Reactor Project, Norway

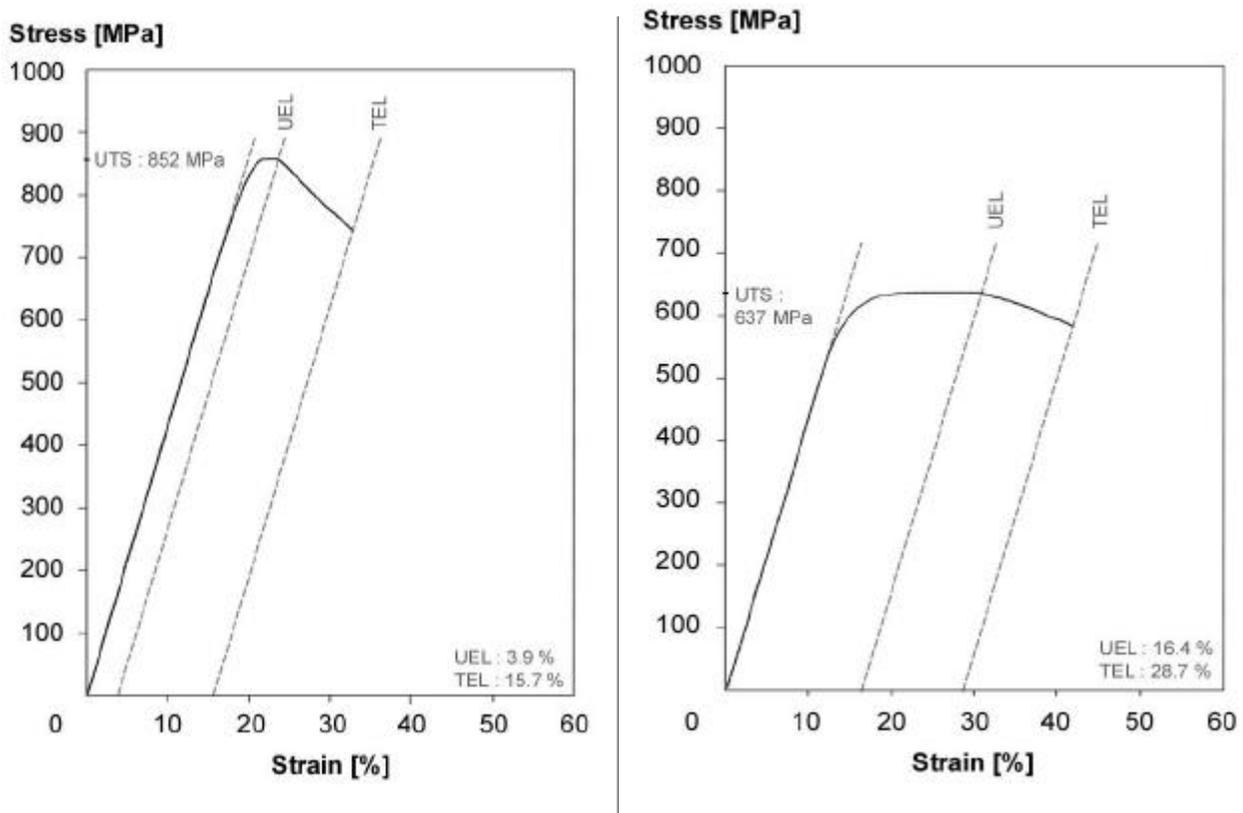
The results from room temperature tensile testing varied in accordance with this observed axial variation in microstructure. The "unaffected zone" at the bottom of the rods showed high UTS and intermediate ductility (see Figure 1(a)). Moving upwards the UTS showed a sharp drop in value accompanied with an increase in ductility. This trend continued until a maximum in the ductility coincided with a minimum in the UTS (see Figure 1(b)). Further up the rod, the ductility decreased to below the value for the non-affected zone, eventually being practically zero in the peak temperature dry-out zone at the top of the rods. However, despite the severe in-pile dry-out testing received by the first six rods, they did not fail in-pile, either during the quench or the subsequent month of normal reactor operating conditions.

Test rods, both pre-irradiated and fresh, that experienced less severe transients (PCTs of 750-850°C) only exhibited a significant improvement in room temperature clad ductility in the dry-out zone, where a small α -phase grain structure was retained throughout the transient testing.

Figure 1. Stress strain curves generated from room temperature tensile testing of clad from a fuel rod exposed to in-pile dry-out from (a) unaffected zone and (b) dry-out zone (PCT < 850°C).
