## INVESTIGATION OF THE IMPACT OF IN-REACTOR SHORT-TERM DRY-OUT INCIDENTS ON FRESH AND PRE-IRRADIATED FUEL CLADDING

OECD Halden Reactor Project, Norway

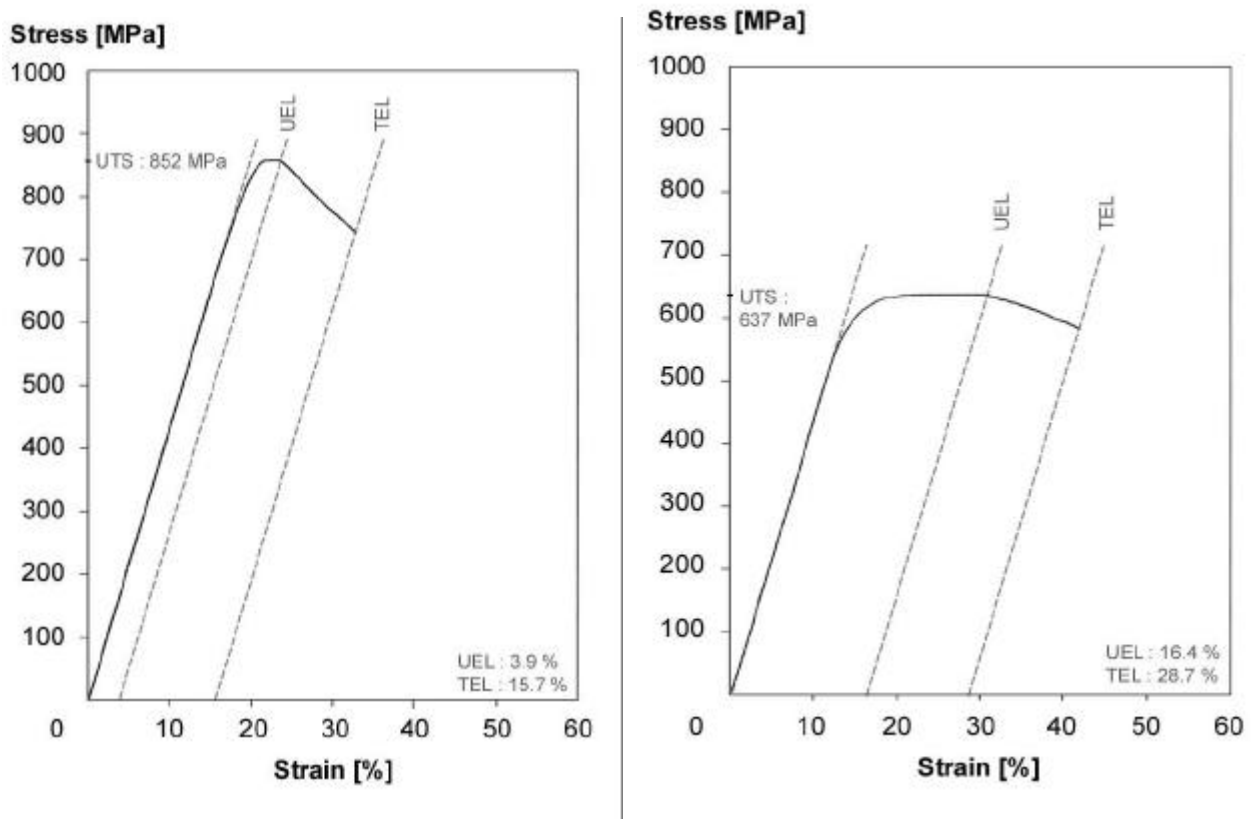
The results from room temperature tensile testing varied in accordance with this observed axial variation in microstructure. The "unaffected zone" at the bottom of the rods showed high UTS and intermediate ductility (see Figure 1(a)). Moving upwards the UTS showed a sharp drop in value accompanied with an increase in ductility. This trend continued until a maximum in the ductility coincided with a minimum in the UTS (see Figure 1(b)). Further up the rod, the ductility decreased to below the value for the non-affected zone, eventually being practically zero in the peak temperature dry-out zone at the top of the rods. However, despite the severe in-pile dry-out testing received by the first six rods, they did not fail in-pile, either during the quench or the subsequent month of normal reactor operating conditions.

Test rods, both pre-irradiated and fresh, that experienced less severe transients (PCTs of 750-850°C) only exhibited a significant improvement in room temperature clad ductility in the dry-out zone, where a small  $\alpha$ -phase grain structure was retained throughout the transient testing.

Figure 1. Stress strain curves generated from room temperature tensile testing of clad from a fuel rod exposed to in-pile dry-out from (a) unaffected zone and (b) dry-out zone (PCT<850°C).
