Nuclear Management Company, LLC  
Point Beach Nuclear Plant  
6610 Nuclear Road  
Two Rivers, WI 54241

Docket Number 50-301  
Point Beach Nuclear Plant, Units 2  
Licensee Event Report 301/2002-002-01  
Pressurizer Safety Valve Failed to Lift at Test Pressure

TITLE (4)  
PRESSURIZER SAFETY VALVE FAILED TO LIFT AT TEST PRESSURE

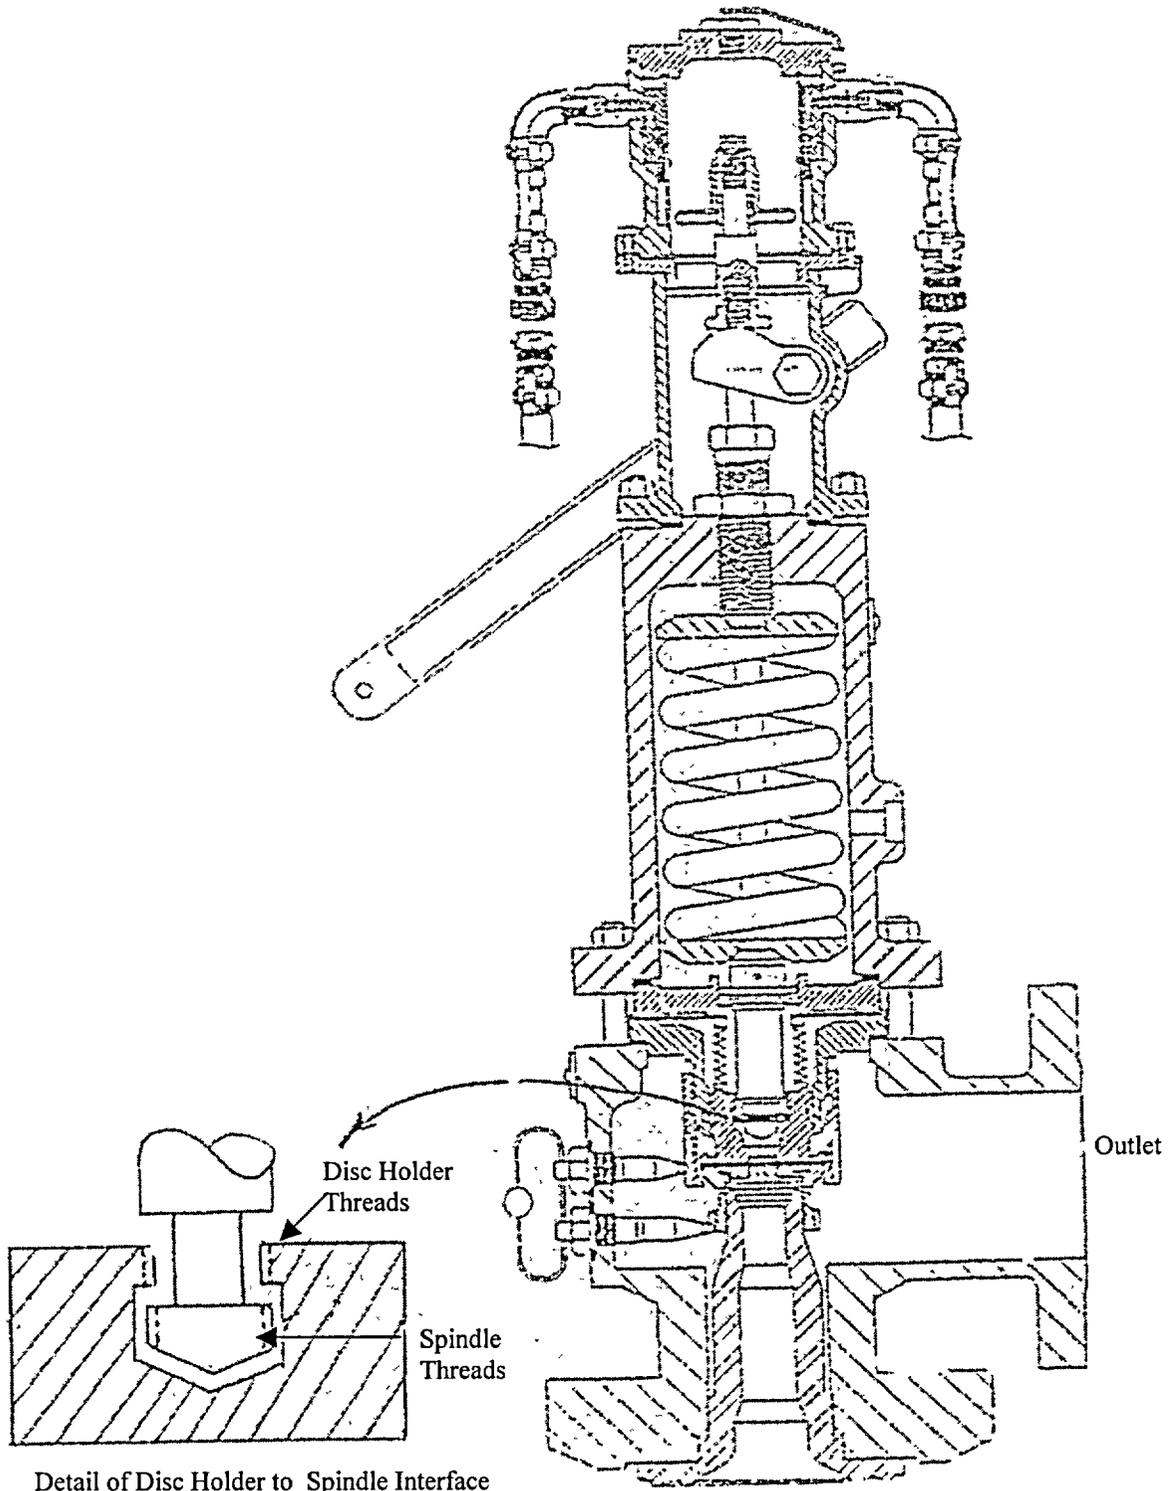
PRESSURIZER SAFETY VALVE - FOR INFORMATION ONLY

The vendor has determined that the cause of this failure of a pressurizer safety valve to lift at the appropriate test pressure was due to improper reassembly of the valve following the previous valve testing in November 2000. Following as-left set point testing of the valve, the valve is tested for seat leakage at 90% of test pressure. If the valve fails this leak test, the valve disc and nozzle are typically lapped, or polished, to remove any slight steam cutting of the valve which can occur during the lift point testing. The valve is then reassembled and leak tested again to ensure that the valve will remain leak tight following reinstallation in the plant. The lapping requires partial disassembly of the valve to separate the valve body from the bonnet. This can be accomplished without affecting the spring setting or lift set point of the valve. However, during the reassembly of the valve following the lapping in November 2000, the technician failed to ensure that the spindle and disc holder were fully engaged, leaving the spindle threads engaged in the disc holder threads (See drawing attached). This caused the actual lift point of the safety valve to exceed the allowable limits. No measurements or testing was conducted following the reassembly to ensure the valve set point was unaffected by the disassembly. The valve manufacturer has estimated that the actual lift point of the misassembled valve would have exceeded 3000 psig, rendering the valve inoperable during the past operating cycle.

Detail of Disc Holder to Spindle Interface  
(Shown Fully Inserted)  
Incomplete Assembly is with Threads  
Engaged

Following the identification of the cause of this valve failure to lift within its prescribed set-point range, Crane has revised their testing and overhaul procedures to require a dimensional check of the valve before and after any disassembly to perform valve lapping. The dimensional check, taken from the top of the valve spindle to the top of the adjusting nut, provides a verification that the valve has been correctly reassembled, and that the spindle threads are not engaged in the disc holder, and the spring setting adjustment bolt, which sets the valve lift point, has not been disturbed.

- Adding procedural guidance on the proper engagement of the disc holder to spindle,
- Adding a procedural requirement that dimensional checks be preformed pre and post "jack and lap" to insure proper assembly of the disc holder to spindle, and
- Adding a required nitrogen pop test to verify valve operability post "jack and lap."
