BRUNSWICK STEAM ELECTRIC PLANT, UNIT NOS. 1 AND 2
DOCKET NOS. 50-325 AND 50-324/LICENSE NOS. DPR-71 AND DPR-62
INSERVICE INSPECTION PROGRAM RELIEF REQUEST - SERVICE WATER
SYSTEM PIPING THROUGH-WALL FLAW

Relief Requested
In Accordance with 10 CFR 50.55a(g)(5)(iii)

Structural Integrity Assessment

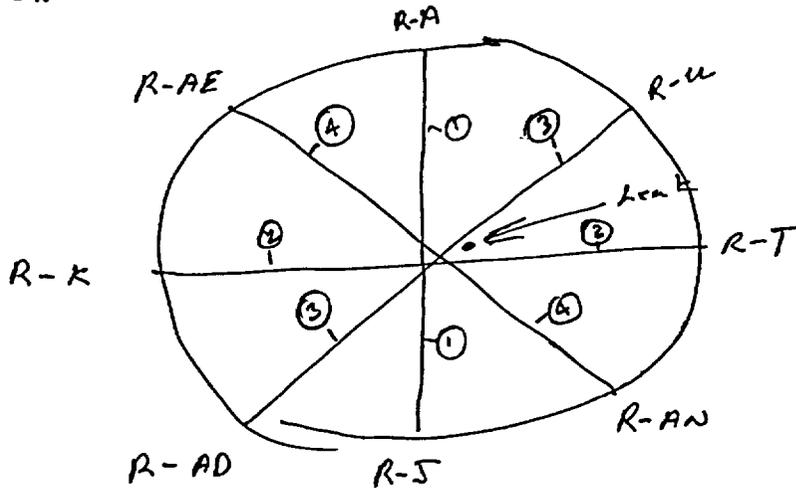
THROUGH WALL LEAK ON SW FLANGE 1" SPACING FOR READINGS LINE2-SW-29-6-046

Maximum Reading = 0.989 (1, T) Average = 0.507
Minimum Reading = 0.113 (1, Y) Standard Deviation = 0.322
Total Readings = 40

Readings started 1" in from Flange Edge on 1" spacings
Leak off of center line at Reading "P"
