ANO-1 Reactor Vessel Nozzle Repair

**Entergy Operations Inc.
October 16, 2002**

Repairs Performed During 1R16 on Nozzle 56

1R17 CRDM Nozzle Weld Repair

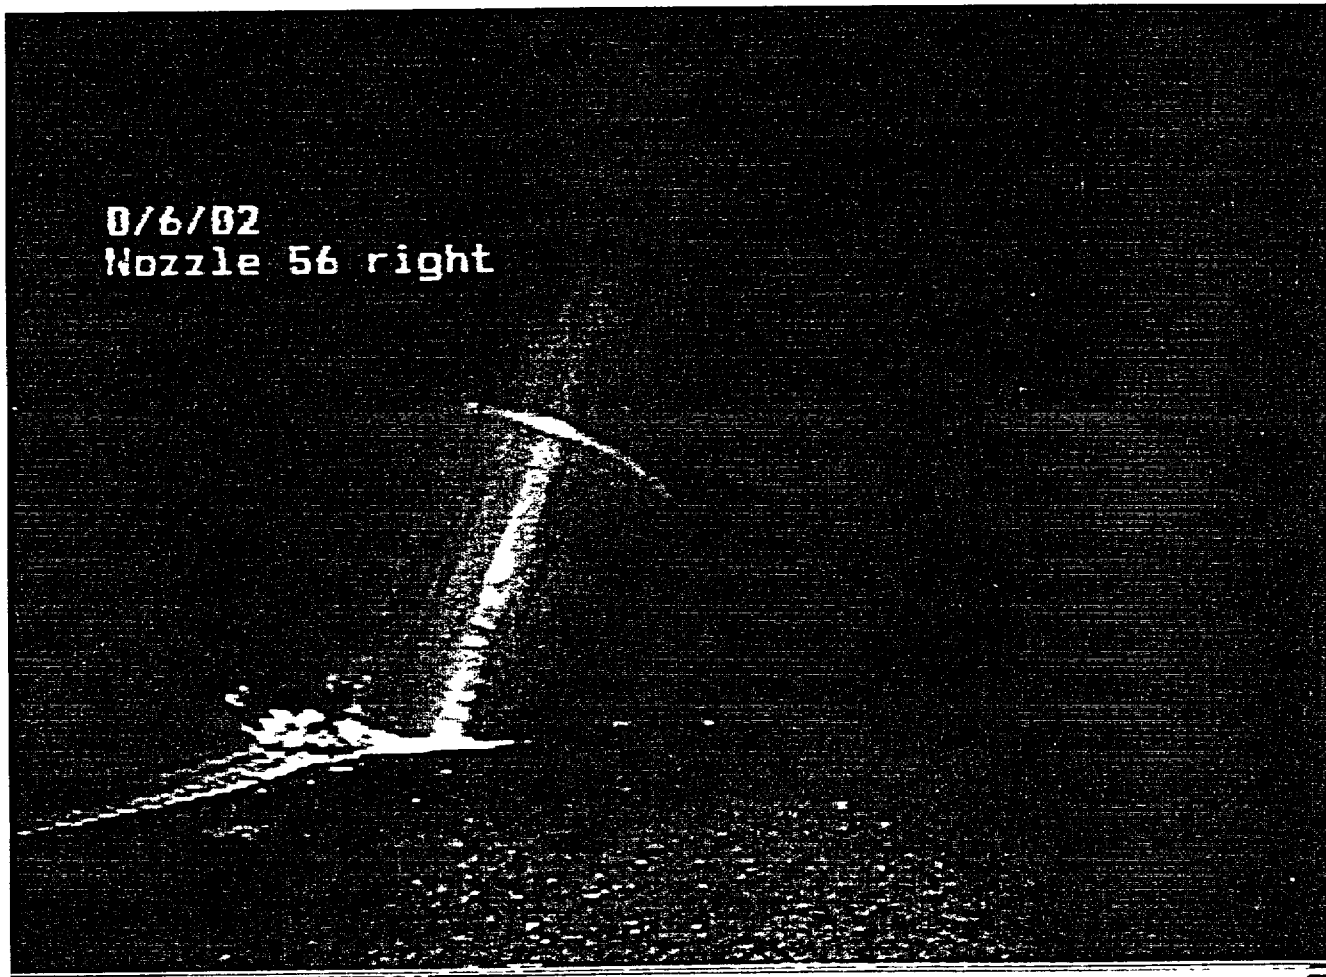
1R17 Nozzle 56 Boric Acid

- Nozzle 56 Determined to be the only leaking nozzle
- No evidence of wastage

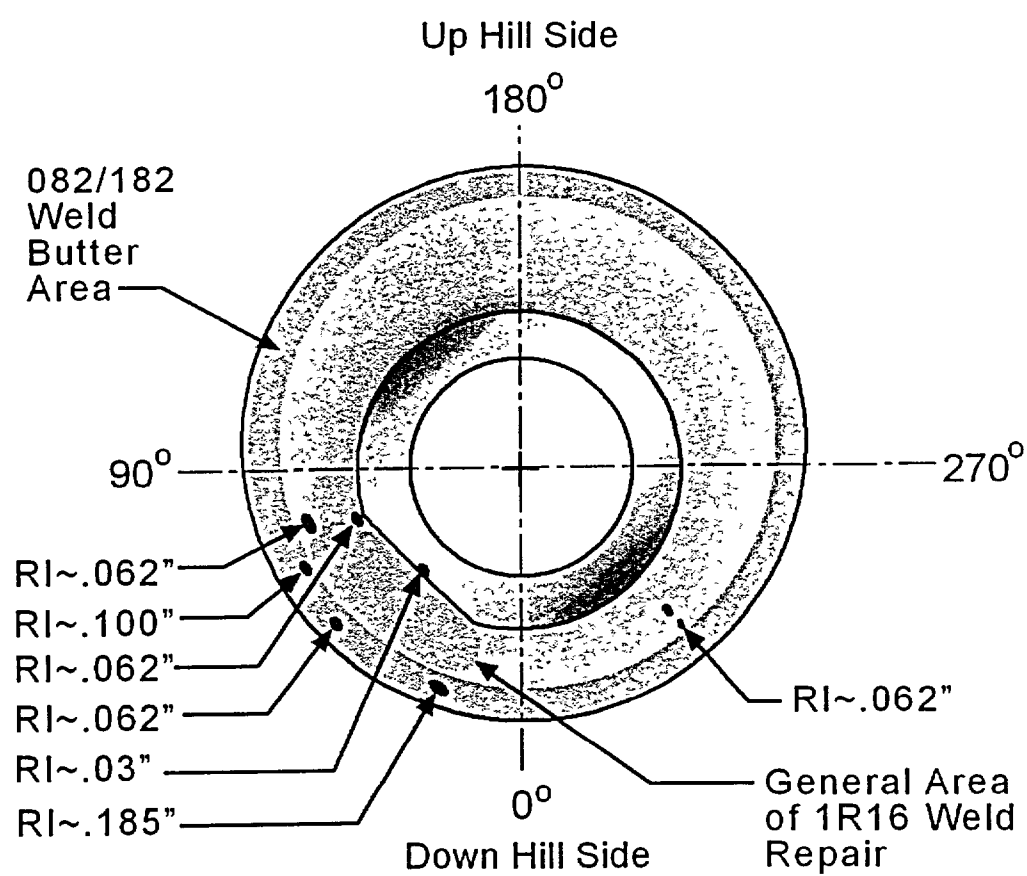
PT Layout of Nozzle 56

- ❖ Four Indications Adjacent to 1R16 Weld Repair
- ❖ Two Indications on Hill Side of Nozzle

- ❖ No Indications Identified to Have Circumferential Extent
