# Davis-Besse Reactor Vessel Head Damage NRC UPDATE

November 2002

This is the third periodic update on the NRC response to the reactor vessel head damage at the Davis-Besse Nuclear Power Station. The updates will be available at public meetings of the NRC Davis-Besse Oversight Panel which is coordinating the agency's activities related to the damage. Each update will include background information to assist the reader in understanding issues associated with the corrosion damage.

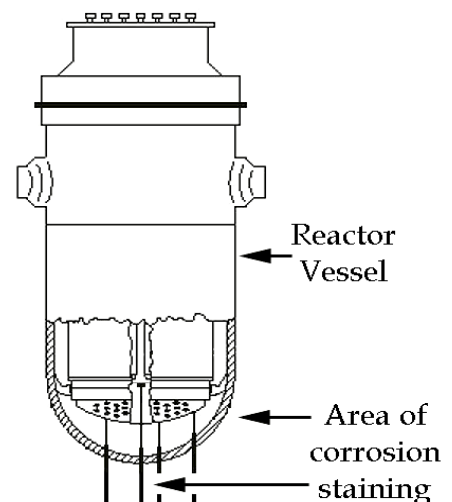
### Results of Bottom Nozzle Tests Are Inconclusive

FirstEnergy identified rust stains on the bottom of the reactor vessel earlier this year. The stains became visible in June when plant workers removed the insulation from the reactor vessel in order to examine its condition. The licensee believes the stains probably resulted from previous cleaning of the reactor vessel head. A less likely possibility was that the stains resulted from leakage from the penetrations for incore monitoring tubes. There has been no history of such leakage in other U.S. pressurized water reactors. There are 52 tubes, each less than one inch in diameter, which contain incore monitoring devices used to measure conditions in the reactor.

The utility's consultant, Framatome, compared the chemical composition of the corrosion on the top of the reactor vessel head to the stains on the bottom. The testing showed some variation between chemical composition of corrosion products from the top of the reactor and stains on the bottom. The analyses, however, did not provide a conclusive link to the upper vessel head cleaning, nor did they show evidence of leakage from the incore tube penetrations.

Davis-Besse is reviewing its options for definitive testing of the bottom nozzles for leaks. The NRC will review the utility's testing and inspection plans and monitor the tests. The issue will be resolved prior to the NRC considering whether the plant can restart.
