St Lucie Unit 1-18 RVHP Inspection Results and Issues October 12, 2002

St. Lucie Unit 1 RVHP Exam Results

St Lucie Unit 1-18
RVHP Inspection Results
and Issues
October 10, 2002

Attachment 2
ENCLOSURE 2

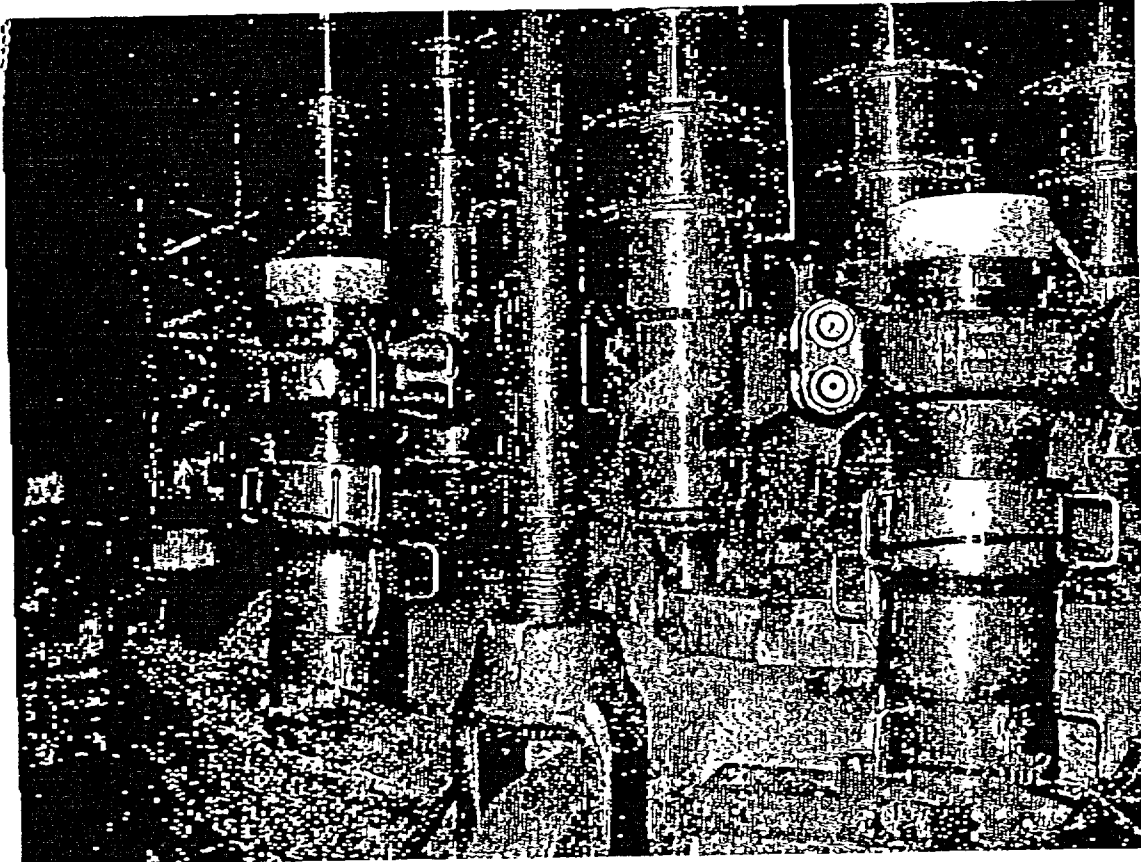
- All 78 penetrations reached in all 4 quadrants
 - No wastage or evidence of boric acid leakage
 - Difficult exam due to the close fitting insulation and asbestos collars
 - Some debris noted- asbestos - not relevant, not significant compared to the EPRI Visual Guidelines report.
 - Will clean/remove debris from representative sample

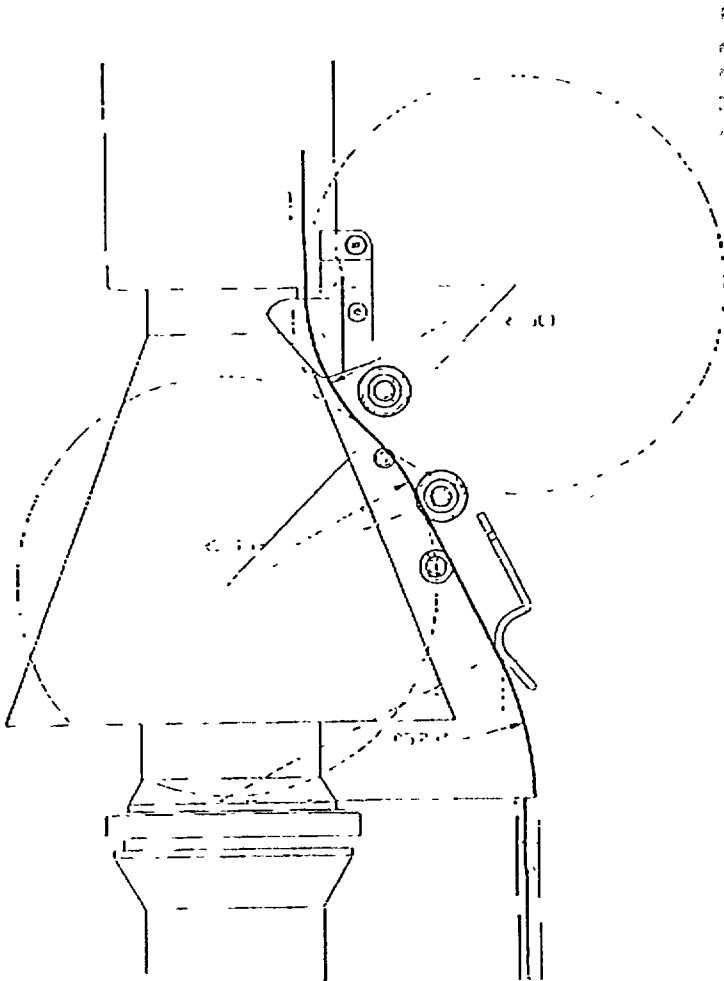
Blade
probe
path

- Experiencing lift off in material below weld root adjacent to the weld
- Missing data is typically less than 180 degrees
 - only 7 are >180 degrees of the 30 analyzed so far
- Bent guide sleeve/interference may preclude obtaining 360 degree UT scan
 - Potentially 2 CEDMs identified

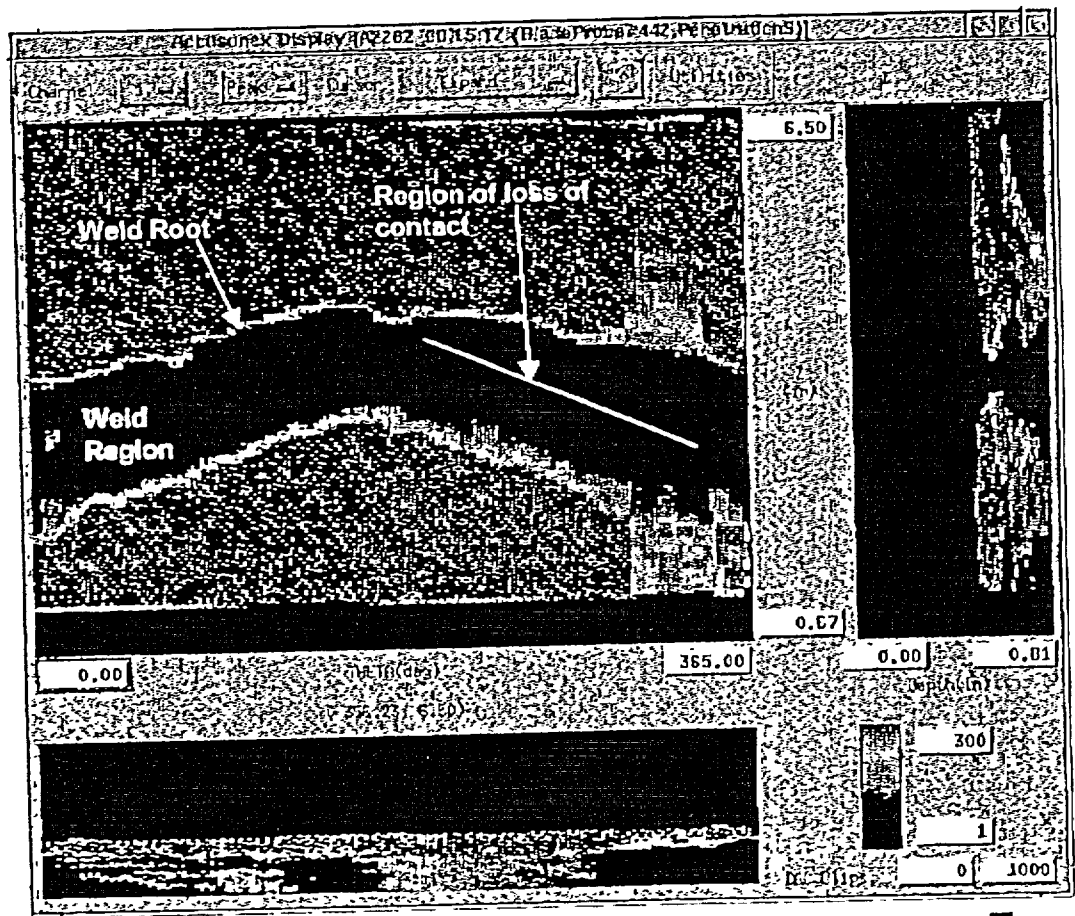
- Typical limited coverage area
- Material adjacent to weld root and above fully interrogated
- Region that safety significant circ flaws could be addressed
