**VIRGINIA ELECTRIC AND POWER COMPANY**  
**NORTH ANNA POWER STATION UNITS 1 & 2**  
**DAM SAFETY AUDIT RESPONSE FOR THE CATEGORY 1**  
**SERVICE WATER RESERVOIR**

Virginia Electric and Power Company  
Response to  
Results of Dam Safety Audits for the Category 1 Service Water  
Reservoir Dam at North Anna Nuclear Power Plant  
Dated May 10, 2002

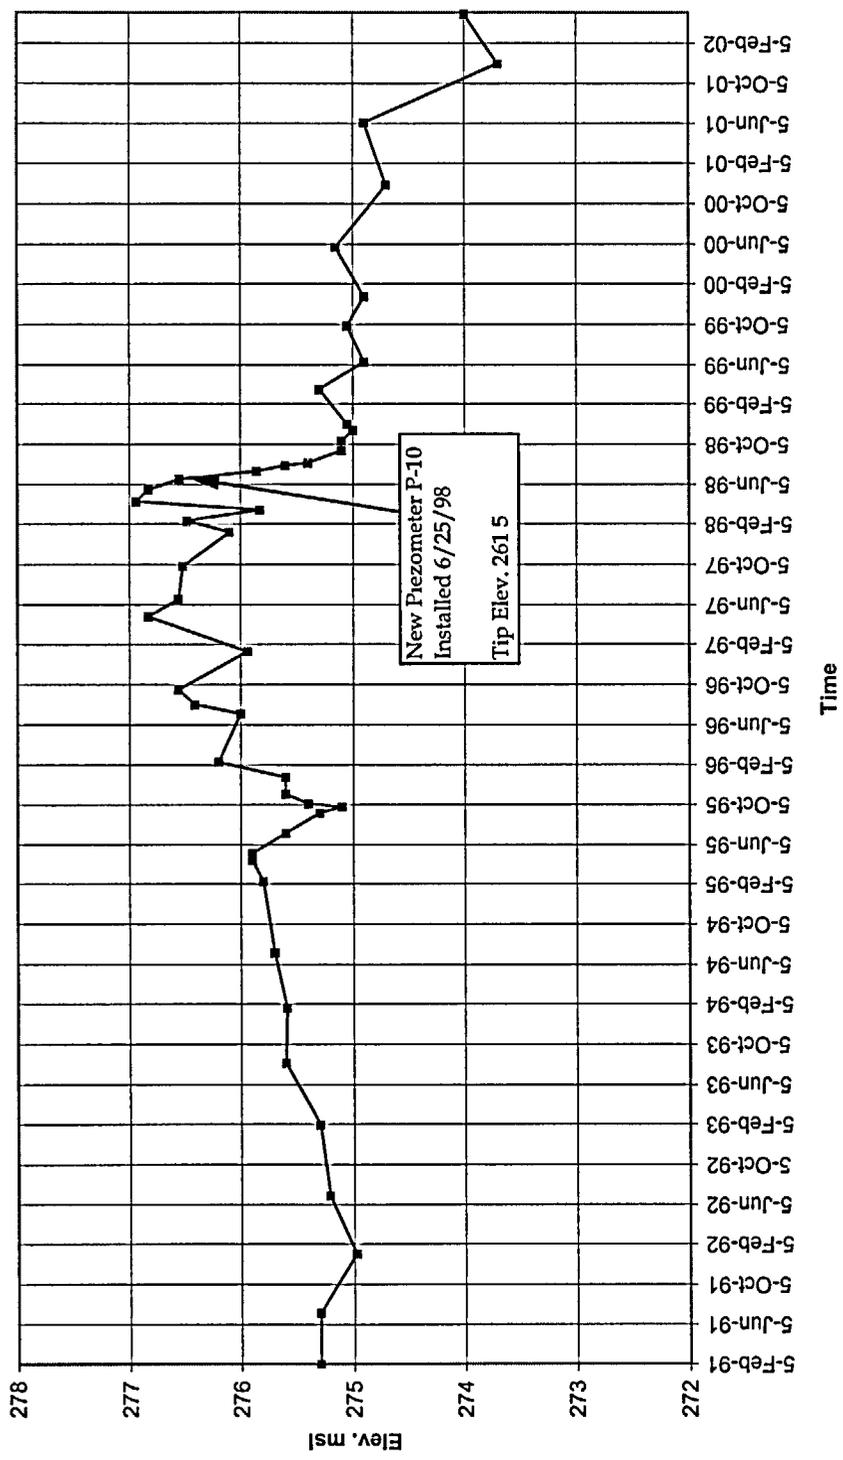
Figure 8

Piezometer 10, SWR  
Toe of SE dike. TRM limit of 280.0.

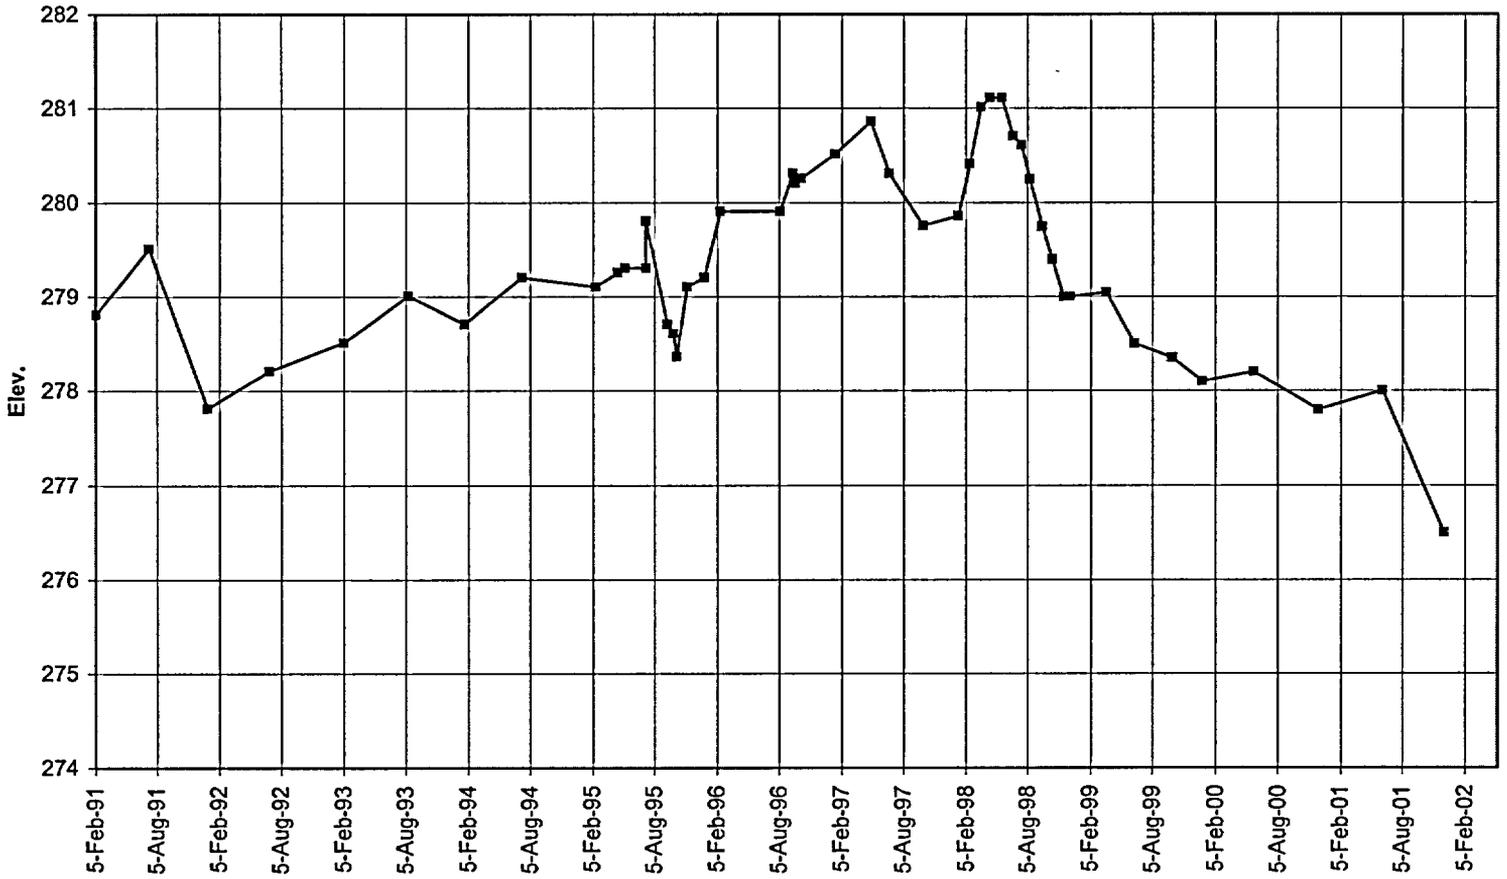
Figure 9

limits at piezometer P-22 were exceeded and subsequently an evaluation by a licensed civil engineer was submitted to the NRC. The conclusions of this evaluation noted that the increases in piezometer levels did not indicate a material increase in seepage from the SWR, only an increase in groundwater.

**Piezometer 22, SWR**  
On top of dike, southern tip of SWR. TRM limit is 295.0.

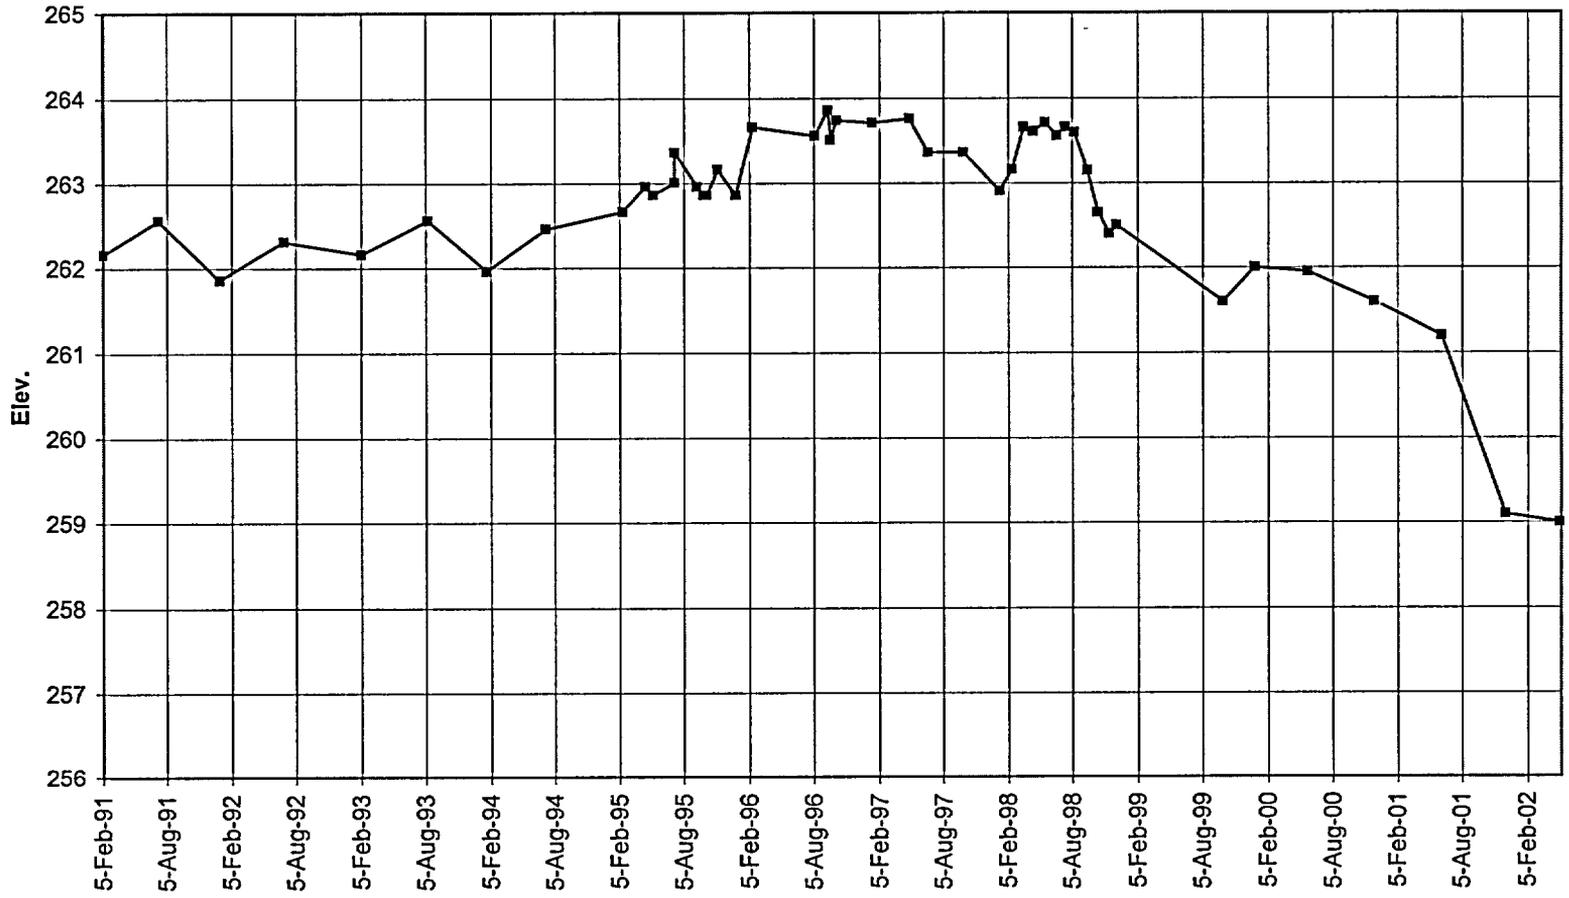
Figure 10

**Piezometer 21, SWR**  
**Top of dike, eastern tip of SWR. TRM limit 295.0.**

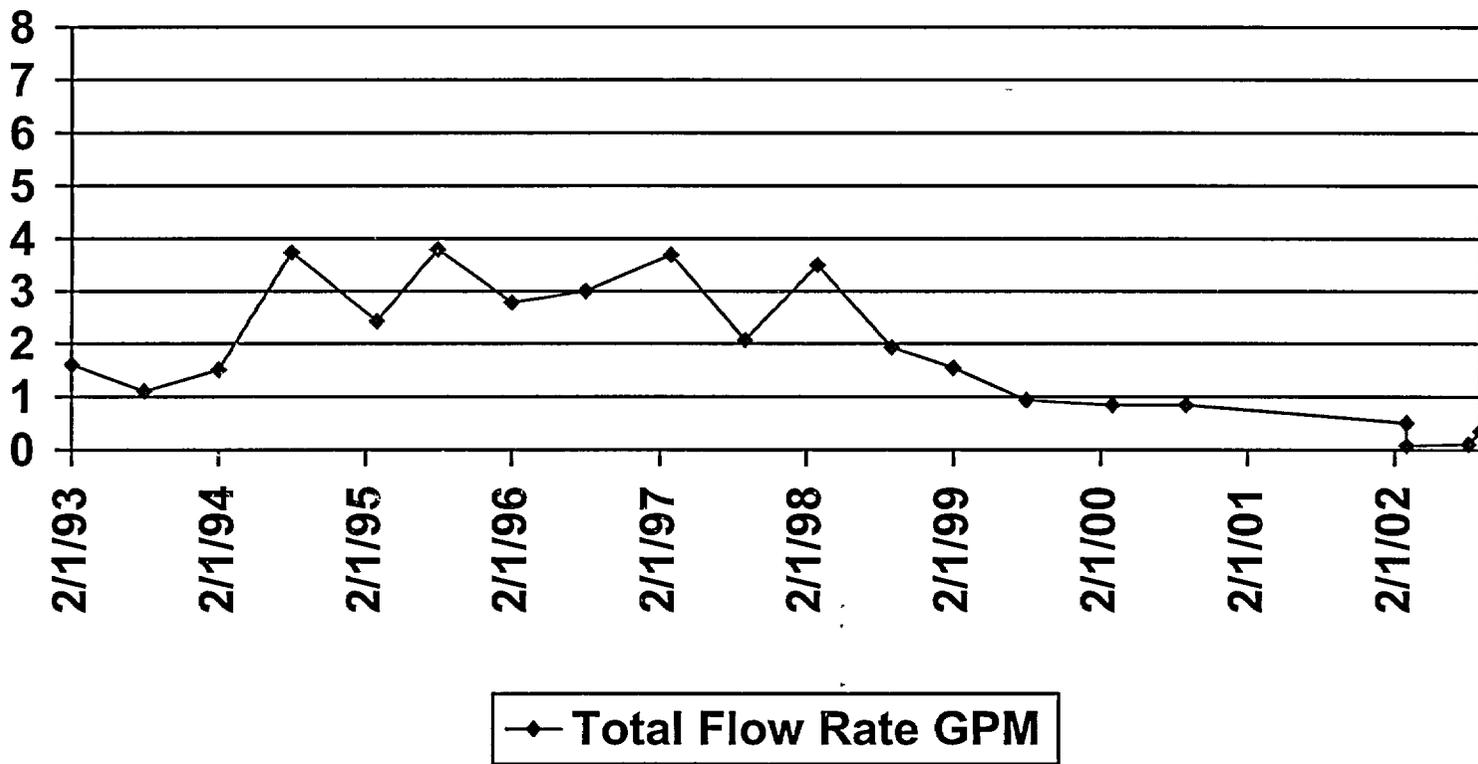
Figure 12  
SWPH Drain Flows  
(6 Outflow Drains)

**Response:** Flows from the horizontal drains beneath the SWPH have trended down consistent with the lack of precipitation over the last three years. In all but one instance, in 1997, the clarity of the flows has always been clear. Increasing to quarterly flow measurements is not considered necessary at this time.
