FPL Energy
Seabrook Station

Root Cause Analysis for CR 02-08166

Evaluation Of "D" Steam Generator Tube Cracking

Root Cause Report For "D" Steam Generator Tube Cracking

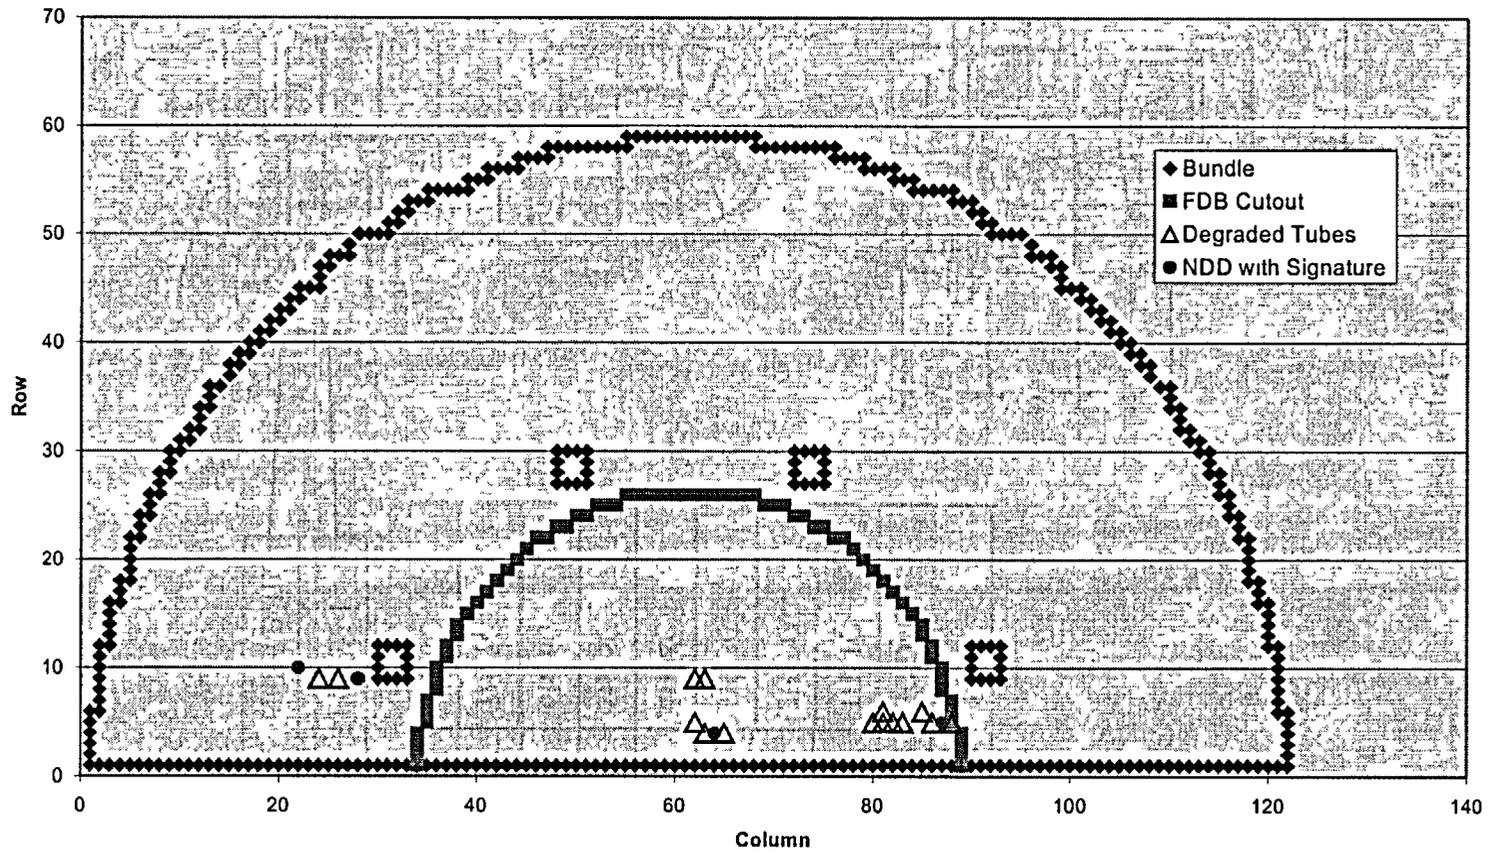
Figure 3-2 Location of Degraded Tubes

1. Seabrook has significantly less operating time than many of the other Model F SG plants that have not observed tube cracking; thus, these indications were unanticipated.
2. Indications were detected in only SG-D.
3. Indications were found at the TSP intersections and not at the top of the tubesheet (TTS) expansion transition where initial cracking would be expected.
4. Indications were reported on both the HL and CL. In all cases where a CL indication was reported, a HL indication was also reported on the same tube. CL cracking at the same time as HL cracking is unexpected due to the lower temperature on the CL.
5. All indications were confined to rows 4 through 9 (see Figure 3-2).

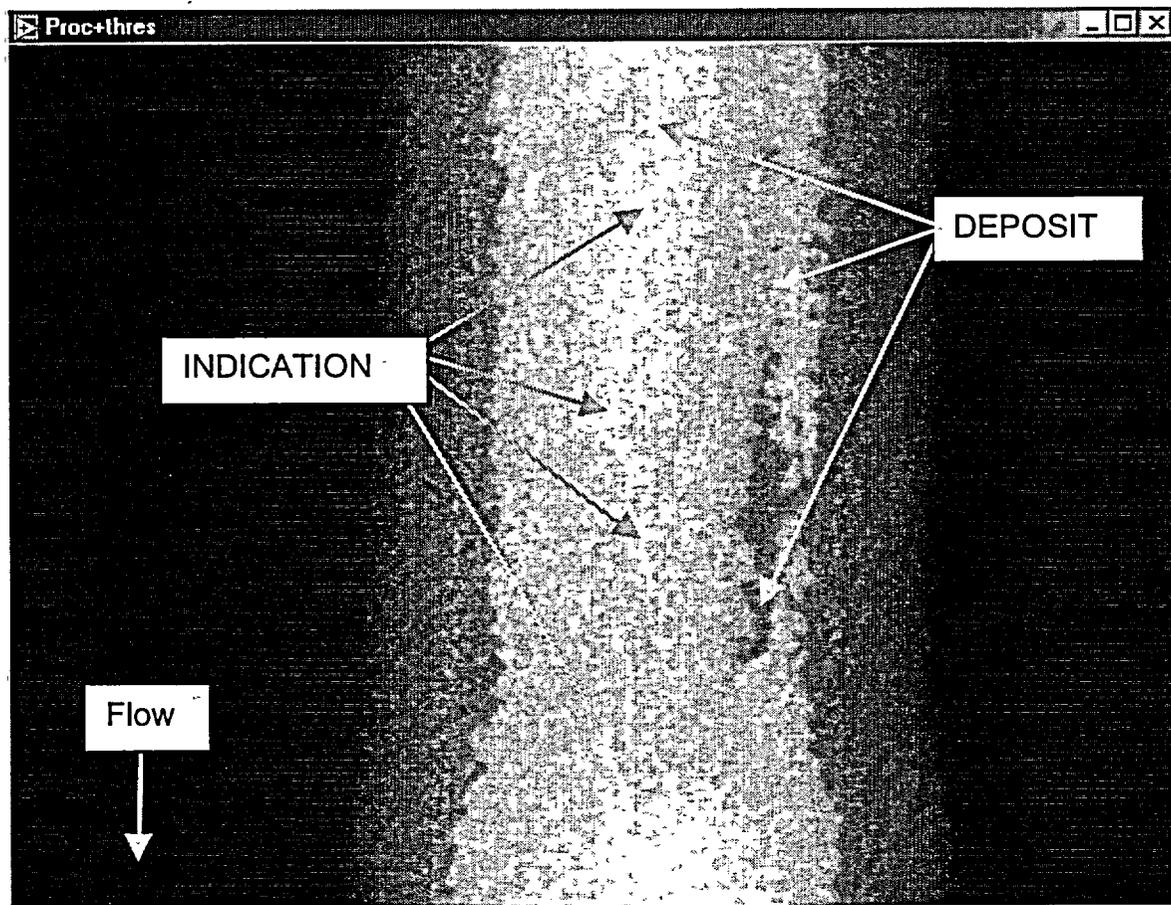
Figure 4-1 X-ray image of Seabrook tube R5C62 hot leg TSP 4 at the 210 degree orientation.

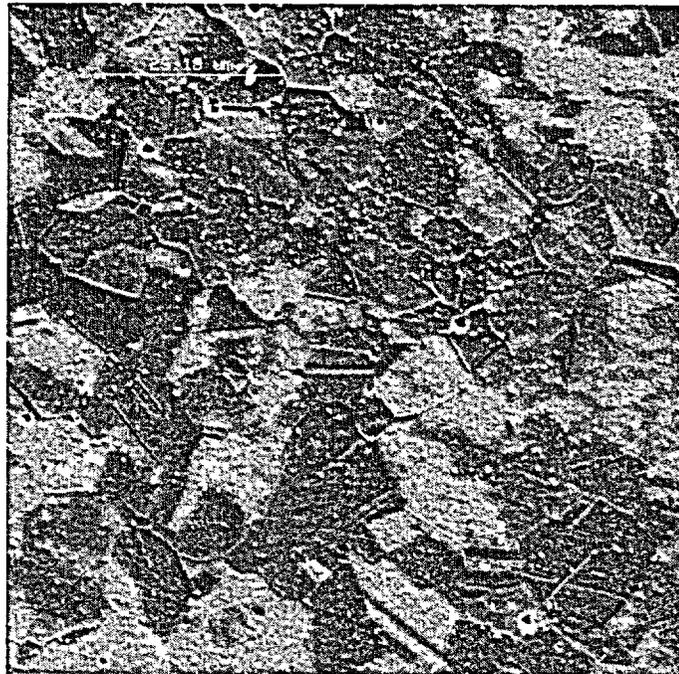
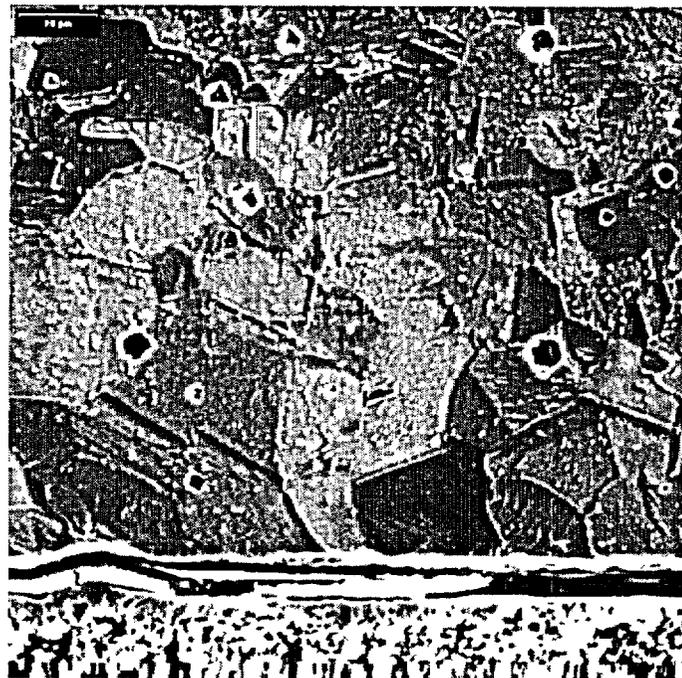
- The microstructure of the pulled tube material (Heat NX1374) is consistent with the expected range of microstructures for material that is within the material specification requirements and processed according to the approved procedures, but is not considered an optimum microstructure.

Figure 4-2 (a) R9C63 CL and (b) R5C62 HL are generally characterized by intragranular precipitation and fine grain size [ASTM 9-11]

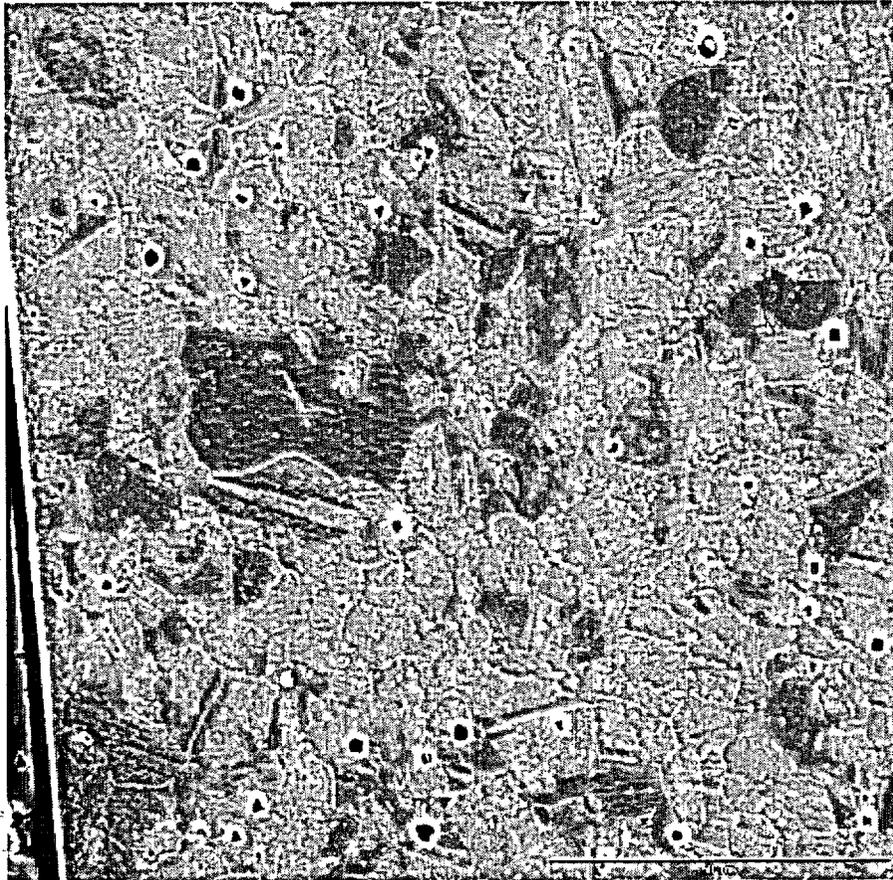
- The microstructure of an archived tube from Heat NX1374 is similar to the microstructures of the pulled tubes.
- The residual stresses in the archived tube from Heat NX1374 are lower than those measured in the pulled tubes, and similar to those expected in thermally treated tubing.
- The microstructures of archived specimens of the other two heats of material represented among the degraded tubes, Heats NX1456 and NX1457, are well within the range of expected microstructures for thermally treated Alloy 600. The microstructure of Heats NX1456 and NX1457 is better than the microstructure of Heat NX1374.

Figure 4-3 11/16" Dia. Archived Tube [Heat NX 1374] Microstructure
[Lot TF6039; TT A0206D]

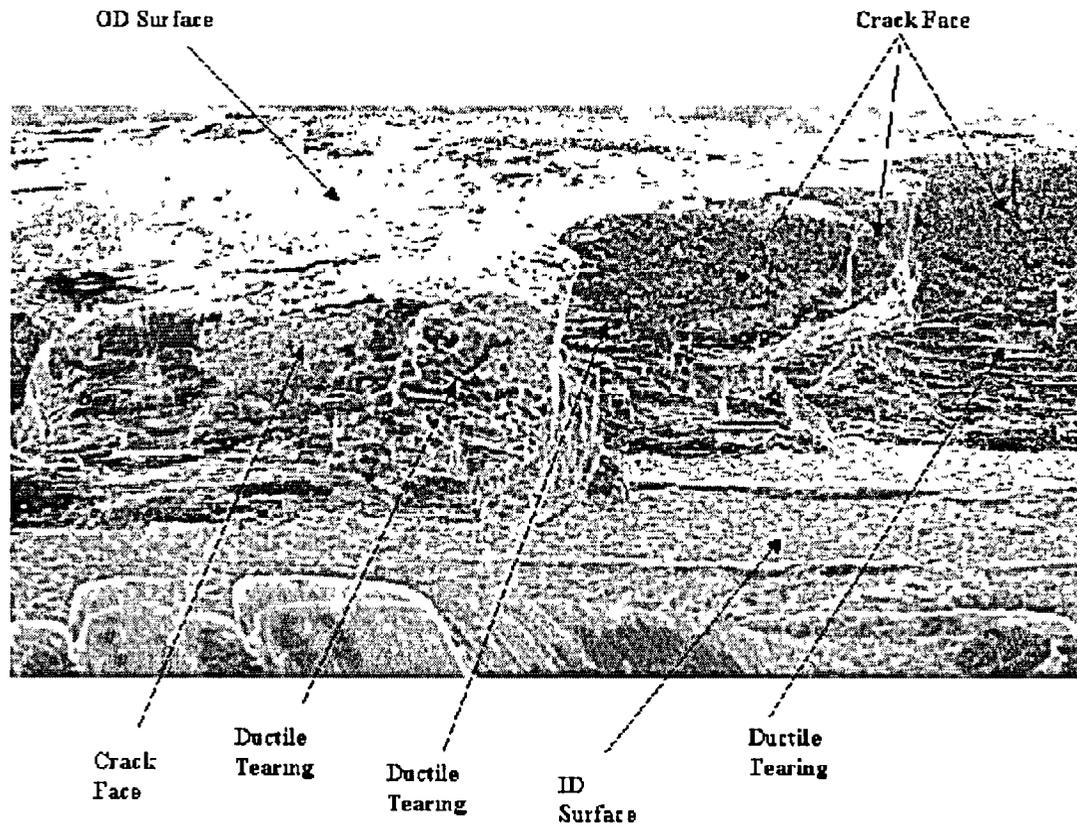
Figure 4-5

Fracture Face - Seabrook Unit 1 - R5C62HL (04H) - Piece
5B2A1 (120 degree) @ 25X

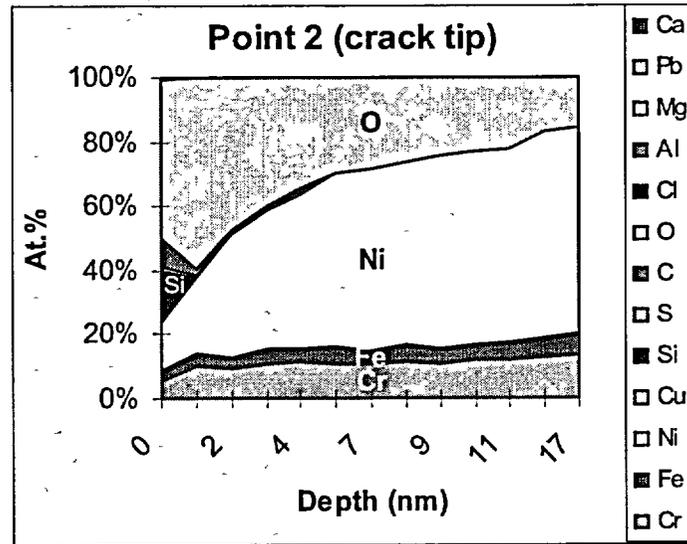
Figure 4-7 AES profile on an opened crack face from the R5C62 HL 4th TSP specimen

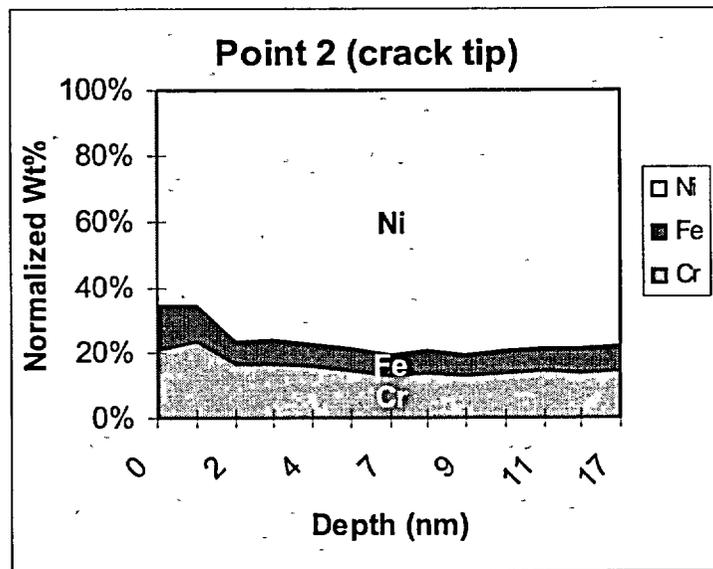
Figure 4-8. Metals Normalized AES profile on an opened crack face from the R5C62 HL 4th TSP specimen.

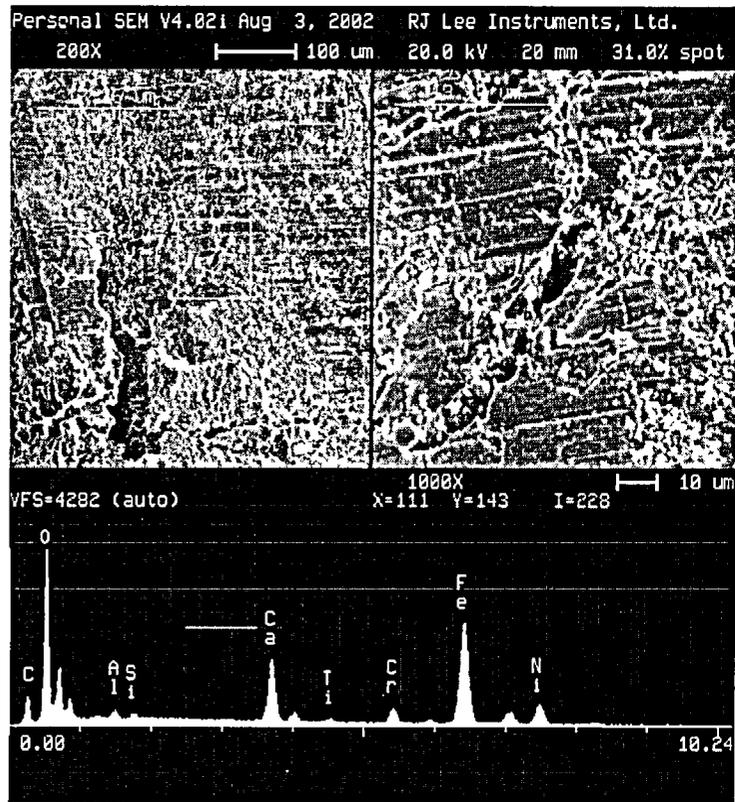
R5C62 - 02H - Piece 3B2B1@240 deg. (101EDS)
Surface deposit analysis at OD crack area

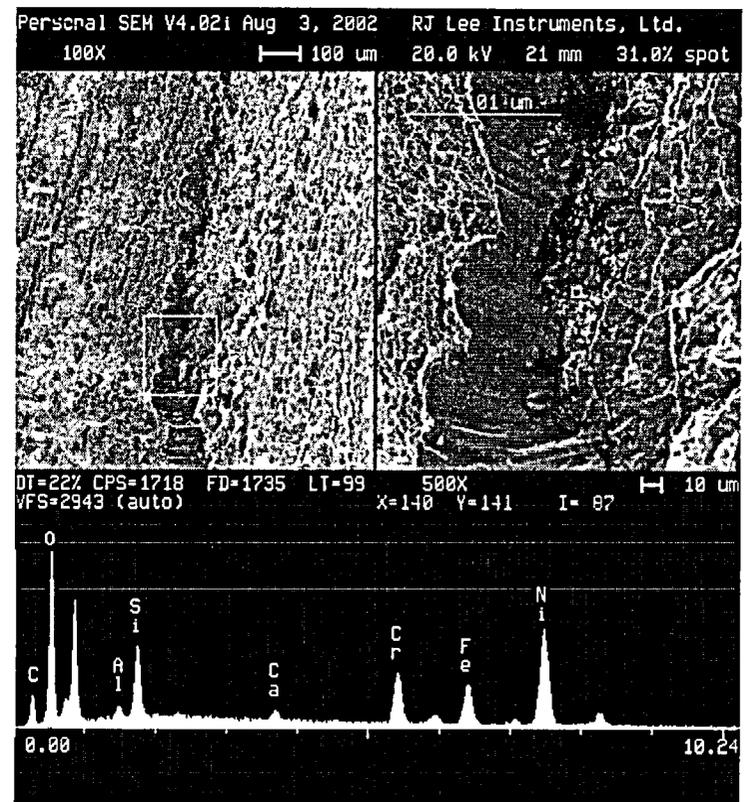
R5C62- 02H - Piece 3B2B1@240 deg. (103EDS)
Surface deposit analysis at OD crack

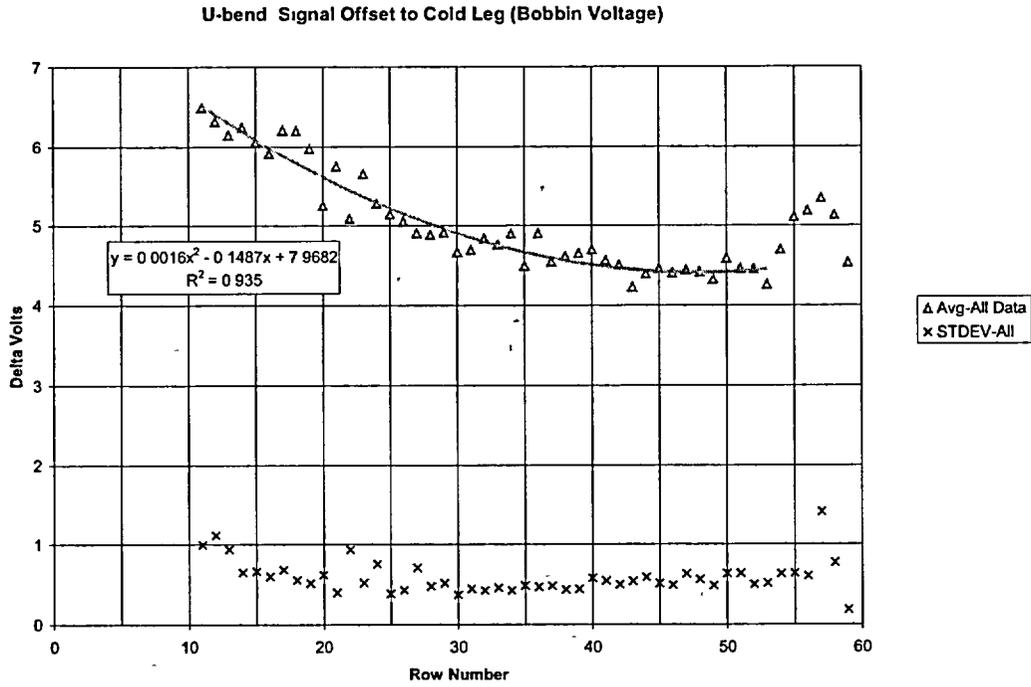
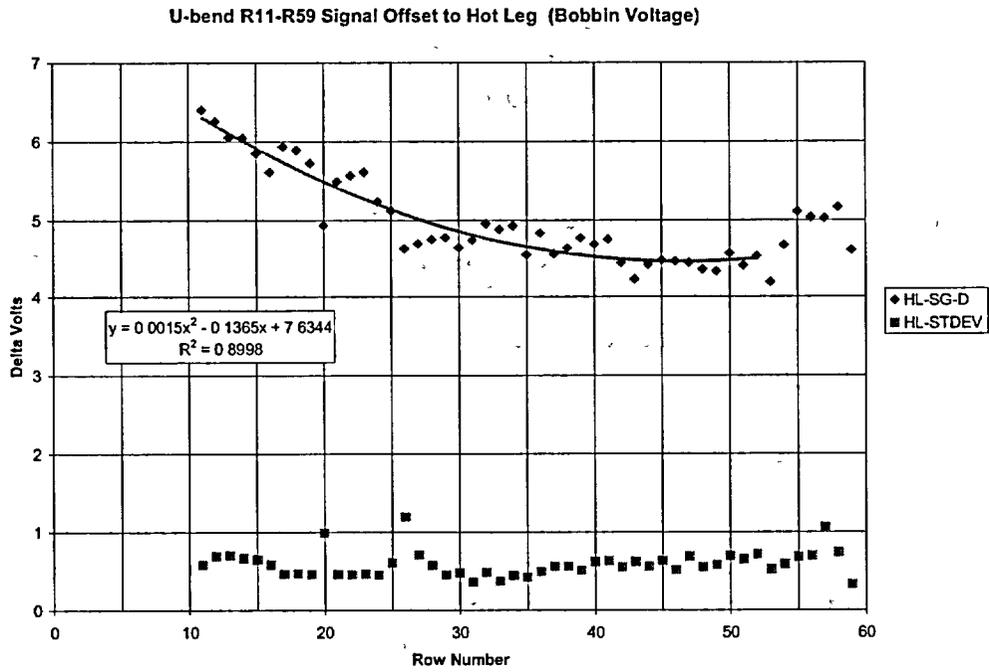
- The EC signature does not provide conclusive information regarding the potential for degradation of the tubes in Rows 11 through 59. However, the average voltage offset of the u-bend signal compared to the straight leg signal provides a good correlation with the u-bend radius. It is not possible to estimate the level of residual stress from the eddy current signature; however the signature comparison suggests that tubes in rows 11 and higher are from a common population and do not have unusually high residual stresses.

Figure 5-4 EC Signal Voltage Offset of U-bend from Straight Leg of the Tubes

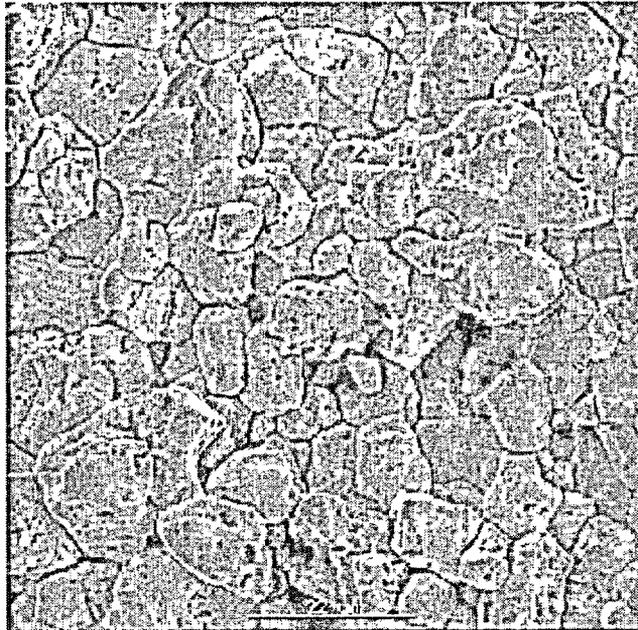
Figure 4- 3. Seabrook Service Sample R5C62 Post Modified Huey Testing

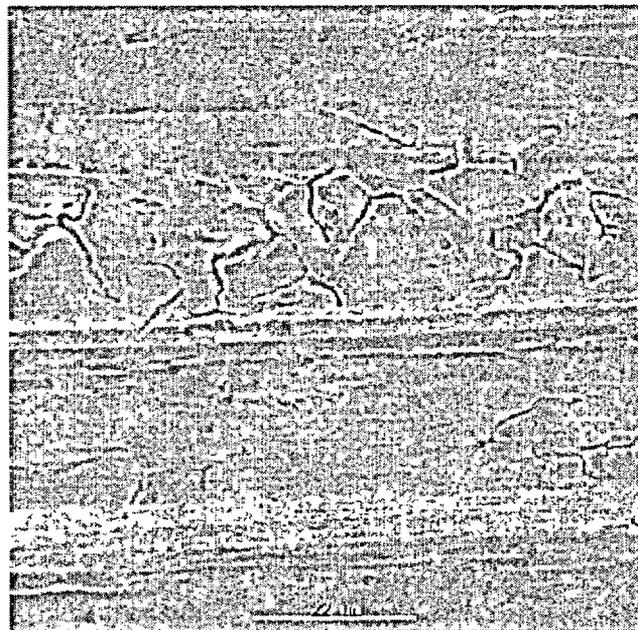
Figure 4- 4. Laboratory Thermally Treated Seabrook Service Sample R5C62 Post Modified Huey Testing

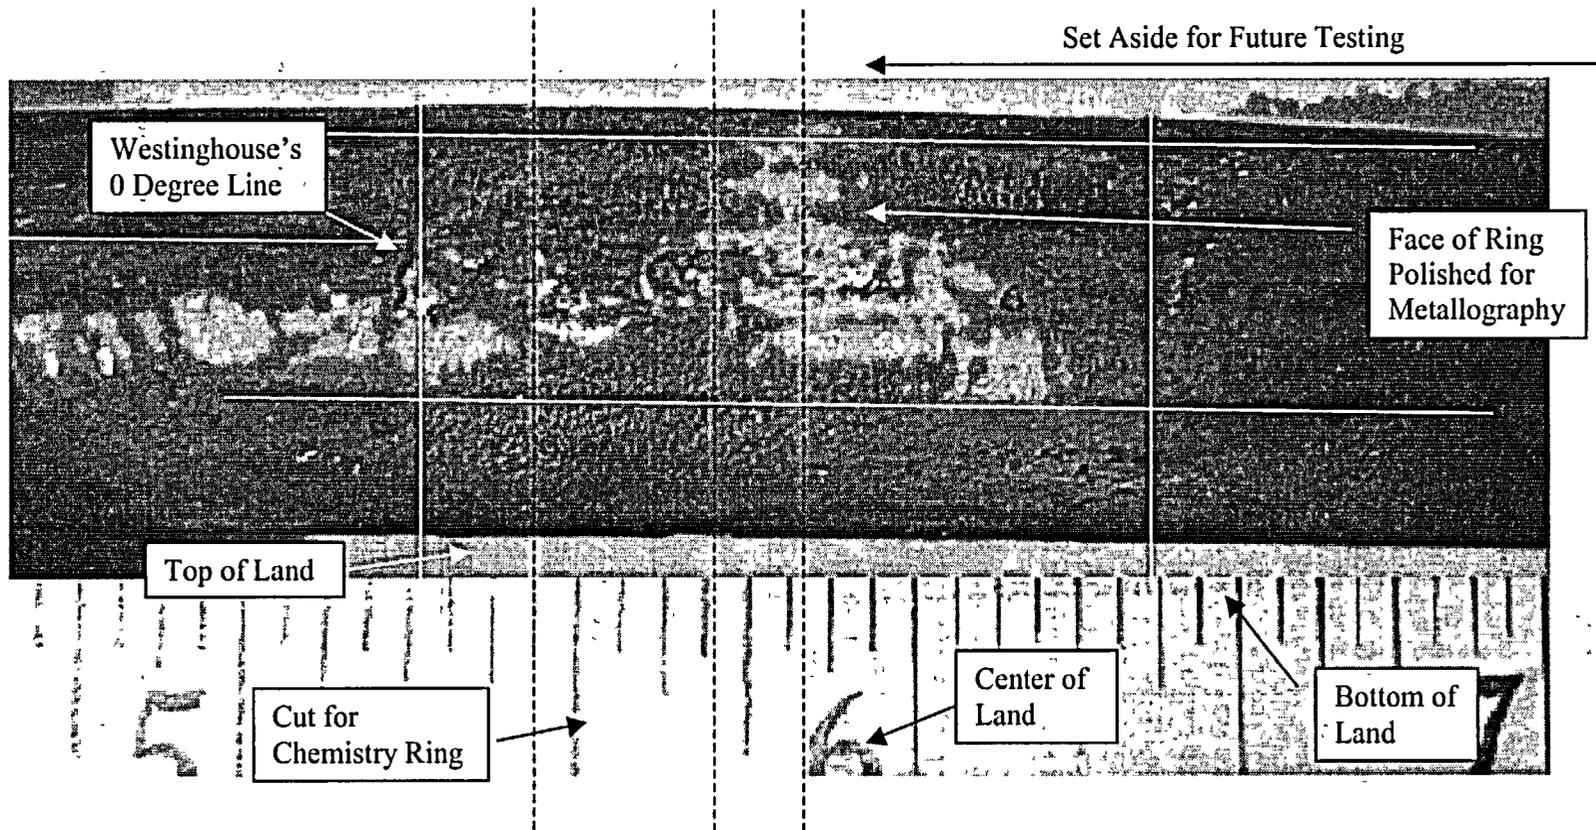
Figure 4- 5. Photograph of Land Area on Cracked Sample, Scale is in Inches

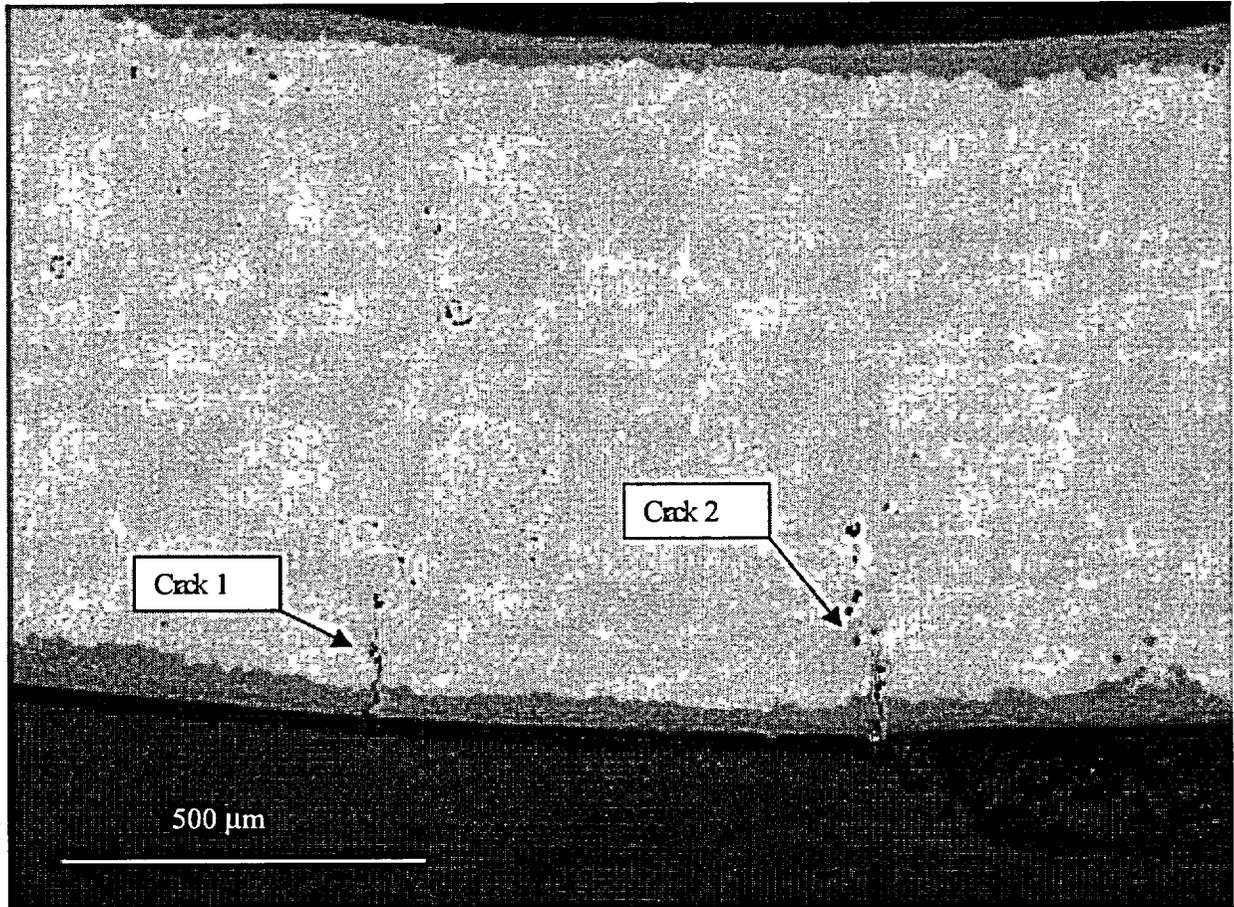
Figure 4- 6. Micrograph of Flawed Sample at the 0 Degree Position

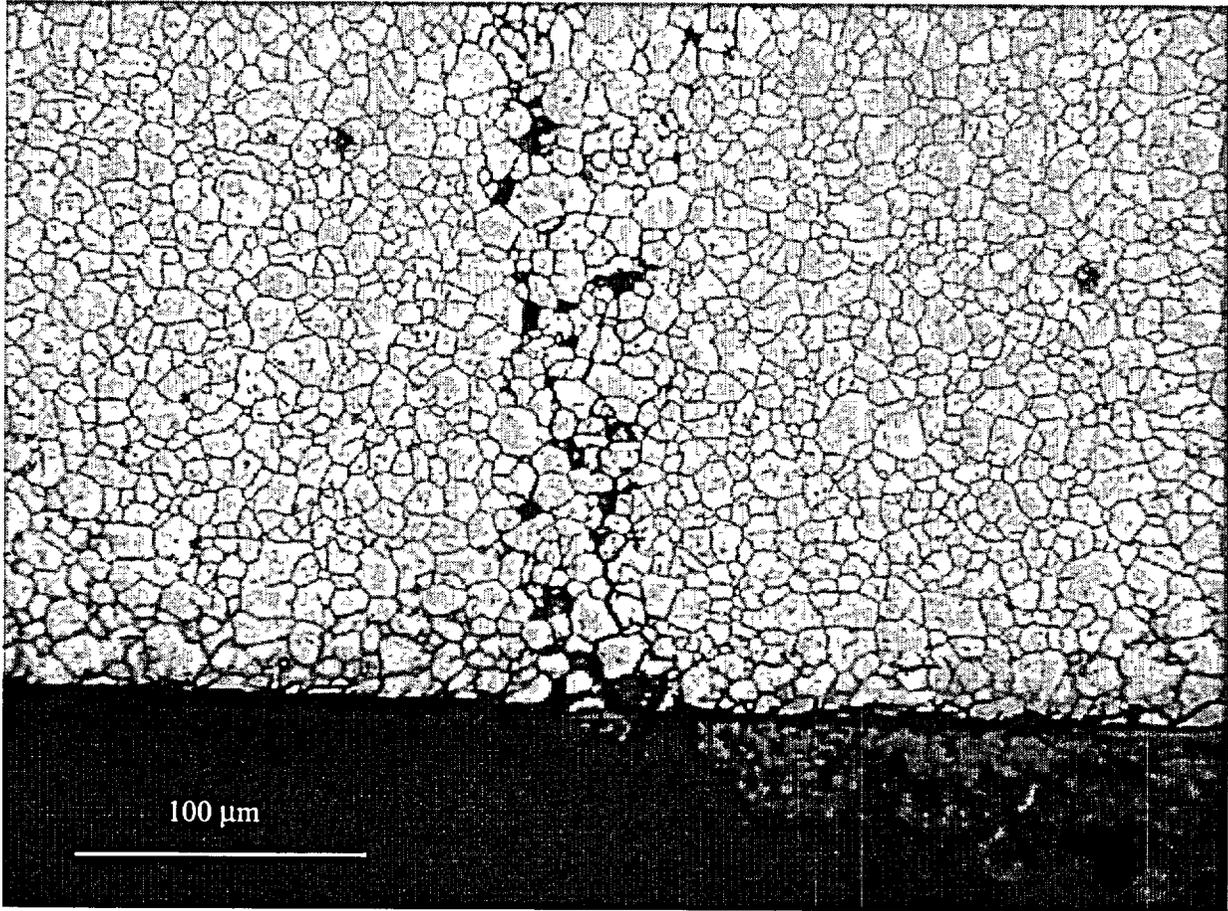
Figure 4- 7. Micrograph of Crack 2 Showing an Intergranular Crack Path

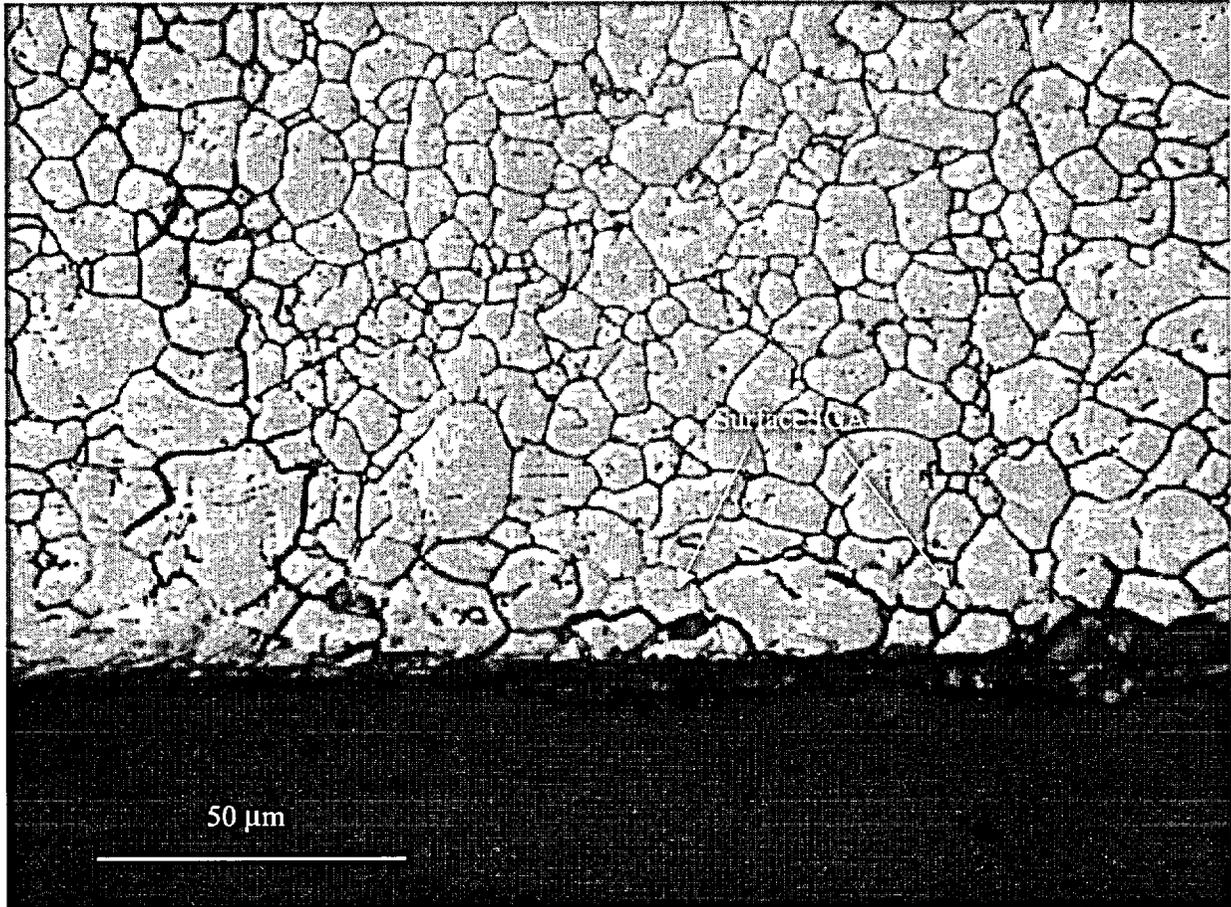
Figure 4- 8. Area on the OD Surface Showing Intergranular Attack, in Land Area

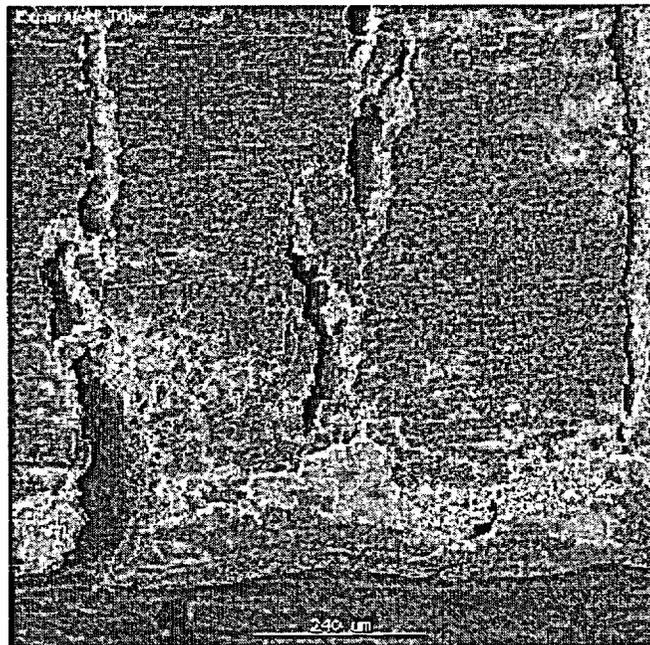
Figure 4- 12. High Magnification SEM Image of Expanded Tube Edge in Land Area

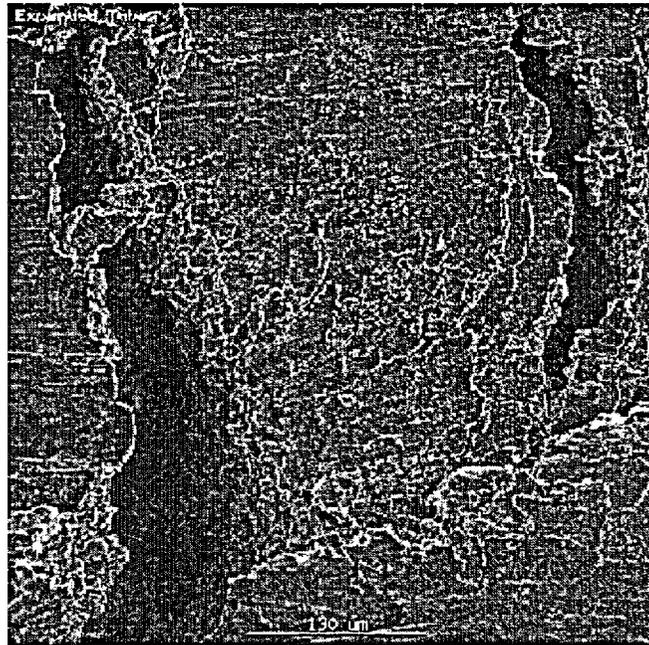
Figure 4- 13. High Magnification SEM Image of Cracks
