# Seabrook Steam Generator Tube Assessment Project

November 14, 2002

*FPL* Energy Seabrook

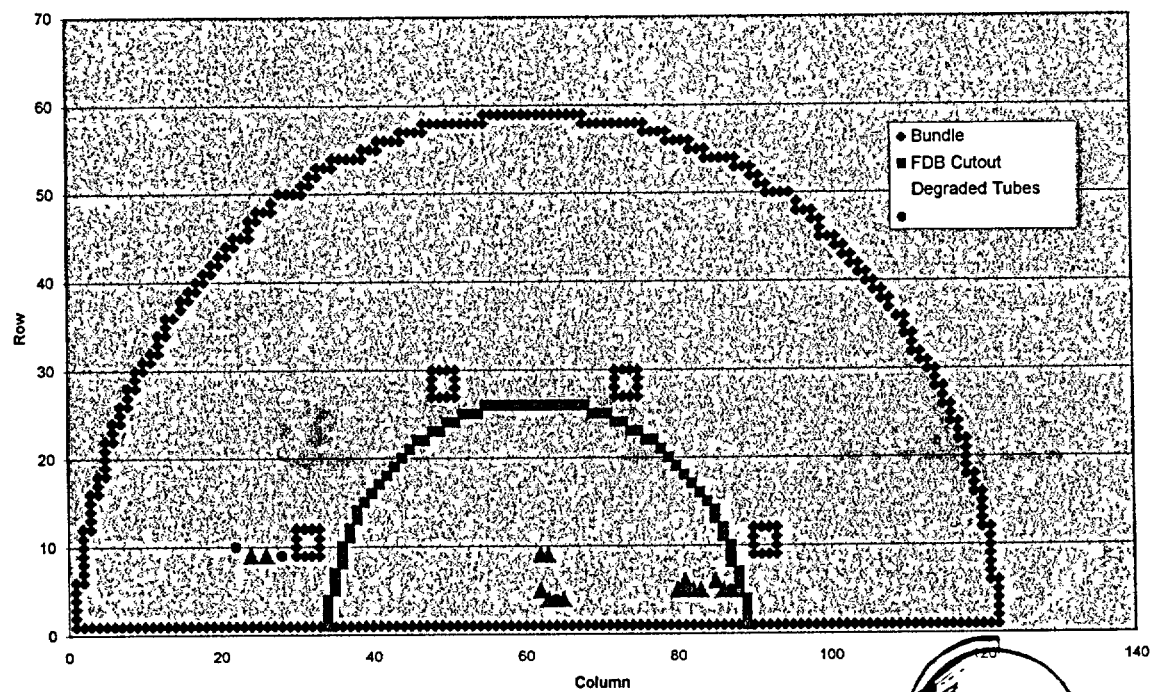
## Location of Degraded Tubes

\ 15 tubes with 42 indications - all at TSPs intersections

\ All indications confined to first ten rows

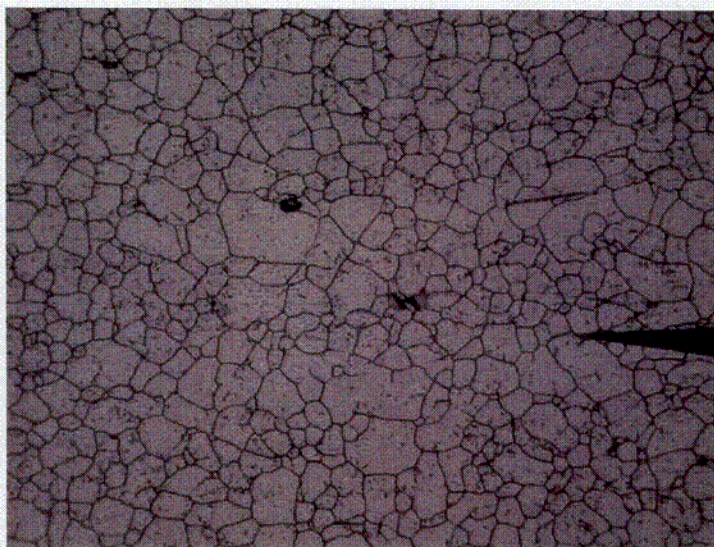
## Pulled Tube Heat 1374 Grain Boundary Etch

- ASTM Grain Size 10-12
- Intragranular Carbides
- Low Carbide Density On The Grain Boundaries

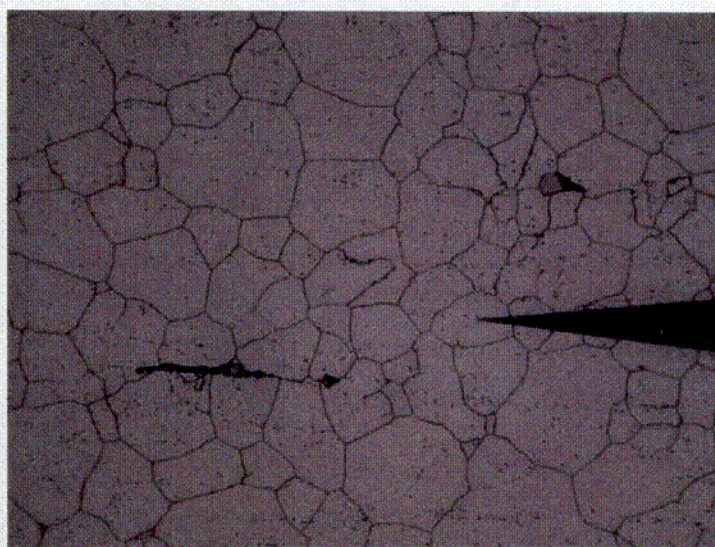
## Archive Heat 1457 Grain Boundary Etch

- ASTM Grain Size 5-7
- Fewer Intragranular Carbides
- Improved Carbide Grain Boundary Density

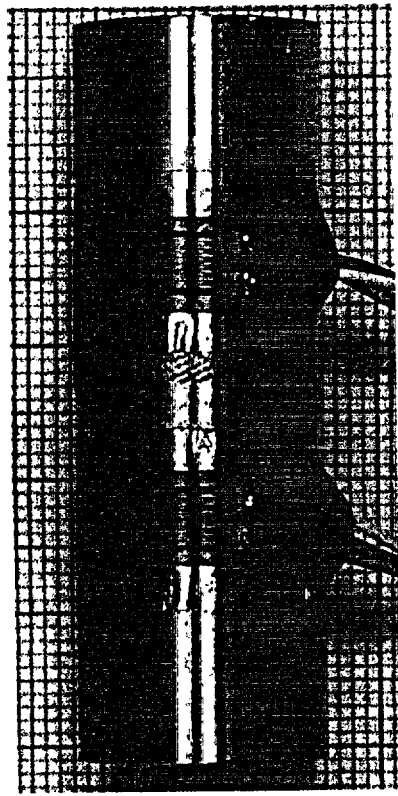
# Residual Stress Split Ring Test Specimen

- Operating Stress - 10 Ksi (Pressure+Thermal)
- Both Pulled Tubes Have An Unexpectedly High Measured Residual Hoop Stress (16-26 Ksi vs 2 Ksi)
- OD Surface Residual Is Up To 2 times Higher
- Low Residual Stress In Archived Tubes From The Affected Heats (1374, 1456, 1457) (1-3 Ksi)

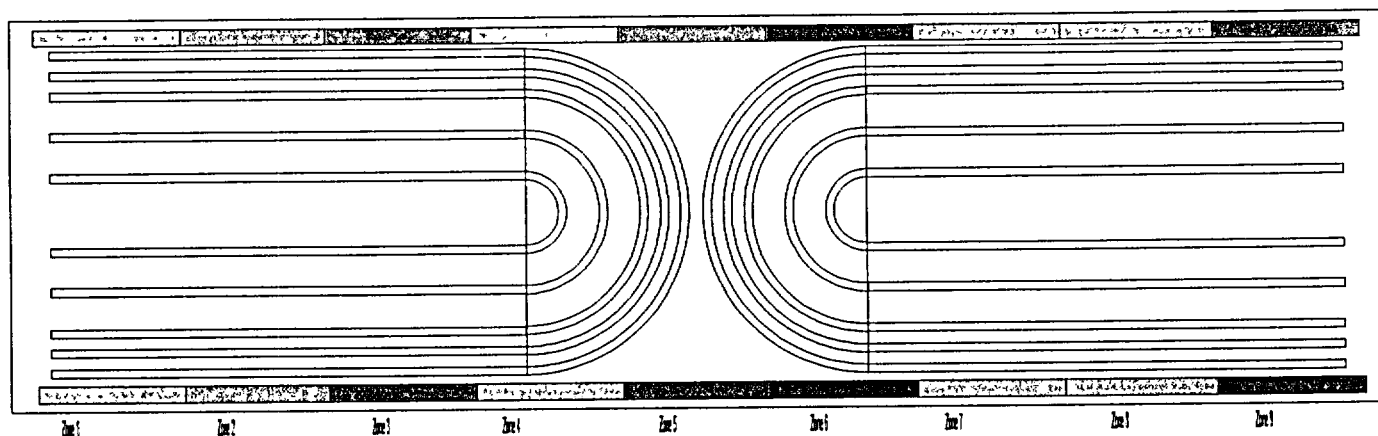
## U-bend Stress Relief Furnace Loading

Zones 1 through 9 are heating zones in the furnace. Only zones 4, 5 and 6 were activated for stress relief of the u-bends.

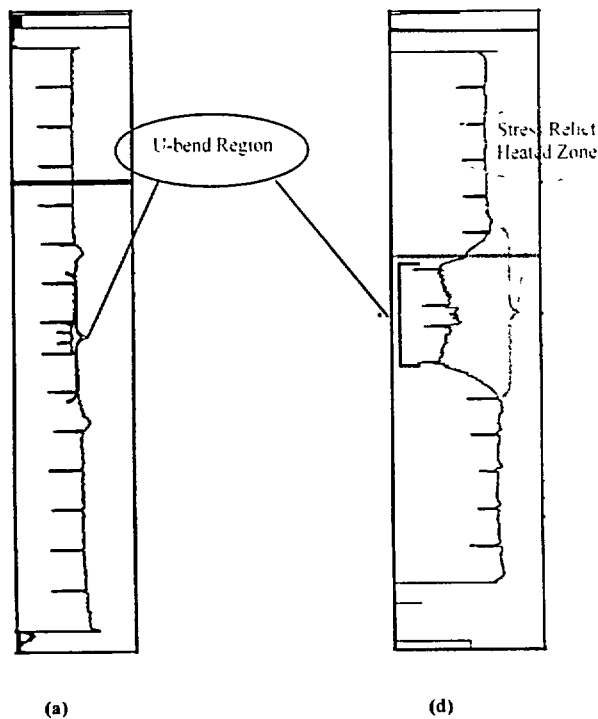
## Row 1-10 150 Hz Eddy Current Signal Traces

- (a) Normal 150 kHz Eddy Current strip chart for a Row <10 thermally treated tube
- (b) Seabrook degraded tube, 150 kHz Eddy Current strip chart for a Row <10 thermally treated tube

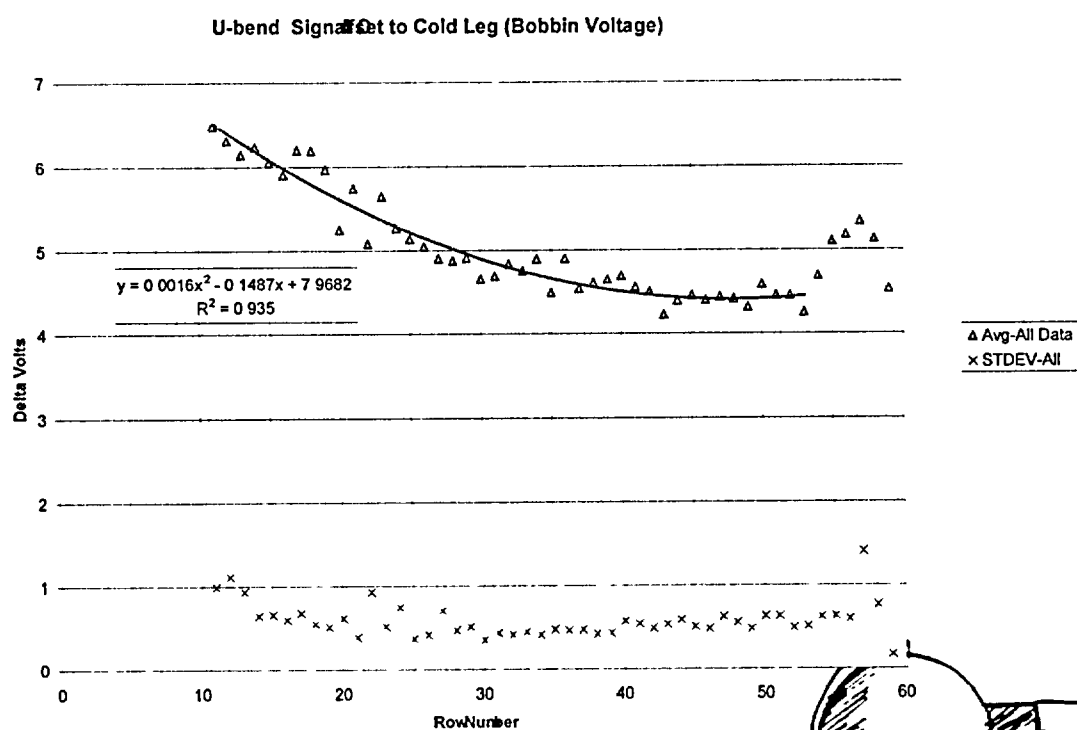
## U-bend Bobbin Signal Offset -CL

- ⌘ Eddy Current Offset Values Provide Excellent Correlation With Bend Radius
- ⌘ Tubes With High Residual Stress In The Straight Length Would Be Apparent
- ⌘ There Are No Outliers – No Signal Reversals
- ⌘ Correlation Between Degraded Tubes And Offset Signal Is 100% In Rows  $< 10$
