Subject: 2002 Annual Site Inspection and Monitoring Compliance Report for UMTRCA Title II Disposal Sites

2002 Annual Site Inspection and Monitoring Compliance Report for Uranium Mill Tailings Radiation Control Act Title II Disposal Sites

November 2002

Prepared by
U.S. Department of Energy
Grand Junction Office
Grand Junction, Colorado

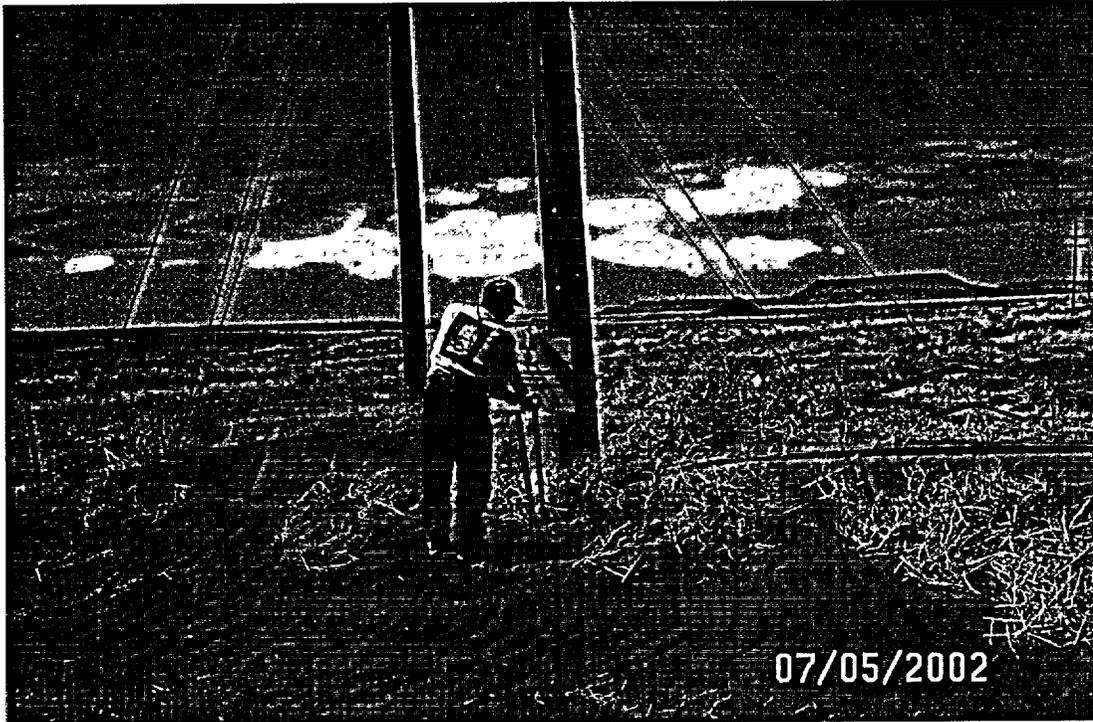
Fifty-four perimeter or warning signs, designated P1 through P52 on Figures 1-1 and 1-2 (including perimeter signs P2A, P2B, P9A, and P9B), are posted at access points along right-of-way intersections with the site boundary and around the main and carbonate tailings disposal cells. At the Bluewater site, all signs are identical and convey the information typically conveyed on entrance signs at other Long-Term Surveillance and Maintenance (LTSM) Program sites. Perimeter sign P1, located at the access gate, was missing; inspectors replaced P1 (PL-1).

BLU 5/2002. PL-1. Replacing sign at entrance gate. (Date shown is incorrect. Actual date is 5/7/2002).

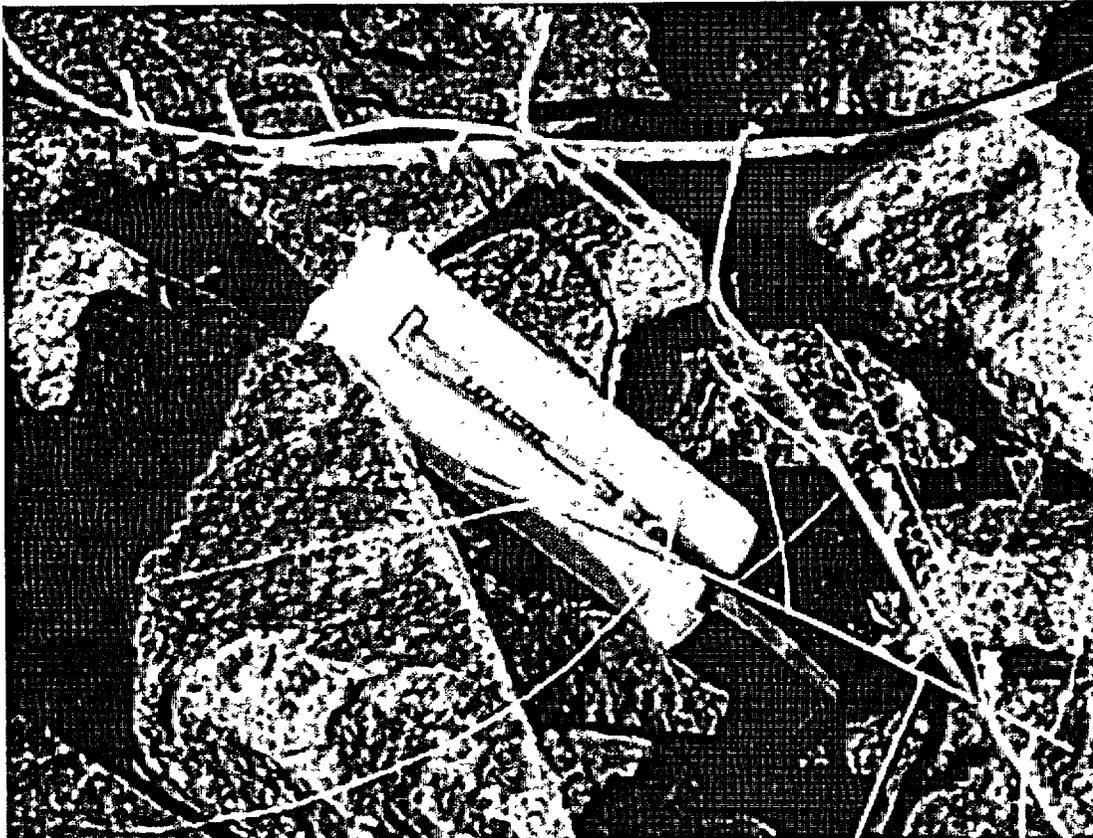
An unexploded blasting cap was found on the northwest edge on the top of the main tailings disposal cell. It was photographed (PL-2) so that inspectors could recognize other potential blasting caps and be cognizant of safety hazards. The blasting cap was not disturbed.

BLU 5/2002. PL-2. Unexploded blasting cap.

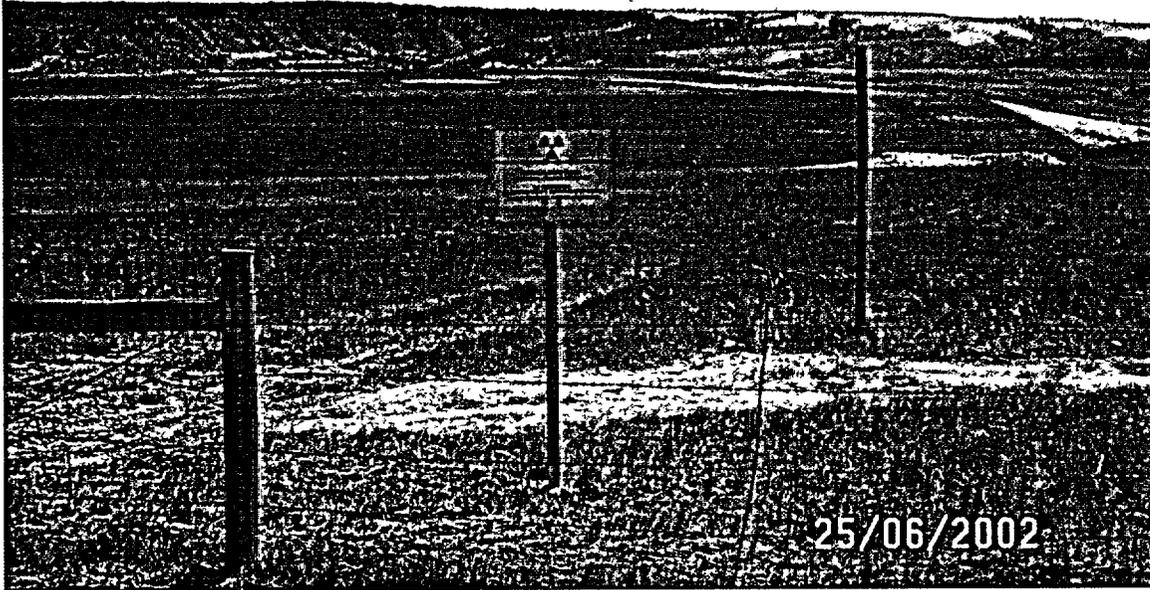
The tubular metal entrance gate is secured by a padlocked chain and is in excellent condition. The site marker and site entrance sign (PL-1) also are in excellent condition.

EDG 6/2002. PL-1. Entrance sign
