From: "BENNETT, STEVE A" <SBENNE2@entergy.com>
To: "Tom Alexion" <twalex@nrc.gov>
Date: 11/5/02 9:14PM
Subject: ANO-1 Draft Response to NRC Bulletin 2002-01

**Request for Additional Information Related to Bulletin 2002-01
Arkansas Nuclear One, Unit 1 (ANO-1)**

1R17 Under-Vessel Inspection

Boroscopic Inspections of ICI Nozzles

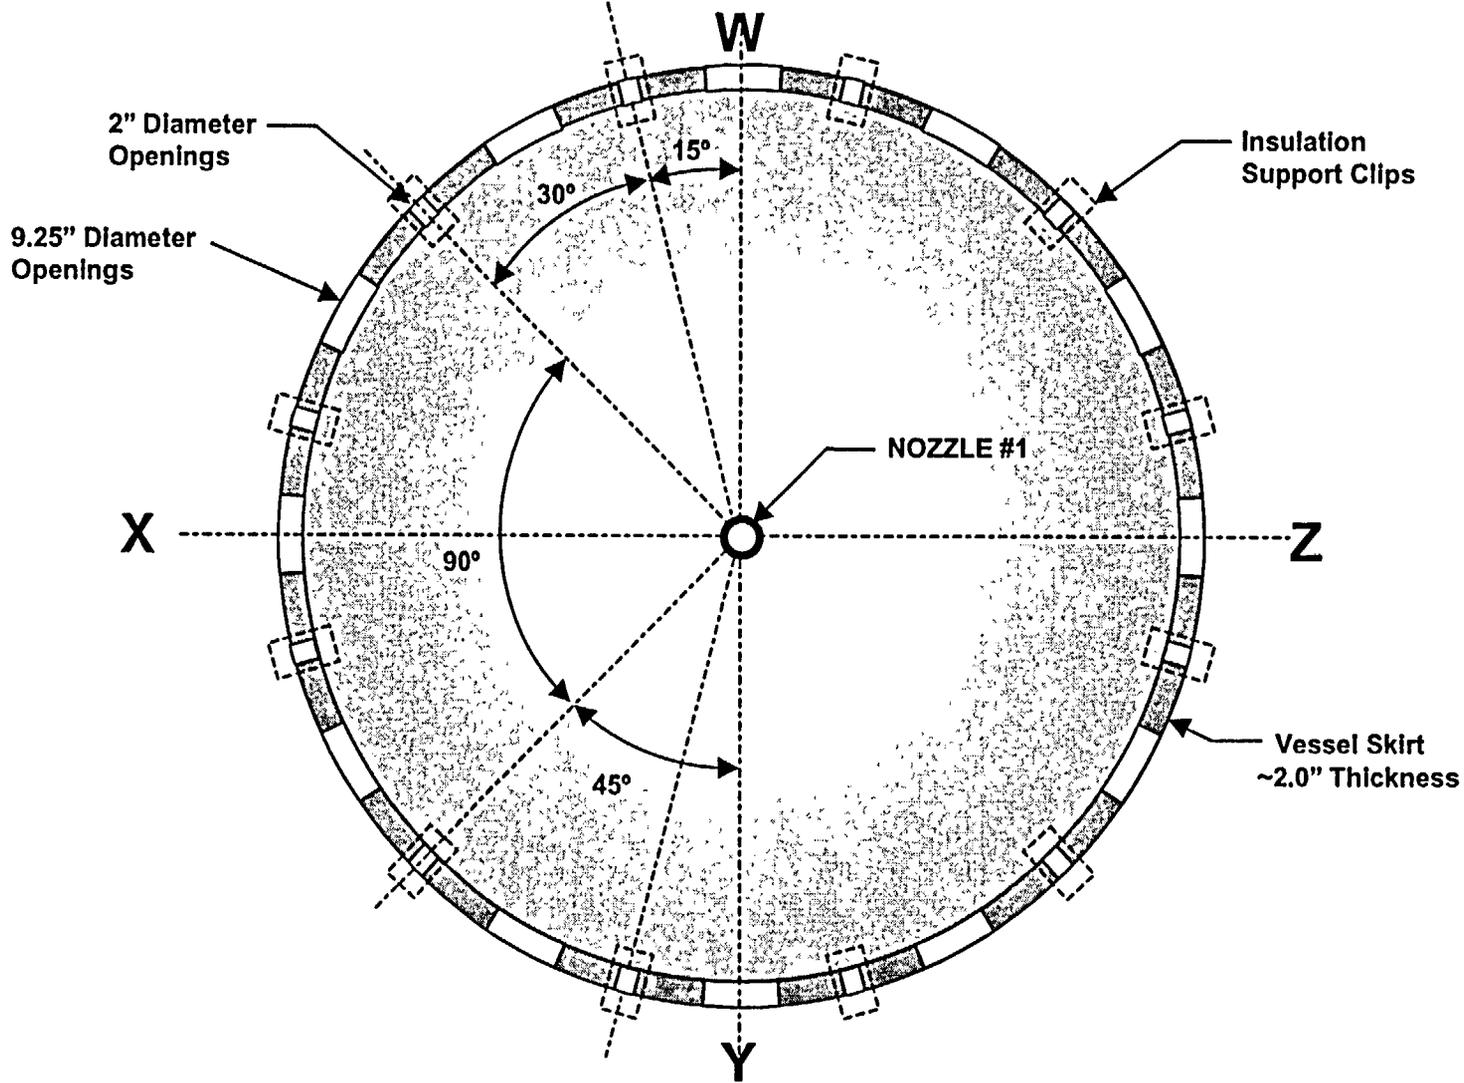
Reactor Vessel Skirt Openings and Locations Plan View – Looking UP

Attachment 1 (Diagrams of penetrations through vessel skirt, nozzle layout, and description) identifies the nozzles that were inspected using a boroscope and the results. The four nozzles inspected by a boroscope were the only incore tubes that had staining below the insulation. The purpose of the boroscope inspection was to determine whether these nozzles had any evidence of leakage at the vessel interface. Attachment 2 provides a scale composite drawing showing the dimensions of the reactor vessel, support skirt, insulation details, and nozzle 1 and 30.

The only other access to the area between the vessel skirt and the vessel insulation is from the bottom of the vessel. Access of this area is difficult to accomplish. One horizontal insulation panel in proximity to nozzle 30 could be removed to gain access to the area below the holes and a boroscope inserted through the area between the two adjacent incore nozzles, up to the accessible two (2) inch diameter holes located

around the circumference of the skirt. Once through the hole, a limited local area between the skirt and insulation could be viewed.

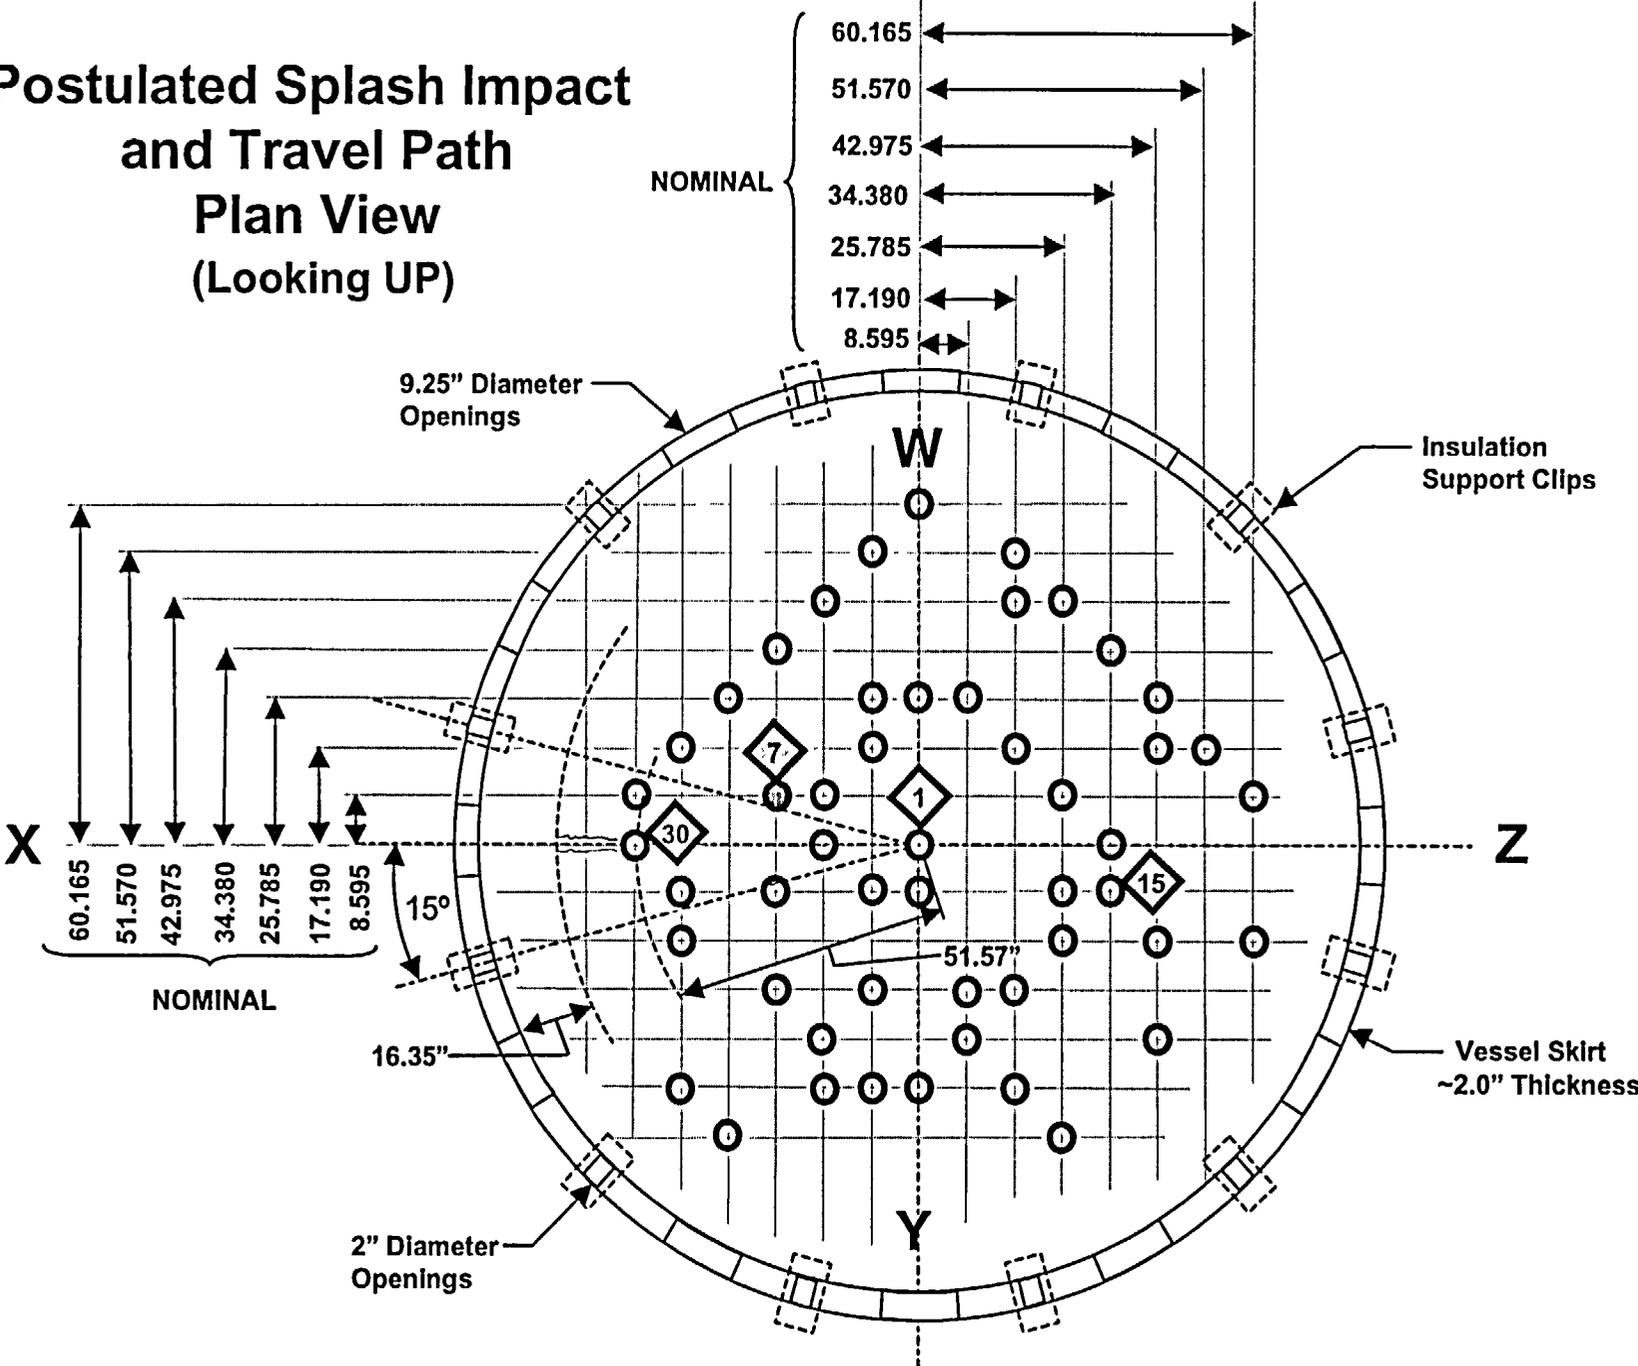
Postulated Splash Impact and Travel Path Plan View (Looking UP)

Based on discussions with site personnel (refueling team, operations, maintenance staff) that were familiar with past activities and issues in the reactor vessel area, instances of cavity seal plate leakage were identified as likely sources for the staining identified in the general area under the vessel. In order to understand the relationship of the vessel, the insulation, the concrete structure, and the drainage path for cavity seal plate leakage, the composite drawing previously identified was developed for this area. Additionally, it was determined that decontamination efforts of the transfer canal near the vessel flange area during the 1980's and early 1990's included rinsing fluid into the cavity seal plate area when the plate was not installed. During this time frame, cavity seal plate leakage was a fairly common occurrence as well as CRDM flange and RVLMS flange leakage decontamination efforts with the cavity seal plate removed. Also an overflow of the incore tank (R-8) that occurred in September 1999 was identified as a source for some of the boron residue identified on the floor in the area under the reactor vessel. Based on these reviews, probable flow paths have been identified that correspond to the indications seen. Documented inspections of the area under the vessel from the previous two outages to the present do not indicate any change in condition to this area.

The reactor cavity seal plate leakage would traverse the annulus area between the vessel and the mirror insulation to reach the undervessel area. The ability to perform additional inspections of the vertical annulus area between the vessel and the mirror insulation has been evaluated. To provide direct visual evidence of the path of borated water through the 2 inch holes in the support skirt above the undervessel insulation, access to the annulus would have to be gained. Possible access routes to inspect the area are limited to access from the top of the reactor vessel and access from below the vessel. There are no access locations between the top and bottom of the vessel because of the primary shield wall. The only openings through the shield wall are around the reactor vessel nozzles and these are too tight a fit to permit access. Access from the top of the vessel to the annulus between the shield wall and the reactor vessel is restricted by the reactor shield blocks. They consist of concrete filled, steel lined blocks. The shield blocks are located below the permanent seal ring at the top of the vessel and above the reactor vessel nozzles. These shield blocks provide a radiation shield in the annulus between the top of the reactor vessel and the floor of the refueling canal. There is no access through these blocks without removing them from above. This can only be accomplished by removing portions of the permanent seal plate.

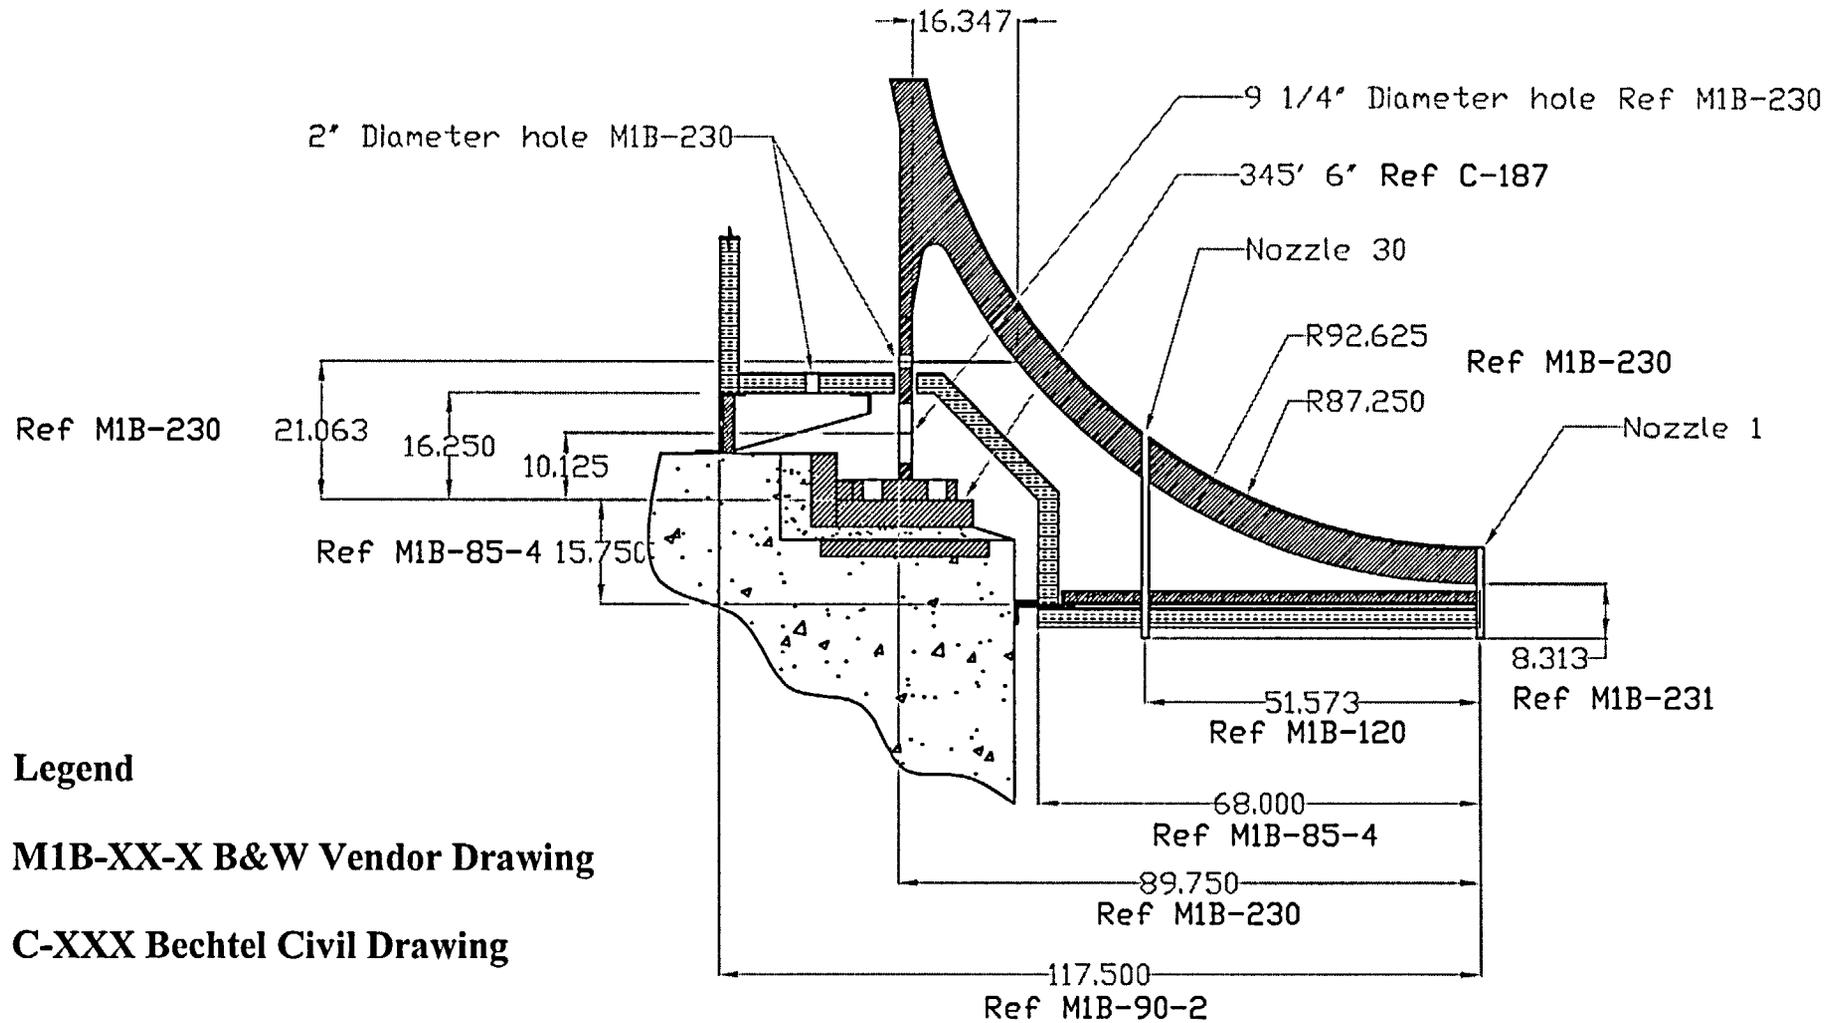
In general, the vessel itself was noted to be relatively clean and in good condition, with uniform brown spotted discoloration of the silver-colored, high-temperature coating. The conditions noted were characterized as normal considering the age of the vessel. No "popcorn" type boric acid deposits or other typical boric acid accumulations were seen at or near the nozzles inspected. The condition noted during the inspection was generally faint white staining of the nozzle piping. Some light brown staining was observed on two nozzles but this is attributed to moisture external to the vessel. Limited boroscope video of the top side of the vessel insulation was obtained in the areas of nozzle # 15 and # 7. This video showed no staining or accumulation of boron on the insulation. The angle iron support structure for the insulation was very clean, with a few small widely spaced surface corrosion areas noted.
