From: Thomas Alexion
To: BENNETT, STEVE A
Date: 11/13/02 3:18PM
Subject: VESSEL PHONE CALLS

SUMMARY OF VESSEL HEAD AND VESSEL BOTTOM PHONE CALLS

Request for Additional Information Related to Bulletin 2002-01 Arkansas Nuclear One, Unit 1 (ANO-1)

**ENTERGY'S DRAFT RESPONSE TO THE NRC'S RAI
ON BULLETIN 2002-01**

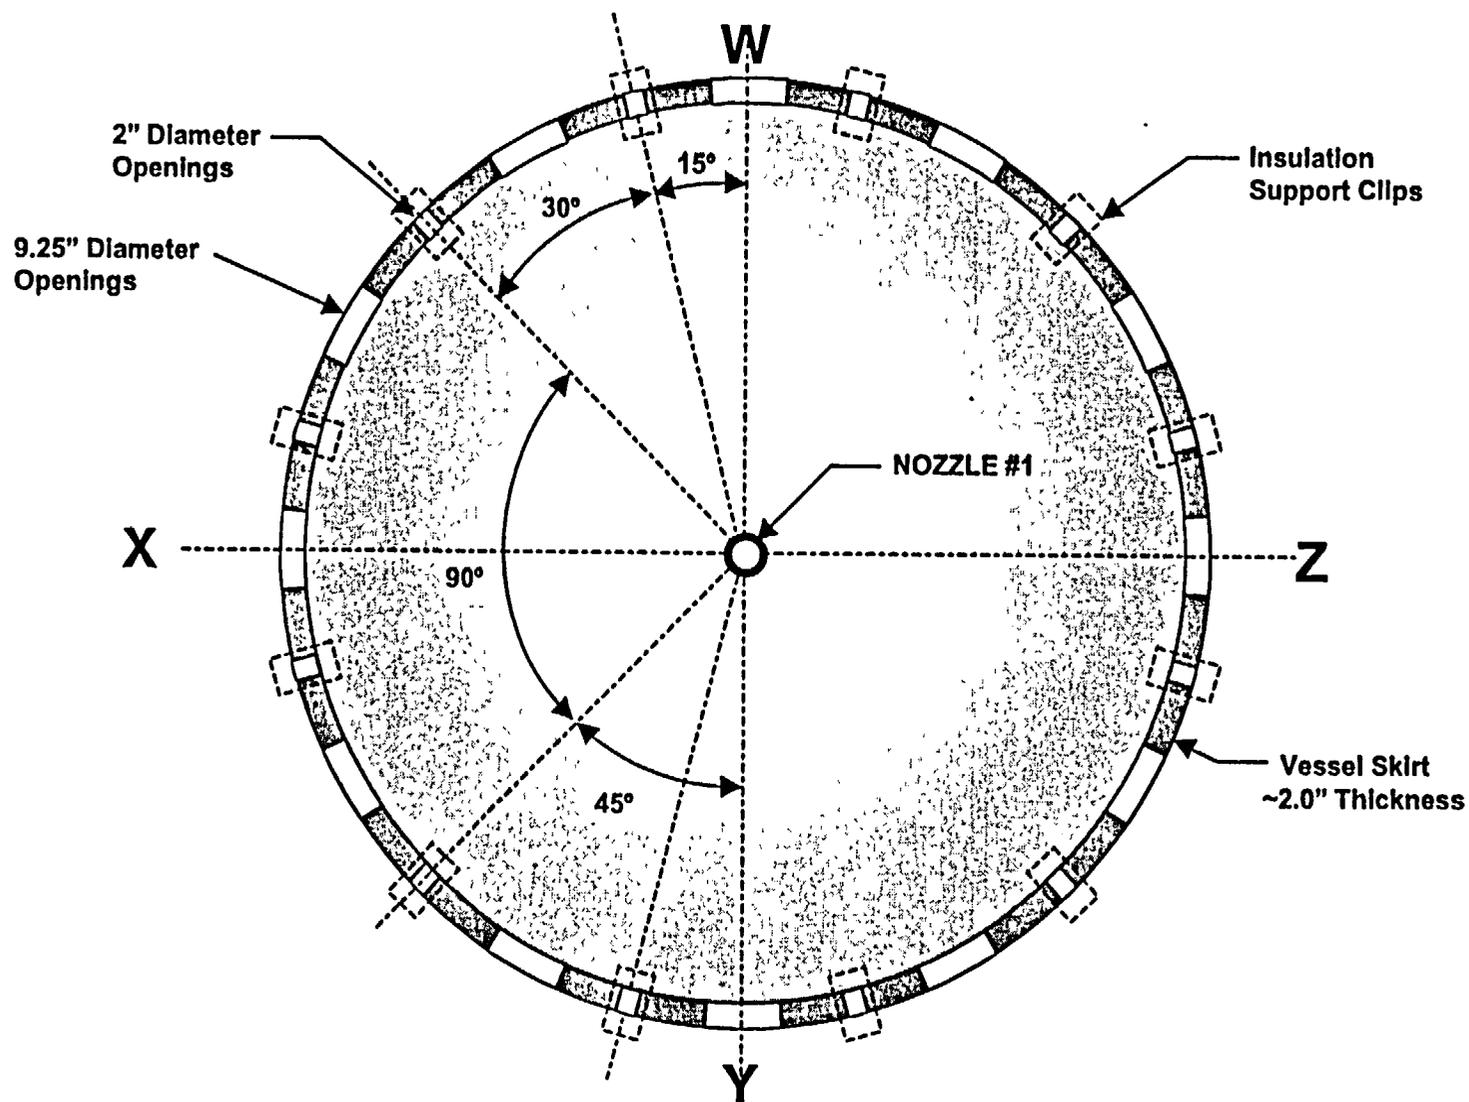
Reactor Vessel Skirt Openings and Locations Plan View – Looking UP

Attachment 1 (Diagrams of penetrations through vessel skirt, nozzle layout, and description) identifies the nozzles that were inspected using a boroscope and the results. The four nozzles inspected by a boroscope were the only incore tubes that had staining below the insulation. The purpose of the boroscope inspection was to determine whether these nozzles had any evidence of leakage at the vessel interface. Attachment 2 provides a scale composite drawing showing the dimensions of the reactor vessel, support skirt, insulation details, and nozzle 1 and 30.

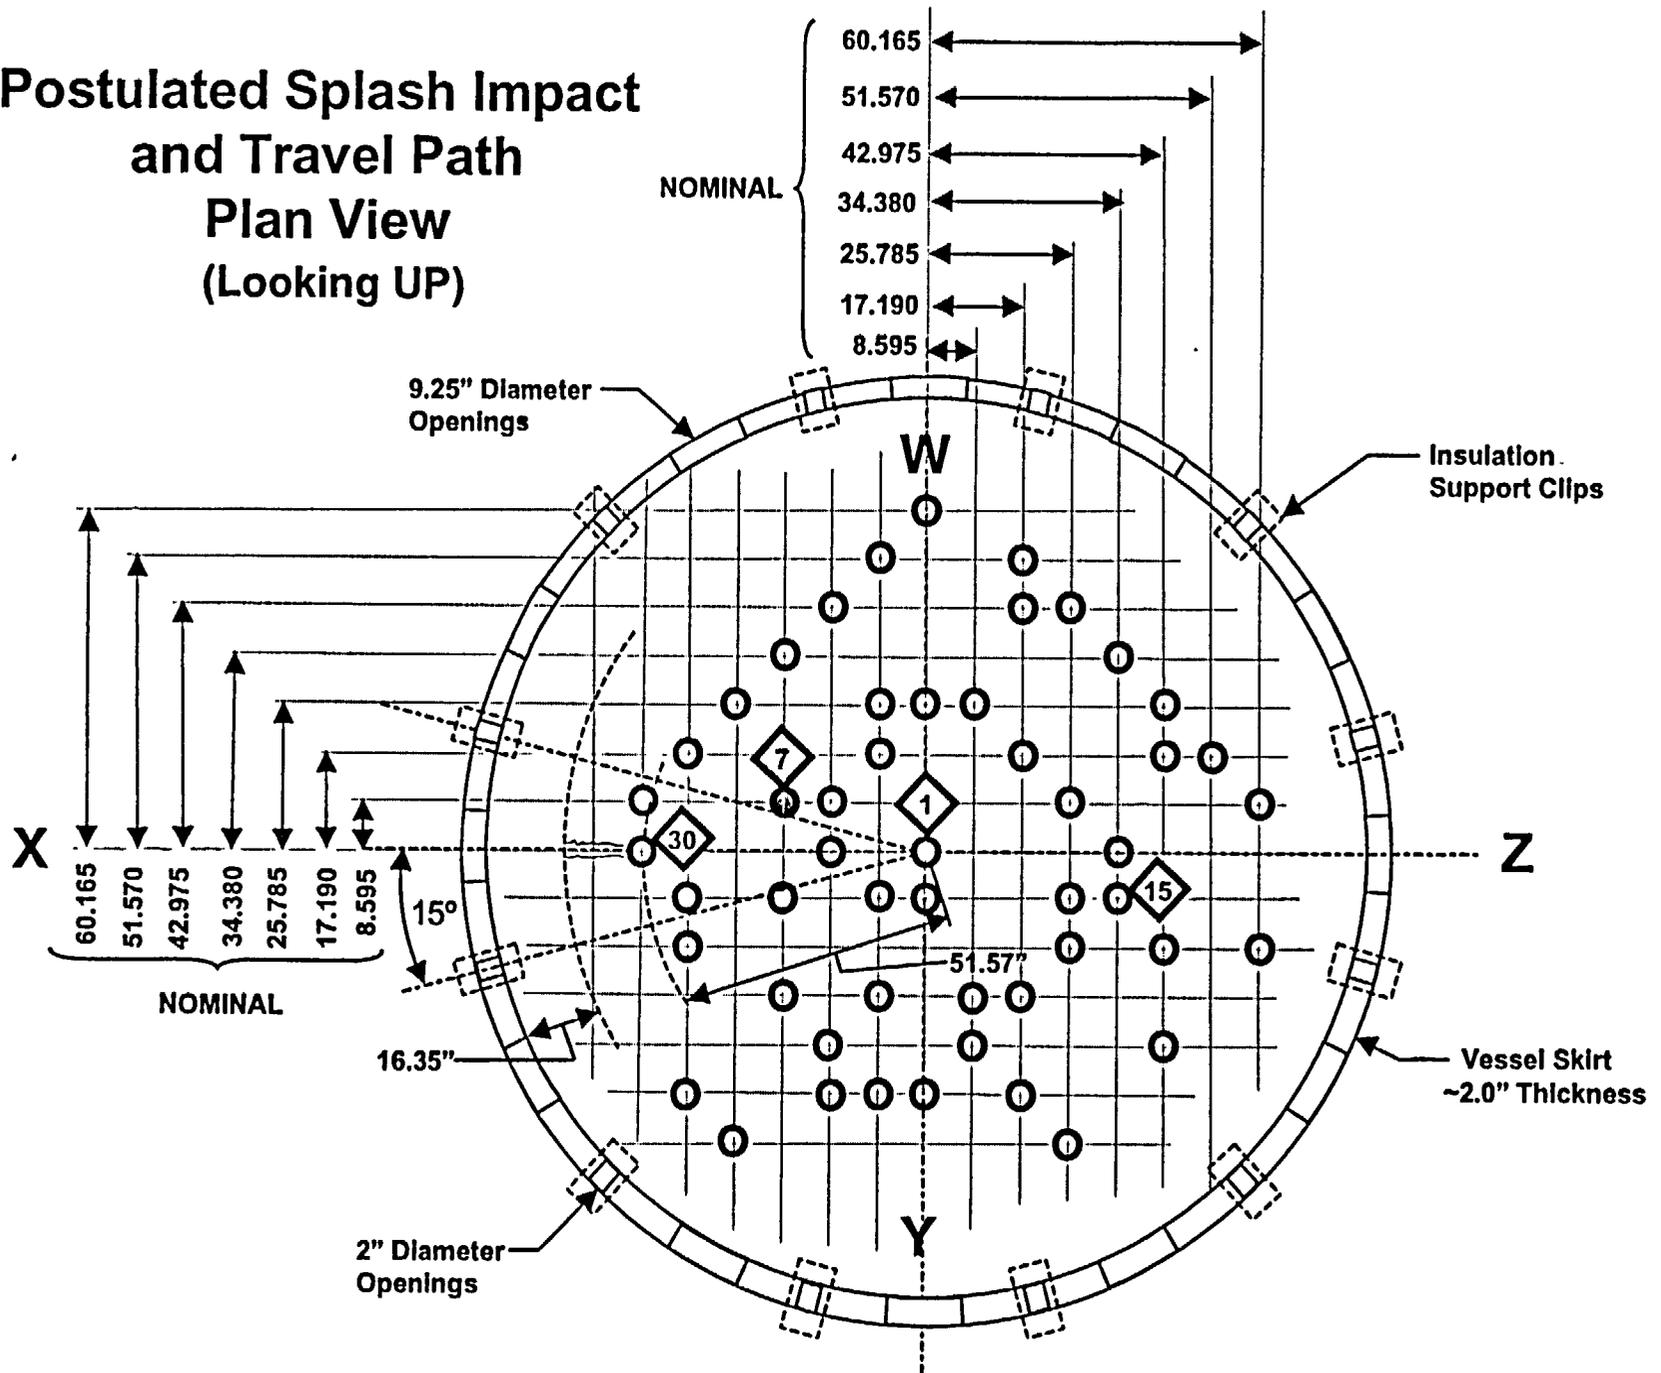
Postulated Splash Impact and Travel Path Plan View (Looking UP)

The reactor cavity seal plate leakage would traverse the annulus area between the vessel and the mirror insulation to reach the undervessel area. The ability to perform additional inspections of the vertical annulus area between the vessel and the mirror insulation has been evaluated. To provide direct visual evidence of the path of borated water through the 2 inch holes in the support skirt above the undervessel insulation, access to the annulus would have to be gained. Possible access routes to inspect the area are limited to access from the top of the reactor vessel and access from below the vessel. There are no access locations between the top and bottom of the vessel because of the primary shield wall. The only openings through the shield wall are around the reactor vessel nozzles and these are too tight a fit to permit access. Access from the top of the vessel to the annulus between the shield wall and the reactor vessel is restricted by the reactor shield blocks. They consist of concrete filled, steel lined blocks. The shield blocks are located below the permanent seal ring at the top of the vessel and above the reactor vessel nozzles. These shield blocks provide a radiation shield in the annulus between the top of the reactor vessel and the floor of the refueling canal. There is no access through these blocks without removing them from above. This can only be accomplished by removing portions of the permanent seal plate.

Nozzle 30	Two thin, faint white traces appear uphill. The source is out of sight of the boroscope on the vessel. The traces run to and down Nozzle 30. The traces appear less than a pencil width	Seal plate leakage that splashed onto the bottom of the vessel.	Past the ID or OD of the seal plate, down the side of the vessel inside the vertical insulation panel, through the upper 2" holes in the vessel support skirt, splashing onto the underside of	Nozzle 30 is on the outer edge of the ICI nozzle pattern, which means there are no other nozzles located uphill of Nozzle 30 that could have acted as a source for these traces.

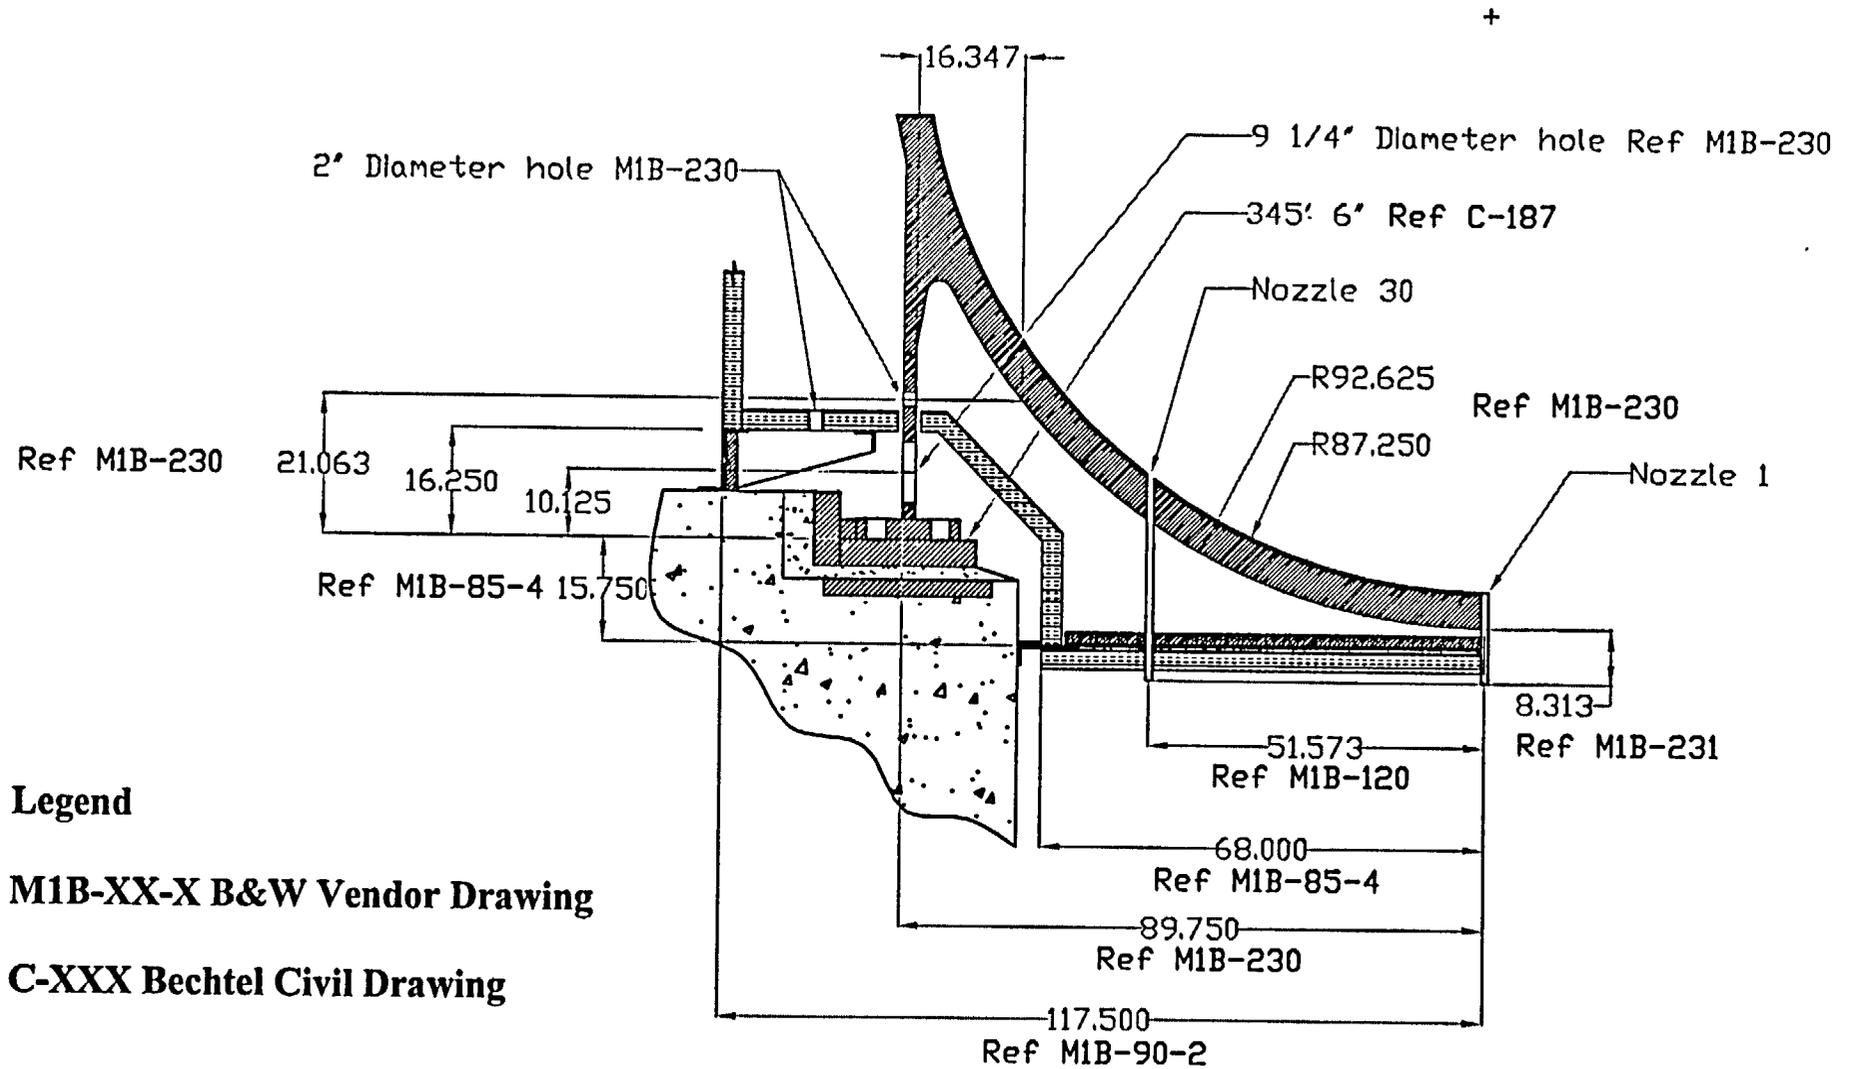
Faint white staining is visible on the nozzle piping extending from the vessel down through the insulation to below the insulation. The stain ranges in width from 1/4 to 1/2 the circumference of the nozzle pipe. Some barely noticeable brown staining is visible on the nozzle piping (approximately 1 pencil width wide. A 360-degree close-up inspection of the nozzle shows no indication of boron originating from the annulus.
