Docket Number 50-266
Point Beach Nuclear Plant, Unit 1
Licensee Event Report 266/2002-002-00
Unit 1 A-Train Reactor Protection Cable Routed in B-Train Cable Trays

LICENSEE EVENT REPORT (LER)

POINT BEACH NUCLEAR PLANT UNIT 1

Unit 1 A-Train Reactor Protection Cable Routed in B-Train Cable Trays

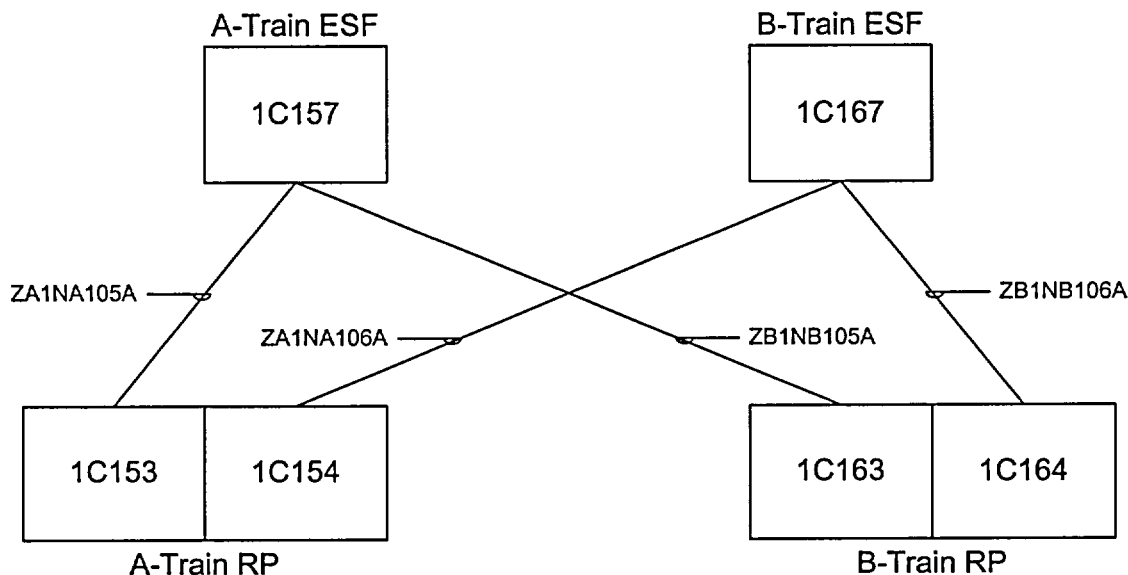
On September 25, 2002 during the performance of a plant modification (MR 00-003), NMC personnel discovered that a Point Beach Nuclear Plant (PBNP) Unit 1 A-Train reactor protection {JC} cable {CBL1} was routed in B-Train cable trays {TY}. At the time of discovery, PBNP Unit 1 was in Mode 6 for its 27th refueling outage. Modification MR 00-003 was being performed to correct previously identified reactor protection cable train separation concerns in the conduits {CND} and cable trays above engineered safety features (ESF) {JE} cabinets {CAB} 1C157 and 1C167. These cabinets and trays are located in the cable spreading room {NA}. While pulling cables out of 1C157, to reroute reactor protection (RP) cable ZB1NB105A, a B-Train cable, cable ZA1NA105A, an A-Train cable, was found in the same conduit (DM-1). This is a Train B conduit. Cables ZB1NB105A and ZA1NA105A are part of the unique four-cable scheme associated with a safety injection (SI) signal. Actuation of one train of ESF will cause a reactor trip signal on both trains. The complete scheme is shown below. Cable ZA1NA105A was designed to be routed between A-train cabinets in A-Train cable trays. However, finding that cable in conduit DM-1 indicates that it is routed in B-train cable trays, which is not in accordance with PBNP design requirements.

Upon discovery of this routing discrepancy, a Corrective Action Program activity request was initiated (CAP 29532) to document the condition. The A-Train SI signal to the reactor protection system was declared inoperable due to improper cable separation. This condition affects Item 16 of Technical Specification Table 3.3.1, "Safety Injection Input from Engineered Safety Features Actuation System." That item is applicable only in Modes 1 and 2 and requires 2 trains to be operable. If a train is inoperable for greater than 18 hours, the reactor is required to be in Mode 3. PBNP Unit 1 was in Mode 6 at the time of this discovery; therefore, the action condition for this item was not applicable at the time of discovery. However, PBNP Unit 1 had operated in Modes 1 and 2 in the past with this existing train separation discrepancy. Therefore, in accordance with the requirements of 10 CFR 50.73(a)(2)(i)(B), PBNP Unit 1 had operated in a condition which was prohibited by the plant's Technical Specifications. As clarified in NUREG 1022, this LER is required even if the condition was not discovered until after the allowable time had elapsed and the condition was rectified immediately upon discovery.

An engineering change request (ECR) to MR 00-003 was initiated to correct the separation violation documented in this report. The ECR abandoned the existing cable and relabeled it as ABN0006. A new cable ZA1NA105A has been installed in dedicated A-train cable trays between 1C153 and 1C157.
