Subject: Oconee Nuclear Station  
Docket No. 50-270  
Licensee Event Report 270/2002-02, Revision 0  
Problem Investigation Process No.: O-02-05496

4. TITLE  
**Reactor Pressure Vessel Head Leakage Due to Primary Water Stress Corrosion Cracking of Alloy 600 Control Rod Drive Nozzles**

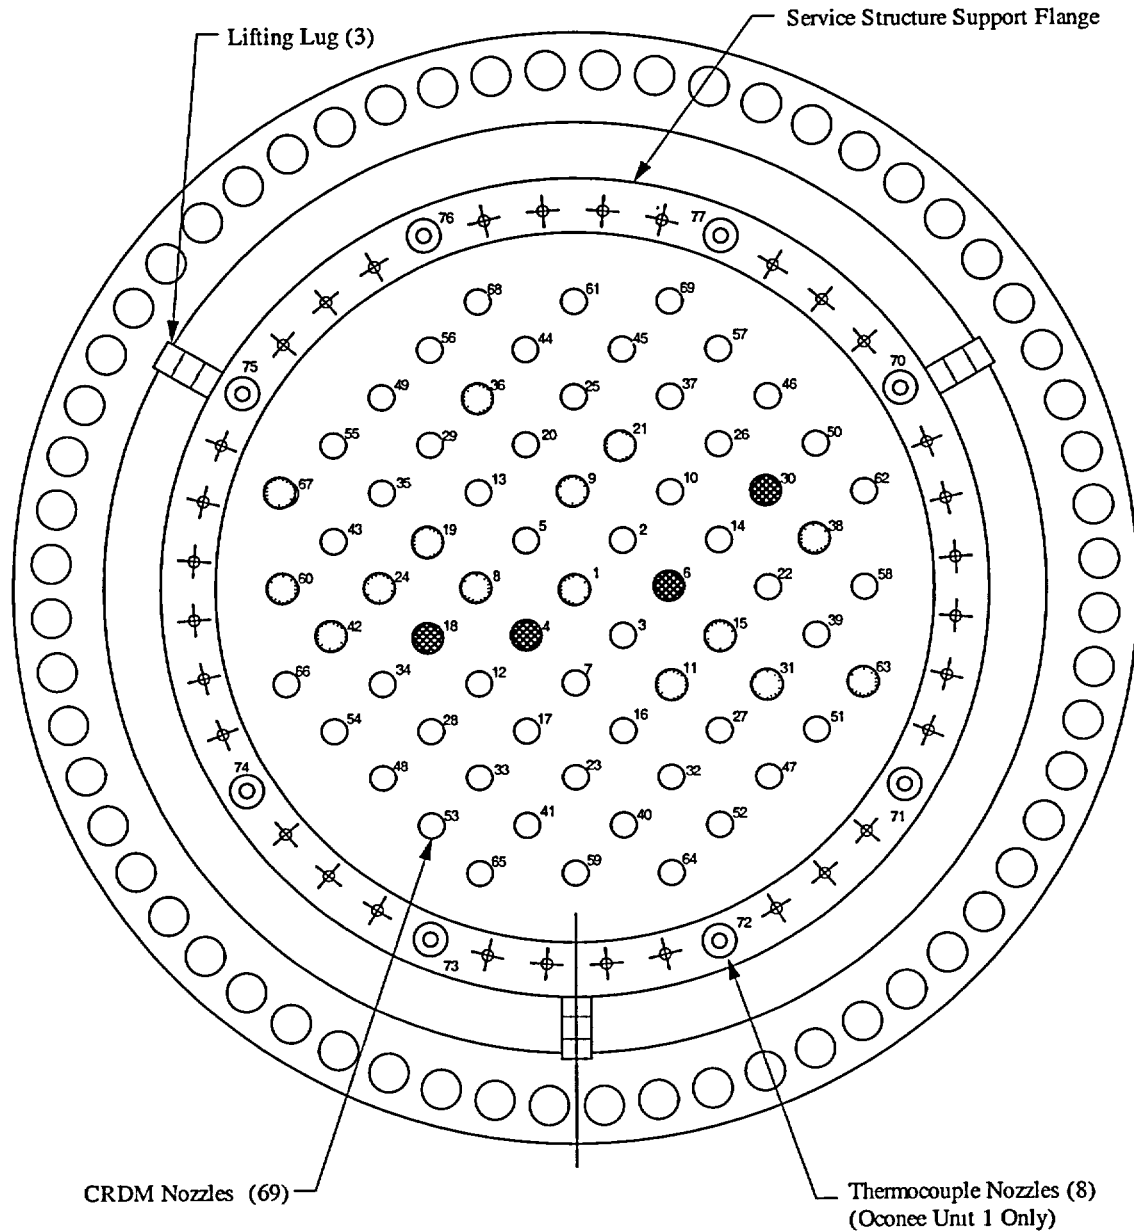
**Figure 1 – Oconee Unit 2 RVH Map**

A total of 15 CRDM nozzles were repaired (Nos. 1, 8, 9, 11, 15, 19, 21, 24, 31, 36, 38, 42, 60, 63 and 67; See Figure 1). The repair configuration was identical to that used for the ONS-1 CRDM nozzle repairs in the spring of 2002, the ONS-2 CRDM nozzle repairs in the spring of 2001 and the ONS-3 repairs in the fall of 2001. The protruding portions of the CRDMs and a length about 5 inches into the RV Head bore were removed by machining. A new pressure boundary weld was installed within the bore, inspected and surfaced conditioned with a water jet peening process.

- Nozzles 1, 8, 9, 11, 15, 19, 21, 24, 31, 36, 38, 42, 60, 63, and 67 were repaired
- Nozzles 4, 6, 18 and 30 were previously repaired during 2EOC18 refueling outage
