Subject: Oconee Nuclear Station
Docket No. 50-270
Licensee Event Report 270/2002-02, Revision 0
Problem Investigation Process No.: O-02-05496

1. FACILITY NAME Oconee Nuclear Station, Unit 2	2. DOCKET NUMBER 050- 0270	3. PAGE 1 OF 8
---	--------------------------------------	--------------------------

4. TITLE
Reactor Pressure Vessel Head Leakage Due to Primary Water Stress Corrosion Cracking of Alloy 600 Control Rod Drive Nozzles

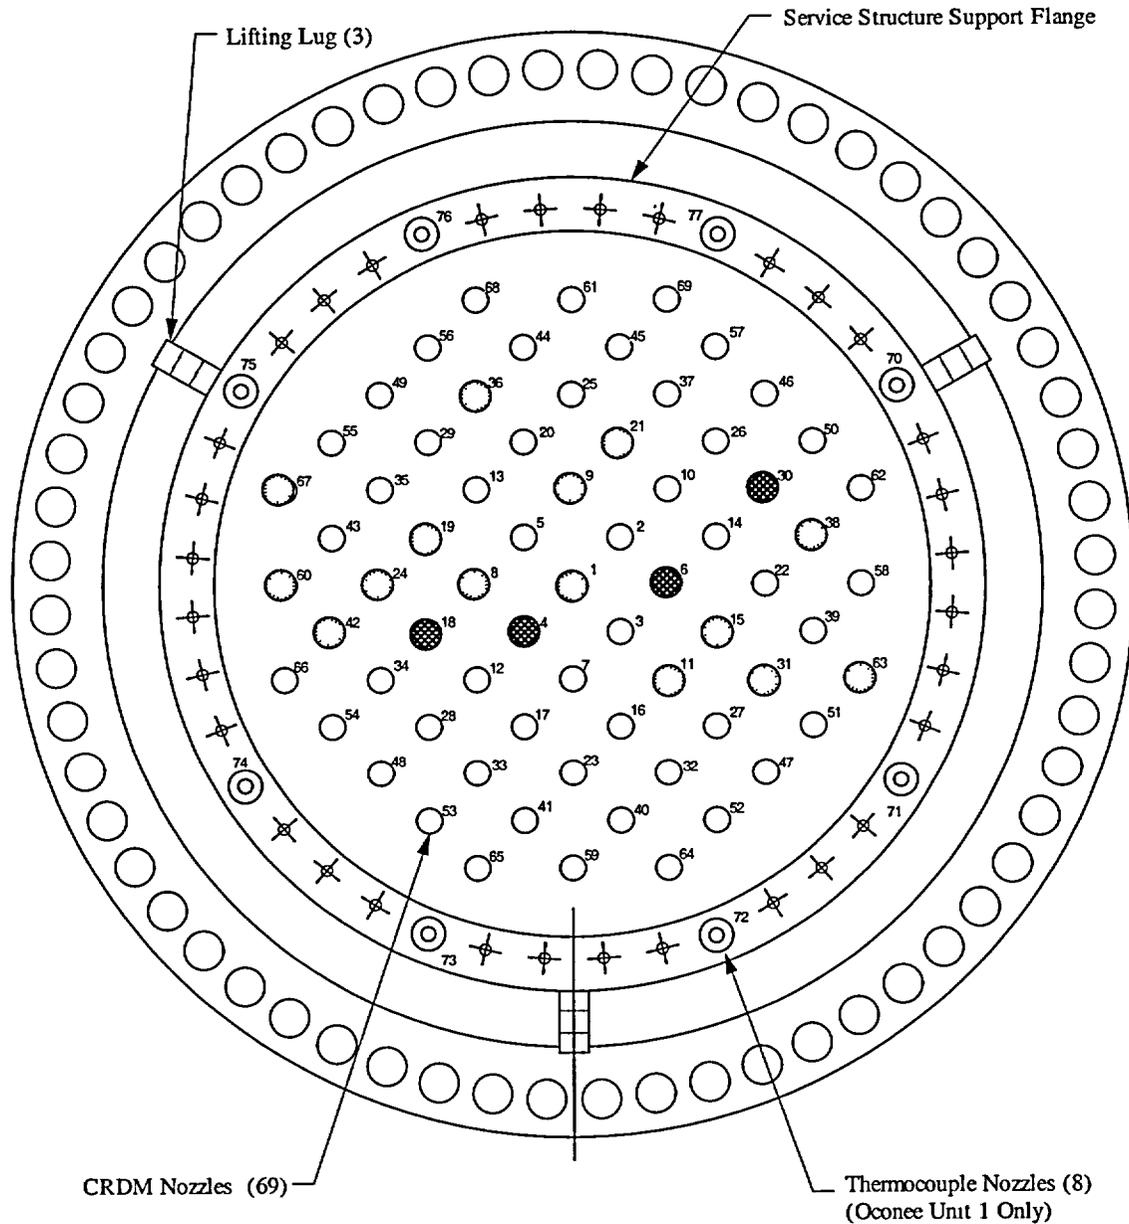
Figure 1 – Oconee Unit 2 RVH Map

Results of the visual inspection revealed seven CRDM nozzles (Nos. 8, 9, 19, 24, 31, 42 and 67) with boron deposits potentially associated with CRDM nozzle leaks. Five additional CRDM nozzles (Nos. 1, 4, 18, 60 & 63) were classified as being "masked," i.e., there was boron residue present but a conclusive leak path from these nozzles could not be seen. CRDM nozzles No. 4 and 18 (along with Nos. 6 and 30) had previously been repaired during the cycle 18 refueling outage (See Figure 1). On October 15, 2002, after confirming that during power operations the Reactor Coolant System [EIS: RCS] pressure boundary had been degraded, an 8-hour notification was made at 1754 hours in

Partial through-wall cracks were identified from the Aramis blade probe UT inspections on CRDMs nozzles 11, 15, 19, 21, 24, 31, 33, 36, 38 & 42. As described above, since additional TDT UT examination showed no indications in CRDM nozzle 33, it was removed from repair consideration. The TDT inspections confirmed an identical number of flaws for the five CRDMs without visual leakage (Nos. 11, 15, 21, 36 & 38). CRDM nozzles 8, 9 & 67 did not show any UT indications, but had obvious visual leakage (leak paths for nozzles 8 and 9 were identified). The masked CRDM nozzles (Nos. 1, 60

& 63) were UT clear, but the under head surface PT inspection results showed unacceptable indications for these as well as for leaking CRDM nozzle 67.

A total of 15 CRDM nozzles were repaired (Nos. 1, 8, 9, 11, 15, 19, 21, 24, 31, 36, 38, 42, 60, 63 and 67; See Figure 1). The repair configuration was identical to that used for the ONS-1 CRDM nozzle repairs in the spring of 2002, the ONS-2 CRDM nozzle repairs in the spring of 2001 and the ONS-3 repairs in the fall of 2001. The protruding portions of the CRDMs and a length about 5 inches into the RV Head bore were removed by machining. A new pressure boundary weld was installed within the bore, inspected and surfaced conditioned with a water jet peening process.

- Nozzles 1, 8, 9, 11, 15, 19, 21, 24, 31, 36, 38, 42, 60, 63, and 67 were repaired
- Nozzles 4, 6, 18 and 30 were previously repaired during 2EOC18 refueling outage
