Crystal River Nuclear Plant  
Docket No. 50-302  
Operating License No DPR-72

Subject: Crystal River Unit 3 – Response to Request for Additional Information Regarding Fall 2001 Steam Generator Inspection

**Response to Request for Additional Information Regarding  
Fall 2001 Steam Generator Inspection**

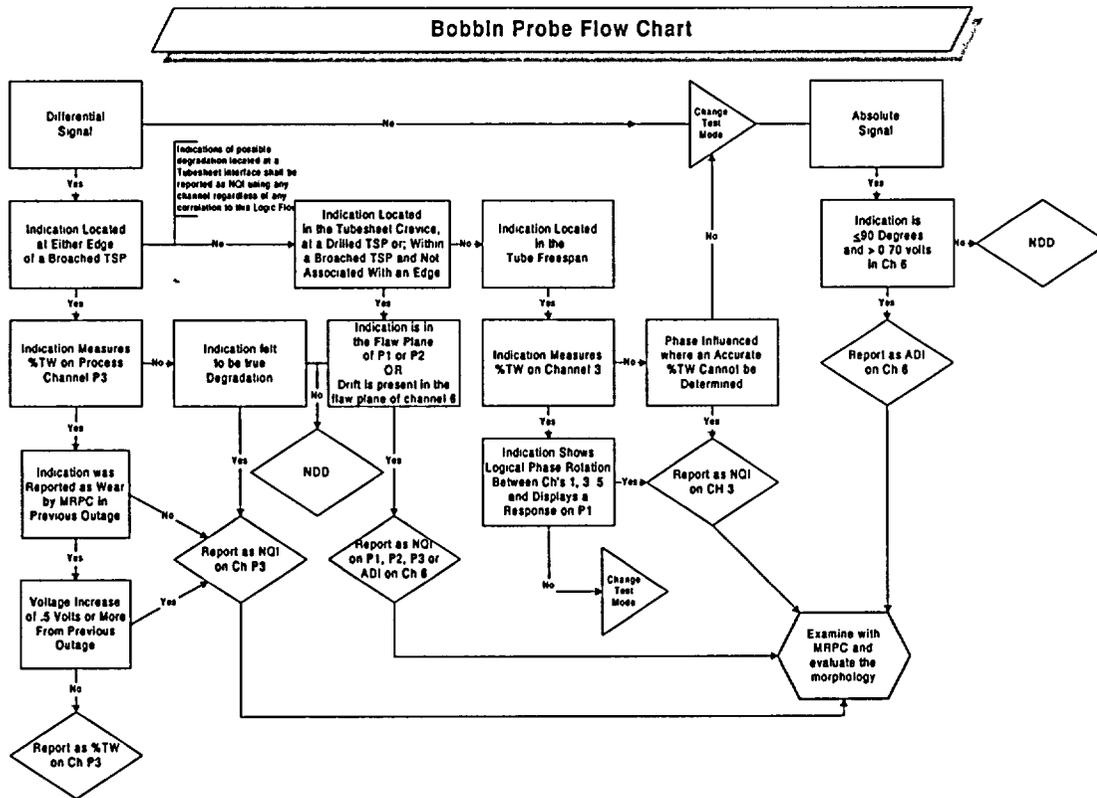
Figure 1

Indications identified at a TSP using the bobbin technique are recorded as a non-quantifiable indication (NQI) code, which requires further investigation by rotating coil (RC). RC is performed on NQI to characterize indication. If the indication was determined to be wear by RC and the bobbin signature has not changed, then an additional RC is not necessarily performed. Indications identified with the bobbin coil are analyzed using a flow chart included in the Crystal River Unit 3 (CR-3) Eddy Current Testing (ET) Data Analysis Guidelines (see Figure 1). A fretting type of wear occurs at TSP intersections from vibration and rubbing of the tube against the TSP. Wear is flow-related and has been identified at tube support plate elevations from the 1<sup>st</sup> to the 15<sup>th</sup> TSPs (as mentioned above, preferentially between the 12th and 7th TSP in OTSG A and between the 10th and 7th TSP in OTSG B). RC inspections have shown the morphologies of the indications to be volumetric [wear] and consistent with the degradation observed in the OTSG pulled tubes. The flaw characteristics take on the shape of the contact surface. Wear may be circular or "D" shaped or elongated. Wear may be flat bottomed or tapered axially, and may occur at one or more of the broached TSP contact areas or at drilled hole locations. Wear indications are typically small amplitude signals seen as distortions of the TSP lobe. Wear has been observed and monitored at CR-3. Tube pulls in 1994 verified the presence of wear at the

TSPs. Tapered as well as rounded wear scars were destructively examined. The ET sizing of the wear areas showed good correlation with the destructive exam results for these pulled tubes. The indication flow chart is included in the Examination Technique Specification Sheet (ETSS) #1 (Figure 1) of the CR-3 ET Data Analyst Guidelines.
