Florida Power
A Progress Energy Company

Crystal River Nuclear Plant
Docket No. 50-302
Operating License No DPR-72

Subject: Crystal River Unit 3 – Response to Request for Additional Information Regarding Fall 2001 Steam Generator Inspection

**Response to Request for Additional Information Regarding
Fall 2001 Steam Generator Inspection**

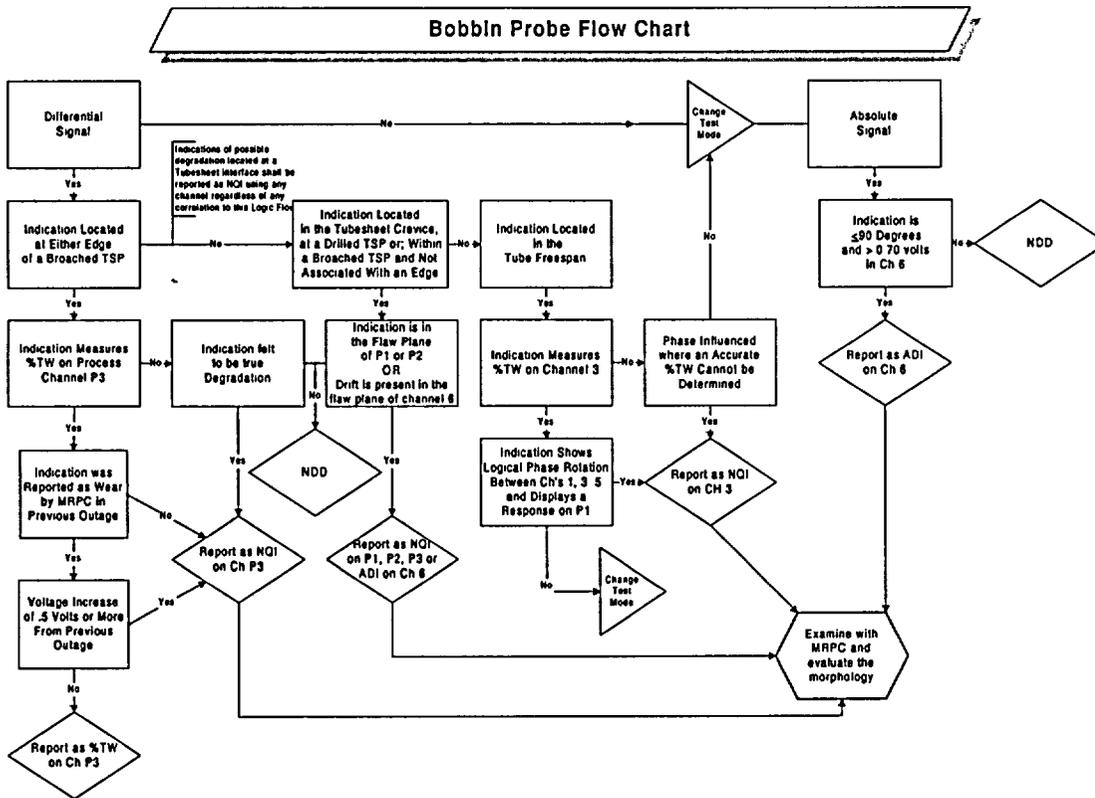
Figure 1

Indications identified at a TSP using the bobbin technique are recorded as a non-quantifiable indication (NQI) code, which requires further investigation by rotating coil (RC). RC is performed on NQI to characterize indication. If the indication was determined to be wear by RC and the bobbin signature has not changed, then an additional RC is not necessarily performed. Indications identified with the bobbin coil are analyzed using a flow chart included in the Crystal River Unit 3 (CR-3) Eddy Current Testing (ET) Data Analysis Guidelines (see Figure 1). A fretting type of wear occurs at TSP intersections from vibration and rubbing of the tube against the TSP. Wear is flow-related and has been identified at tube support plate elevations from the 1st to the 15th TSPs (as mentioned above, preferentially between the 12th and 7th TSP in OTSG A and between the 10th and 7th TSP in OTSG B). RC inspections have shown the morphologies of the indications to be volumetric [wear] and consistent with the degradation observed in the OTSG pulled tubes. The flaw characteristics take on the shape of the contact surface. Wear may be circular or "D" shaped or elongated. Wear may be flat bottomed or tapered axially, and may occur at one or more of the broached TSP contact areas or at drilled hole locations. Wear indications are typically small amplitude signals seen as distortions of the TSP lobe. Wear has been observed and monitored at CR-3. Tube pulls in 1994 verified the presence of wear at the

TSPs. Tapered as well as rounded wear scars were destructively examined. The ET sizing of the wear areas showed good correlation with the destructive exam results for these pulled tubes. The indication flow chart is included in the Examination Technique Specification Sheet (ETSS) #1 (Figure 1) of the CR-3 ET Data Analyst Guidelines.
