Serial: RNP-RA/02-0175

H. B. ROBINSON STEAM ELECTRIC PLANT, UNIT NO. 2
DOCKET NO. 50-261/LICENSE NO. DPR-23

**SUBMITTAL OF RESULTS OF REACTOR
PRESSURE VESSEL HEAD AND VESSEL HEAD PENETRATION
NOZZLE INSPECTIONS PERFORMED DURING REFUELING OUTAGE 21**

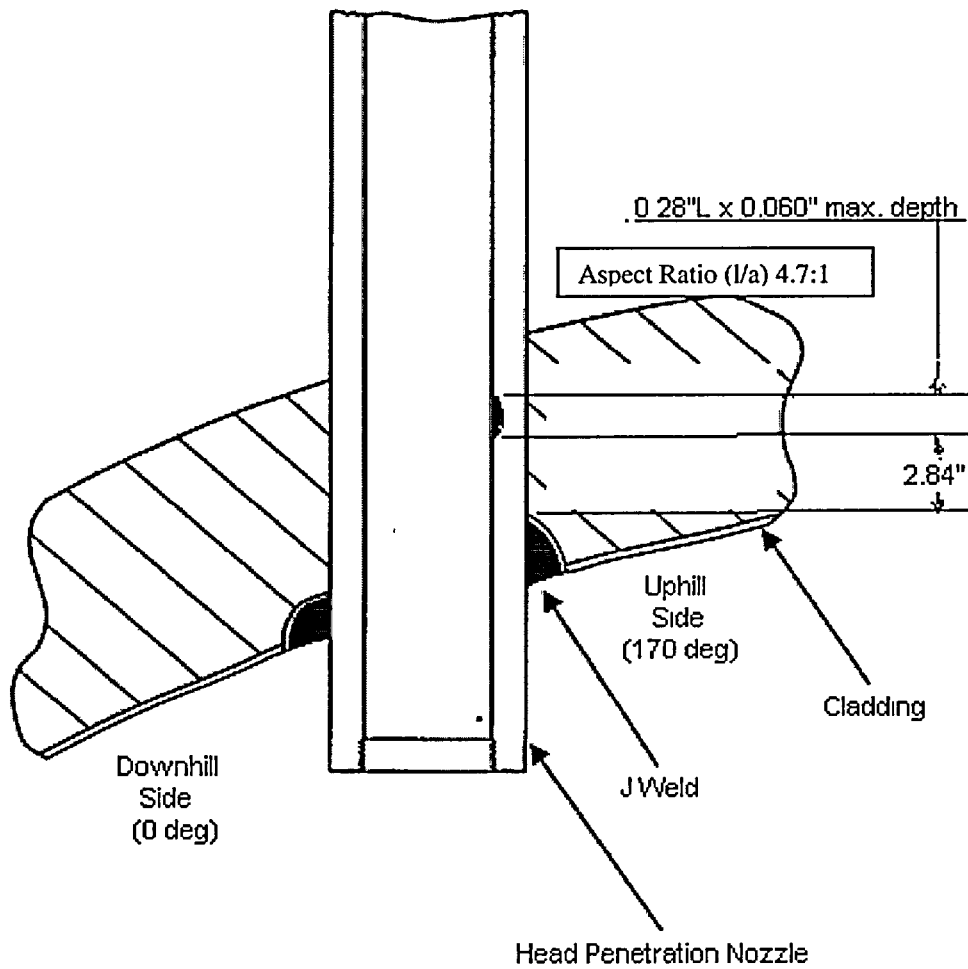
DRAWING OF PENETRATION NUMBER 47 RECORDABLE INDICATION

The NDE of the RPV head penetrations found no evidence of service-related degradation. One recordable indication was identified that did not require repair. An engineering analysis of this indication has been completed, and the crack growth model associated with this analysis shows that the applied stress intensity factor for the indication is below the threshold for crack propagation. The engineering analysis further concluded that the indication is most likely a scratch or other surface anomaly resulting from the manufacturing process, and there is no concern for this indication during future service. Attachment IV provides a figure that shows the general size, location, and orientation of the indication.

One recordable parent tube indication was identified in Penetration Tube No. 47. The indication was visible with the PCS24 TOFD ultrasonic testing transducer pair oriented for detection of axial indications. The indication is located wholly in the Alloy 600 penetration tube material and is axial in orientation. The bottom edge of the 0.28 inch long indication is located at 2.84 inches above the top edge of the weld at the 170-degree location, nearly at the uphill peak, with a depth less than 0.060 inch. The flaw aspect ratio is 4.7:1. An engineering analysis of this indication has been completed, and the crack growth model associated with this analysis shows that the applied stress intensity factor for the indication is below the threshold for crack propagation. The engineering analysis further concluded that the indication is most likely a scratch or other surface anomaly resulting from the manufacturing process, and there is no concern for this indication during future service. Attachment IV provides a figure that shows the general size, location, and orientation of the indication.
