Crystal River Nuclear Plant
Docket No. 50-302
Operating License No. DPR-72

Subject: LICENSEE EVENT REPORT 50-302/02-002-00

4. TITLE
Reactor Trip Due To Substation Generator Output Breaker Relay Mis-operation

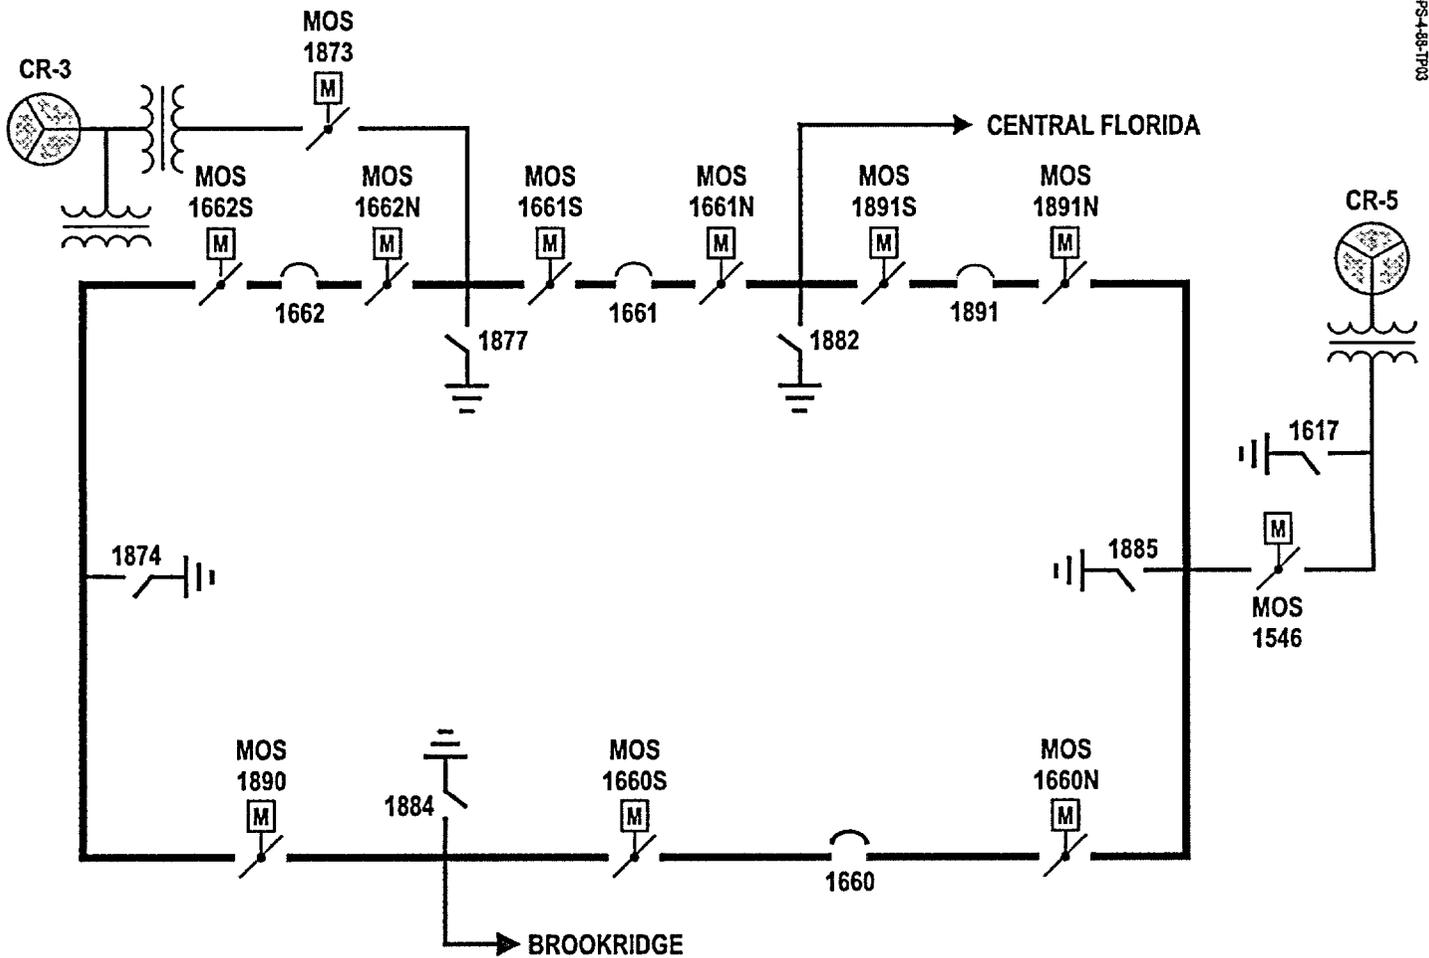
DRAWING #1

CR-3 connects to the 500KV substation through breakers 1661 and/or 1662 (see Drawing #1 - 500KV Substation Simplified Drawing). The 500KV substation [FK] also includes the incoming feeder from CR-5 (fossil generating plant), and outgoing transmission lines [FK, CBL] to Central Florida and Brookridge substations. Breakers 1661 and 1662 are designed to separate CR-3 from the grid under normal and abnormal conditions. Various relaying schemes associated with breakers 1661 and 1662 are designed to assure protection for the CR-3 main generator and 500KV substation from electrical faults.

CR-3 experienced a turbine trip and subsequent anticipatory reactor trip due to unexpected operation of breaker 1662 during system protective relay [FK, RLY] testing. Normal operating configuration would have required both 500KV generator output breakers 1661 and 1662 to open. However, breaker 1661 was out of service for maintenance and modification work. Post modification testing being performed was associated with relaying schemes for breaker 1661 and recent improvements made in the 500KV substation.

The cause for opening of 500KV substation generator output breaker 1662 was mis-operation of an Agastat 7024AC time delay relay contact [FK, 21] used to remove power from the 39E phase-to-phase fault relay and 39F phase-to-ground fault relay. Upon removal of the supply power to the Agastat 7024AC time delay relay, the relay contact created a voltage spike of the 39E relay power supply.

Engineering Change EC 50696, Revision 1, has been implemented. The way the 39E and 39F relays are disabled when the PT potential signal from the Central Florida transmission line is unavailable has been changed to prevent a repeat of the inadvertent trip of the CR-3 500KV substation generator output breakers. Previously, an Agastat 7024AC time delay relay removed the 125 volt direct current power from the 39E and 39F relays at 1.5 seconds after the loss of potential from the Central Florida transmission line potential transformers. The Agastat relay has been replaced by a multi-function programmable relay to block the trip signal from the 39E and 39F relays in addition to de-energizing input power to the relays. The new relay has an instantaneous pick-up set of contacts for energizing the power supplies and a 0.5 second delay for the trip signal when the relay is energized. When the new relay is de-energized, there is a 1.5 second delay for the trip signal and a 2 second delay for de-energizing the power supplies. The trip signal will effectively be blocked (0.5 seconds) both when applying control power and when removing control power from the two relays (39E and 39F). The 0.5 second blocking function will allow the 39E and 39F relay power supplies to energize (de-energize) without propagating a spurious trip of breakers 1661 and 1662.
