**TENNESSEE VALLEY AUTHORITY - BROWNS FERRY NUCLEAR PLANT (BFN) -
UNIT 3 - DOCKET 50-296 - FACILITY OPERATING LICENSE DPR-68 -
LICENSEE EVENT REPORT (LER) 50-296/2002-004-00**

1. FACILITY NAME Browns Ferry Nuclear Plant Unit 3					2. DOCKET NUMBER 05000296			3. PAGE 1 OF 8			
4. TITLE Loss of High Pressure Coolant Injection (HPCI) Flow Controller Power Supply

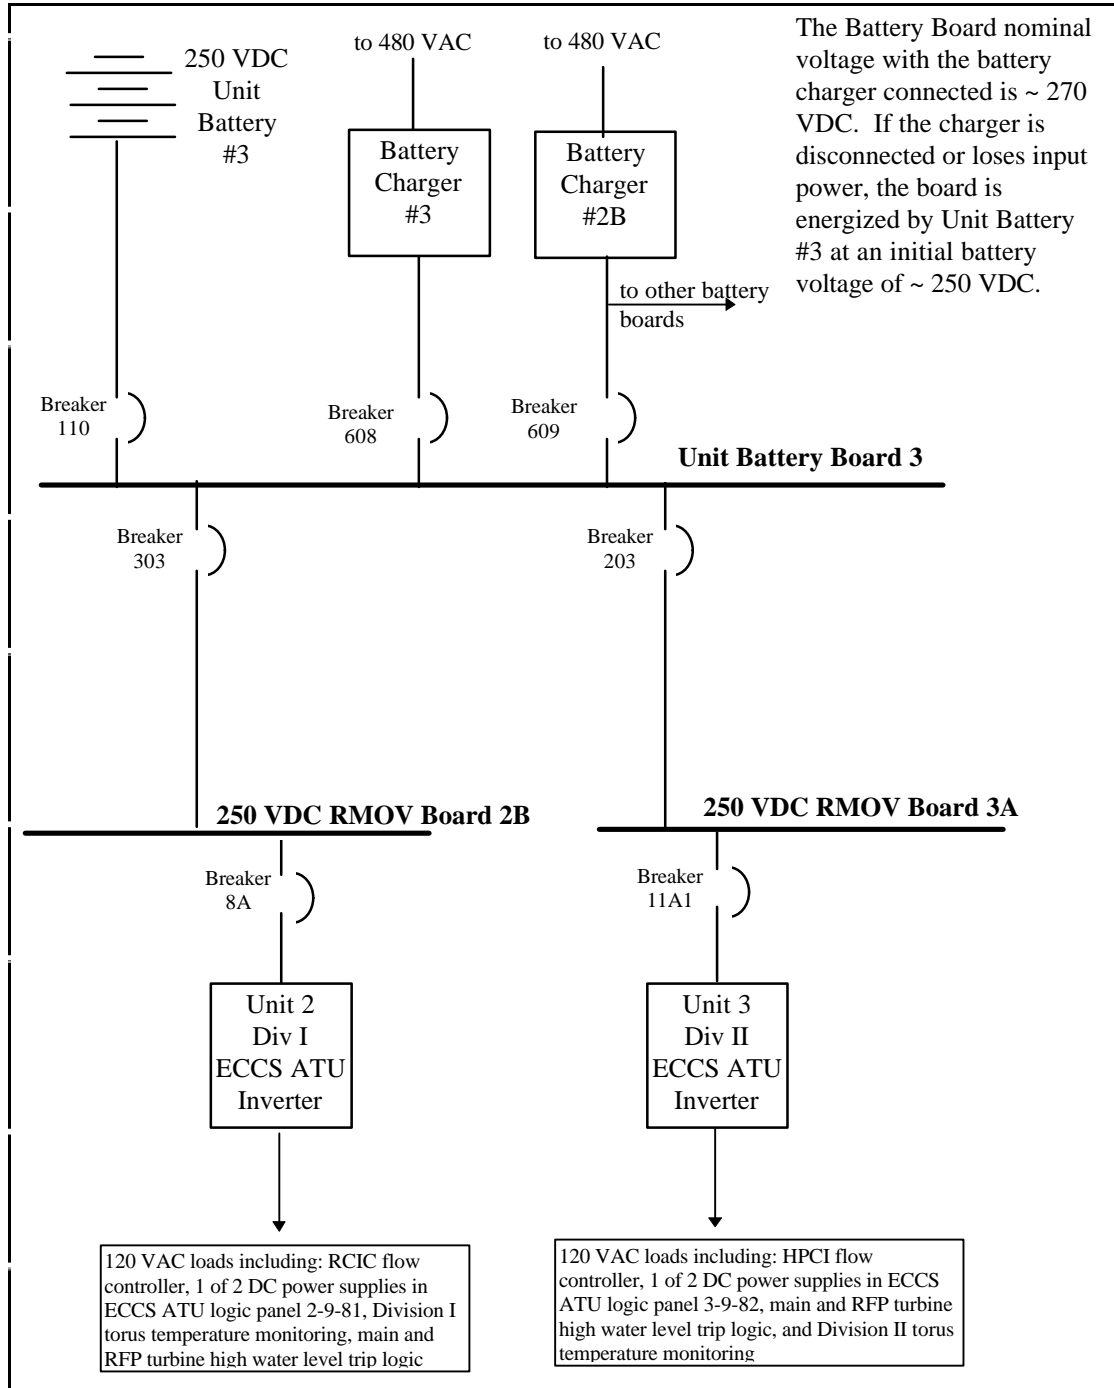
With the loss of 3-INV-256-0002, 120 VAC power to the following inverter loads was lost:

- the flow controller for the HPCI system
- the B channel of the high reactor water level trip logic for the main turbine and reactor feed pump (RFP) turbines
- one of two power supplies which provide 24 VDC power to ECCS ATU logic panel 3-9-82
- Division II of the U3 torus temperature monitoring instrumentation

Figure 1 on the following page depicts these loading connections.
