**Commissioners TA Briefing  
Davis-Besse Reactor Vessel Head**

**AGENDA  
March 14, 2002**

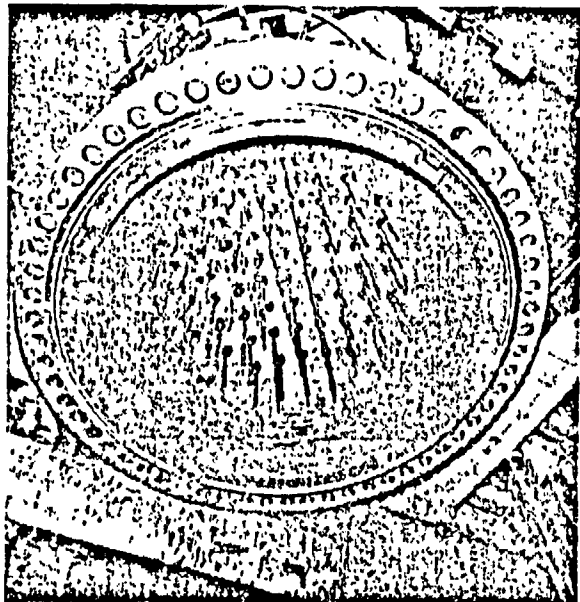
# DAVIS-BESSE RPV HEAD

Boric acid-like-material covering reactor pressure vessel head for several cycles

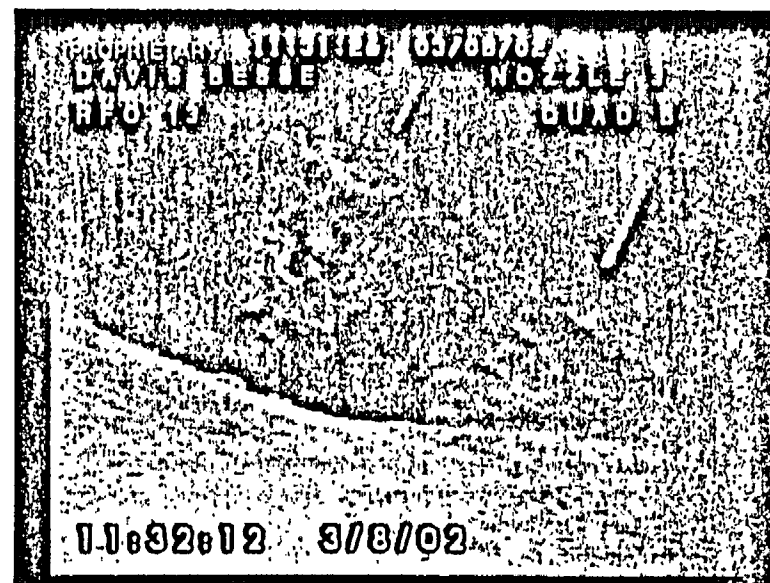
# DAVIS-BESSE NOZZLE 3

Largest cavity - nozzle 3

Length: approximately 5-inches

Width: approximately 4 to 5-inches at widest point

Depth: approximately 6-inches
