Millstone Nuclear Power Station, Unit No. 2
Supplemental Response to NRC Bulletin 2001-01
Circumferential Cracking of Reactor Pressure Vessel Head Penetration Nozzles

ERC 25203-ER-02-0005
Reactor Vessel Head Penetration Inspection Plan
for Ultrasonic Examination of Interference Fit

Reactor Vessel Head Penetration Inspection Plan for Ultrasonic Examination of Interference Fit

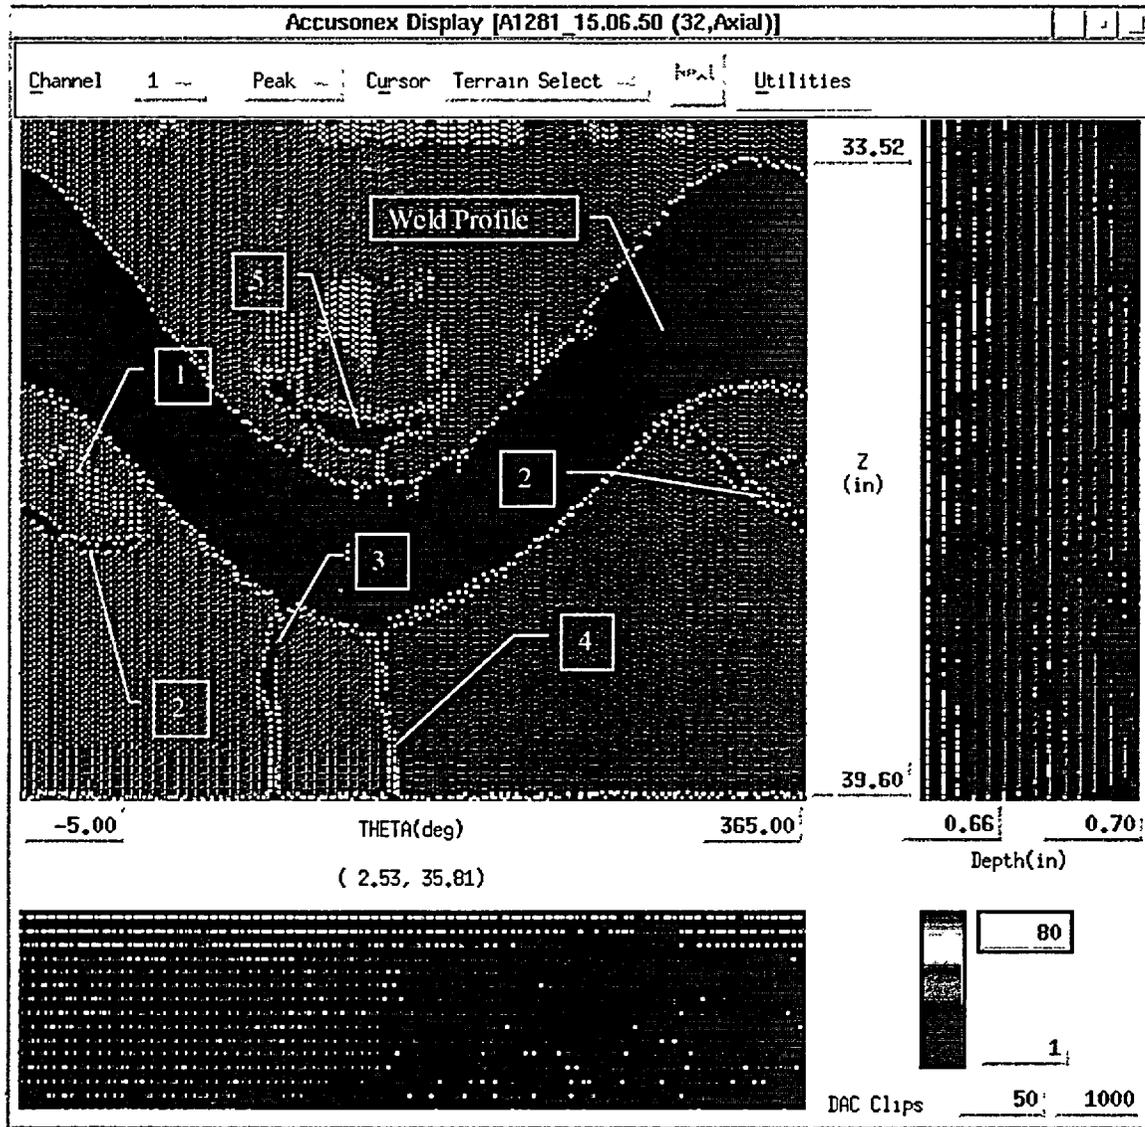
On Figure 1 (below), the analyst selected a slice of information (time/distance), which best illustrated the parameters of interest (cracks in relation to the weld). The areas of high energy are colored red and the areas of low energy are colored black. The large sinusoidal shape in the middle of the display is the weld. Note the total loss of back reflection in the area of the weld, indicating that the sound energy was allowed to propagate into the weld. The sound energy is also not reflected toward the receiving transducer at this point in time in the location of the four cracks labeled 2 through 5.

The small, vertical, multi-colored bar code in the bottom right corner of the illustration is set with a color range of 1 through 80.

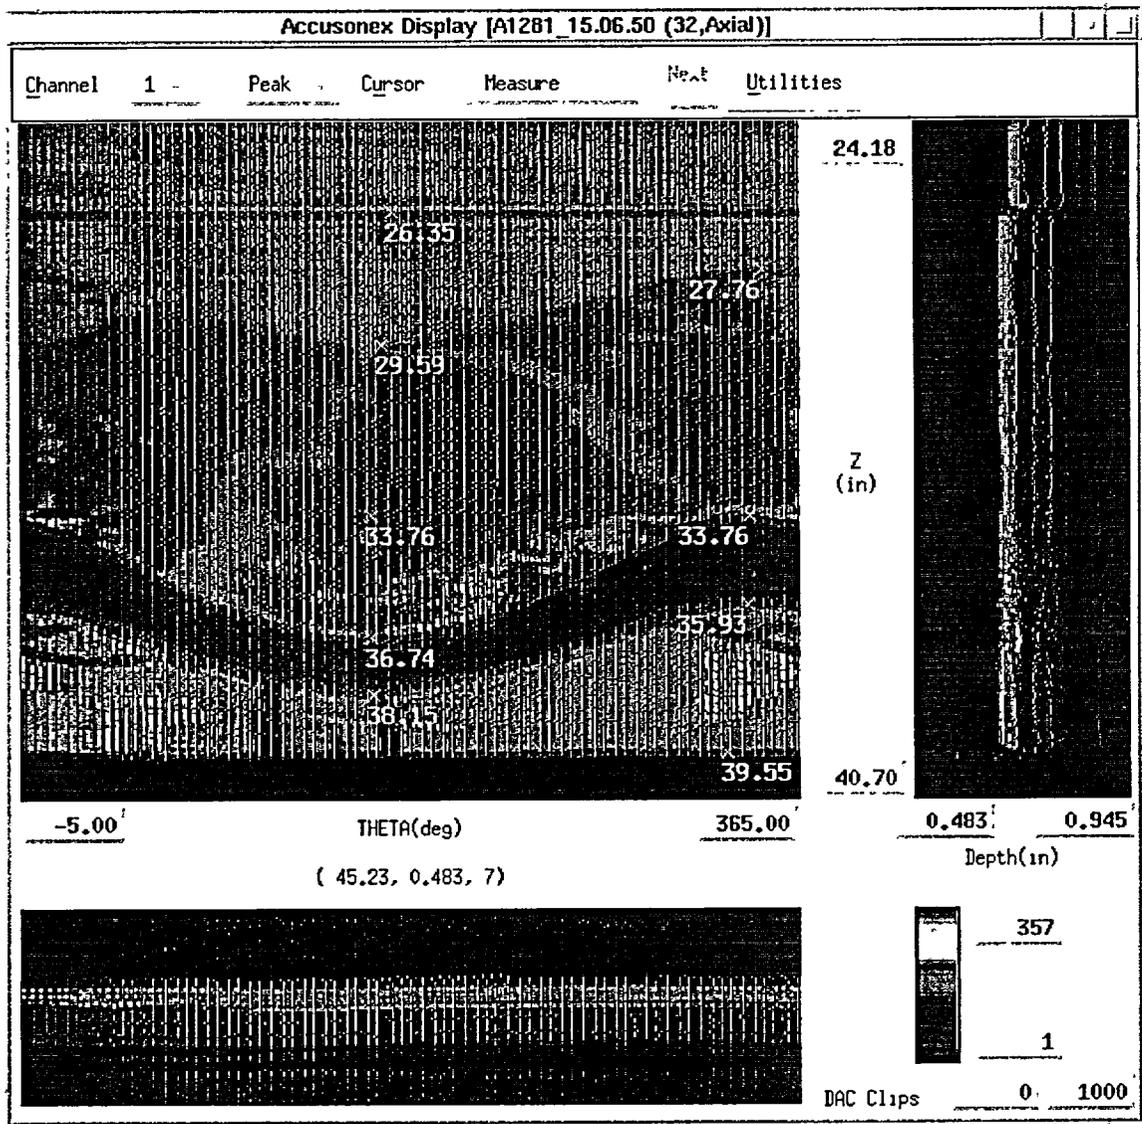
Figure 2

Figure 2, is the same penetration. In this illustration, the primary area of interest was to measure the location of the top of the vessel head, interference fit, and weld, before starting the repair. Location 26.35 is a transition area where there is a geometry change in the tube, above the top of the vessel head. Location 27.76 is the top of the vessel head on the uphill side of the nozzle and location 29.59 is the top of the vessel head on the downhill side of the nozzle. Note how the rise and fall of the vessel head conforms to the rise and fall of the weld indicating the geometry of the vessel head curvature. The area between location 29.59 and location 33.76 is the interference fit. The general area between the top and bottom of the interference fit has less sound energy reflected than any other area in this illustration other than the weld. Location 39.55 is the bottom of the nozzle. The area between 39.55 and the bottom of the weld is a metal to air interface.

Although the color scheme was set to optimize the other parameters, two distinct areas of high reflection are visible through the interference fit. These two areas are the RCS leak paths through the interference fit.

Note the color settings on the color bar code are 1 through 357.

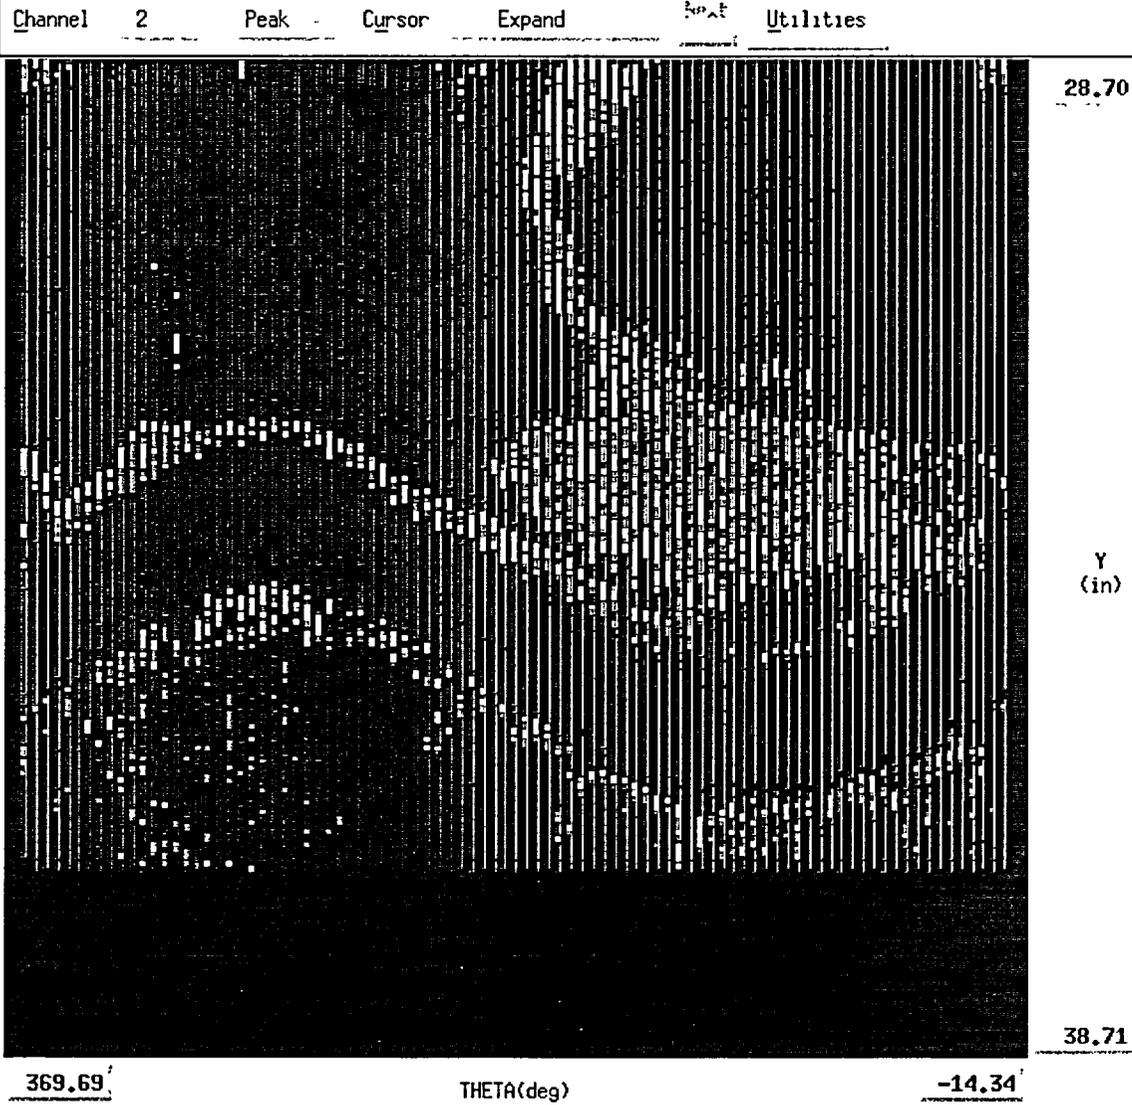
Figure 3 and Figure 4 are both of another power station. Although a different color scheme was used for both of these illustrations, the leak path is clearly visible through the interference fit portion of the annular region above the weld. The area between the low side of the weld and the interference fit has a void with very high reflectivity. Numerous crack indications lead into this void with one clear leak path leading out.

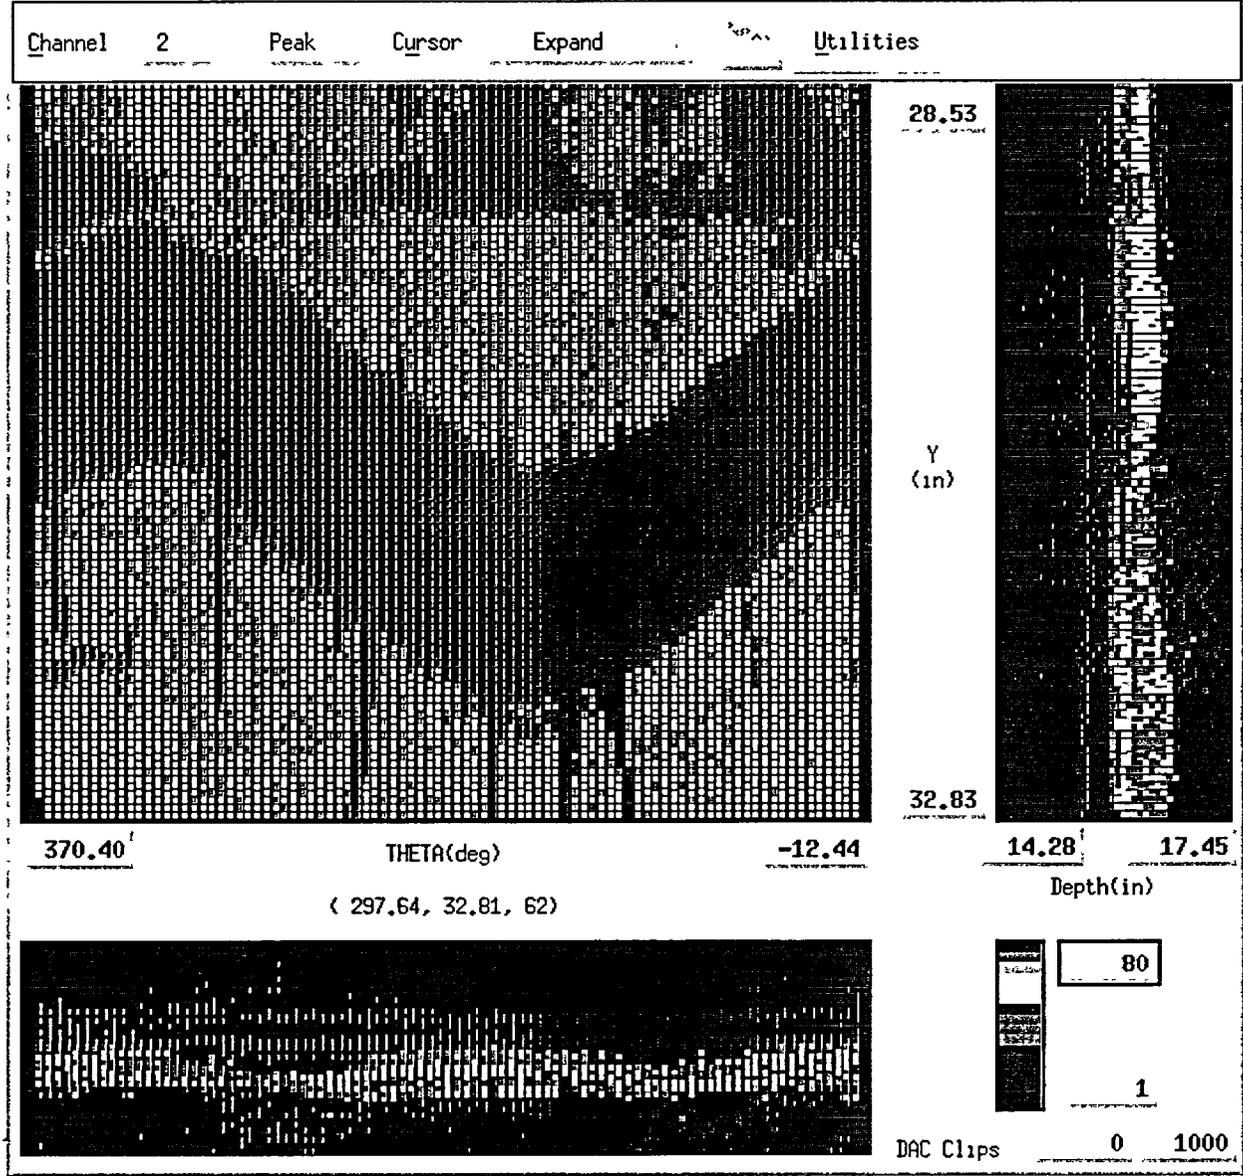
Figure 5 is a printout of the ultrasonic C-scan display from another CRDM. In this illustration, numerous cracks are depicted leaking into the area between the interference fit and the low side of the weld, just as in Figures 3 and 4. In this Figure, the leak path through the interference fit is located on the high side of the weld.

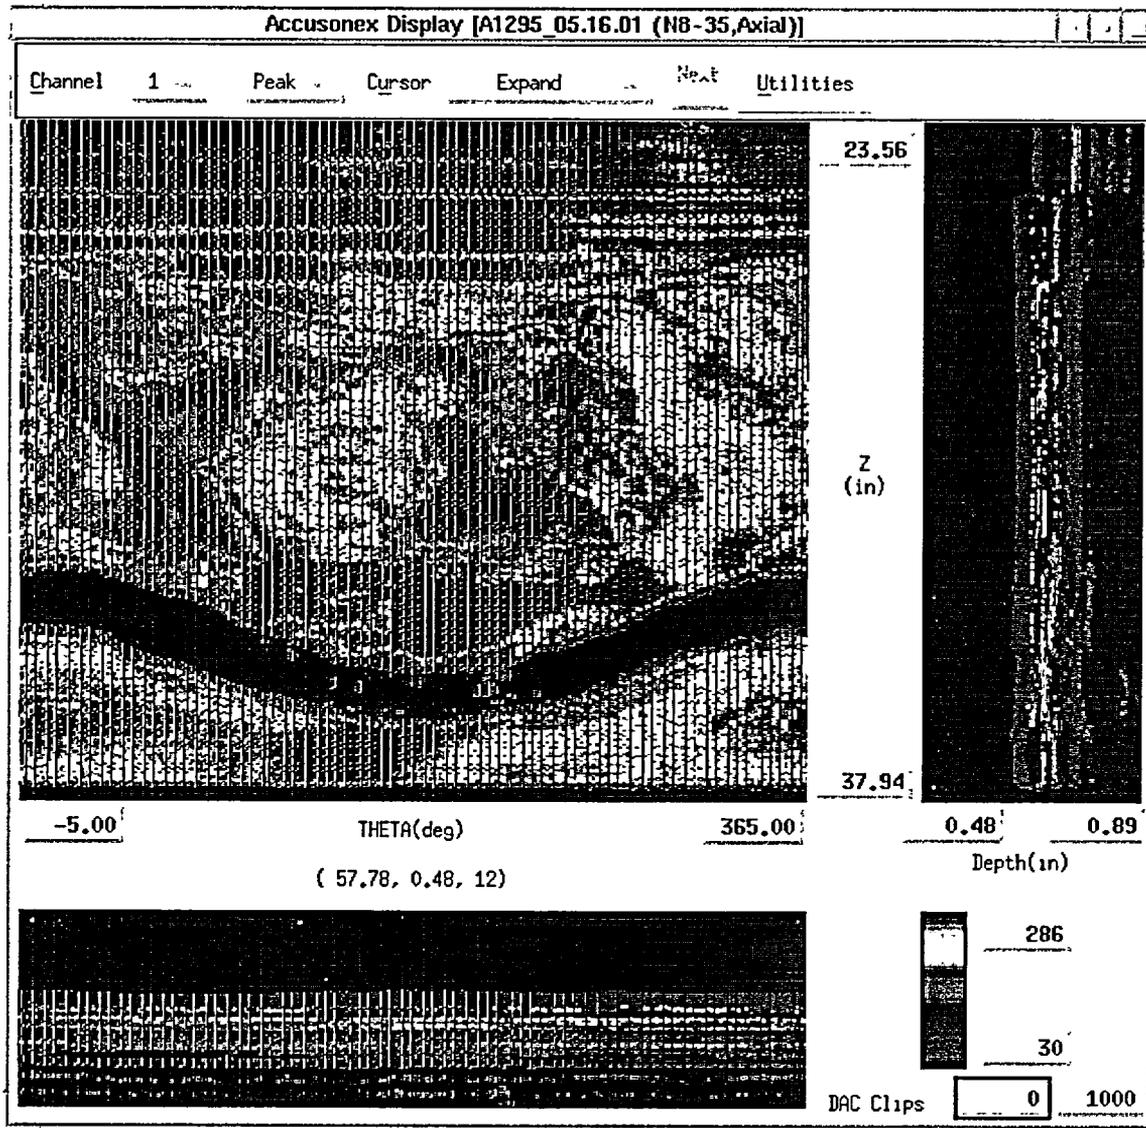
Figure 7 is a printout from a different power station. Again we see an illustration that is less than ideal for a visual study in reflected energy. The color range is 30 to 286 but more importantly, magenta appears between dark blue and black on the color bar code. If the magenta areas that appear in the interference fit and weld portions of the illustration were a color between blue and black it would be more obvious where the areas of energy transmittance are. While an optimal color range selection would provide a better presentation, it is still evident that the area above the low side of the weld and under the interference fit has extremely high reflection. Large areas of high energy reflection are observed passing through the interference fit, denoting a leak. In this particular nozzle, the crack was not detected with ultrasonic flaw detection techniques but a liquid penetrant exam did detect a through wall crack in the weld. This leak would have been detected with an ultrasonic scan of the interference fit.

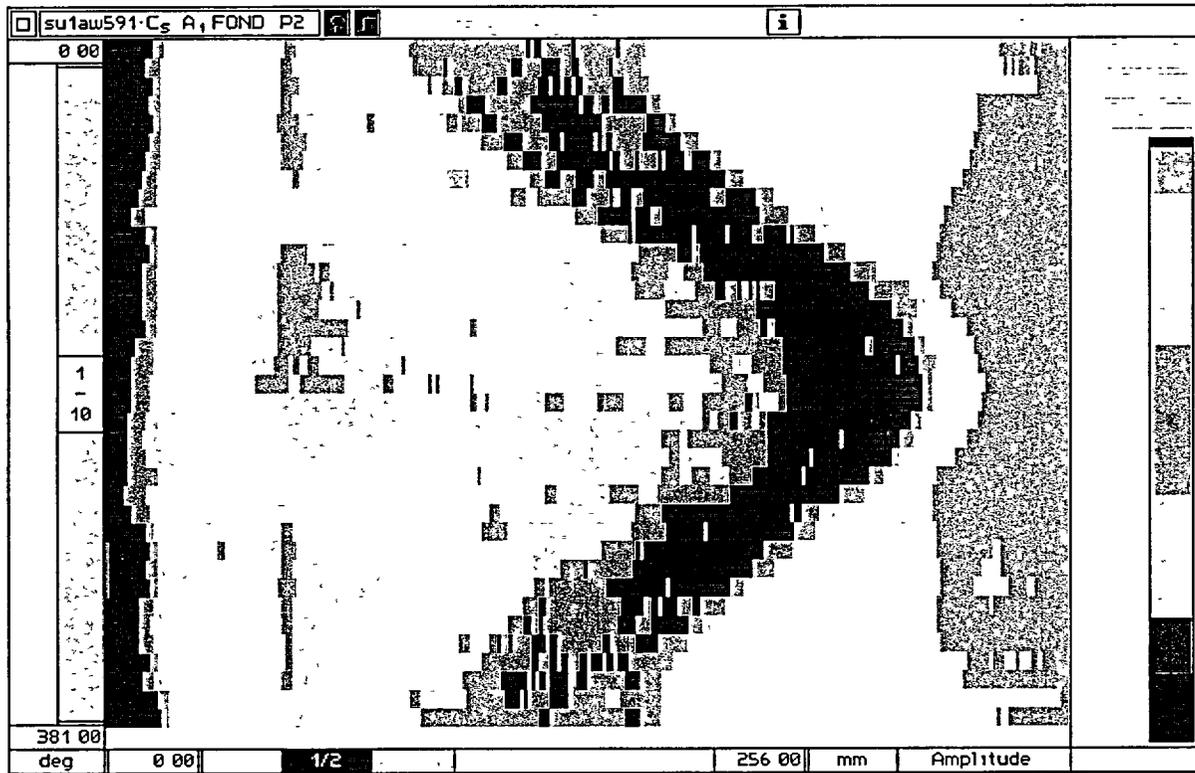
Even though the color scheme in Figure 8 has a light blue shade between the beige and green and also a light blue shade between green and dark blue on the color code bar, it is obvious that there are no leak paths or areas of high energy reflection in the interference fit, (which now appears on the right side of the illustration).

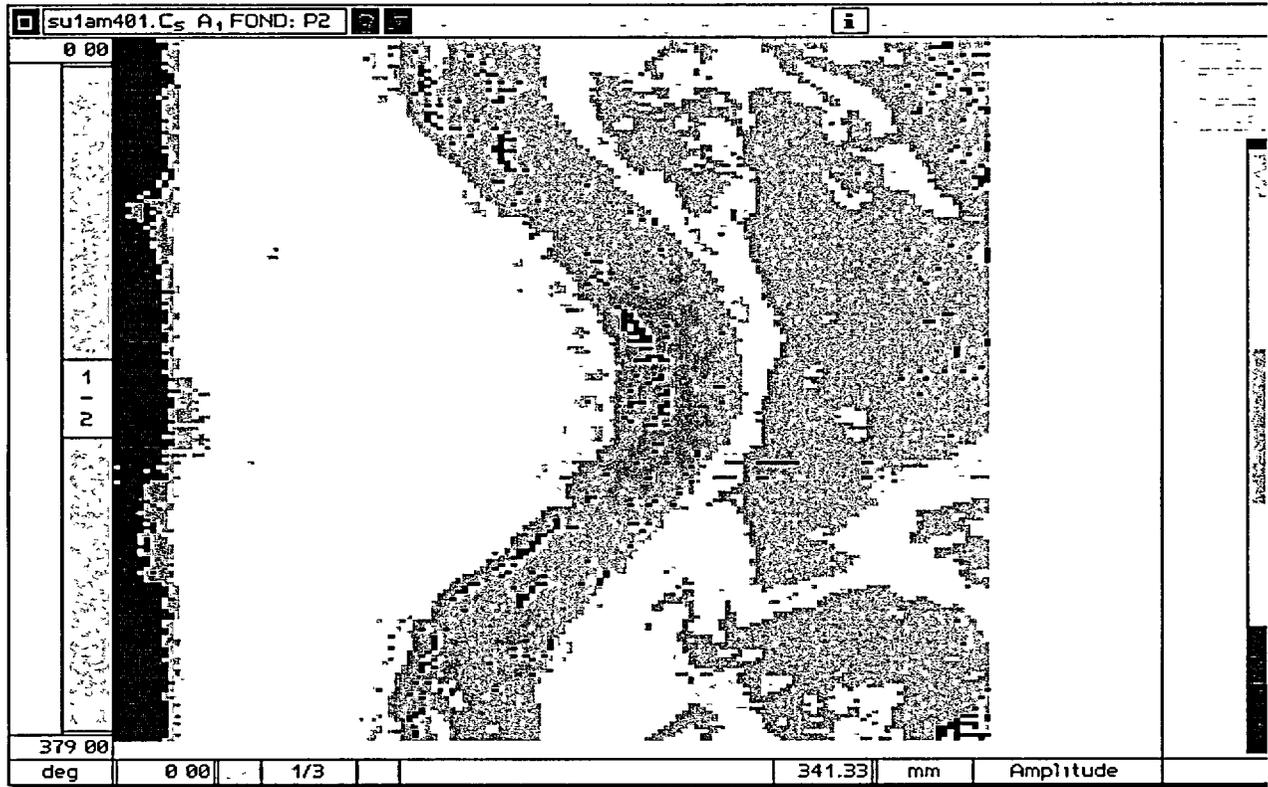
Figure 9

In Figure 9, there is an area above the weld and below the interference fit that displays an area of high energy reflection. The leak path through the interference fit is also visible. Although no cracks were detected with the ultrasonic flaw detection technique, a liquid penetrant test of the weld did produce an indication that turned out to be a through wall leak in the weld.

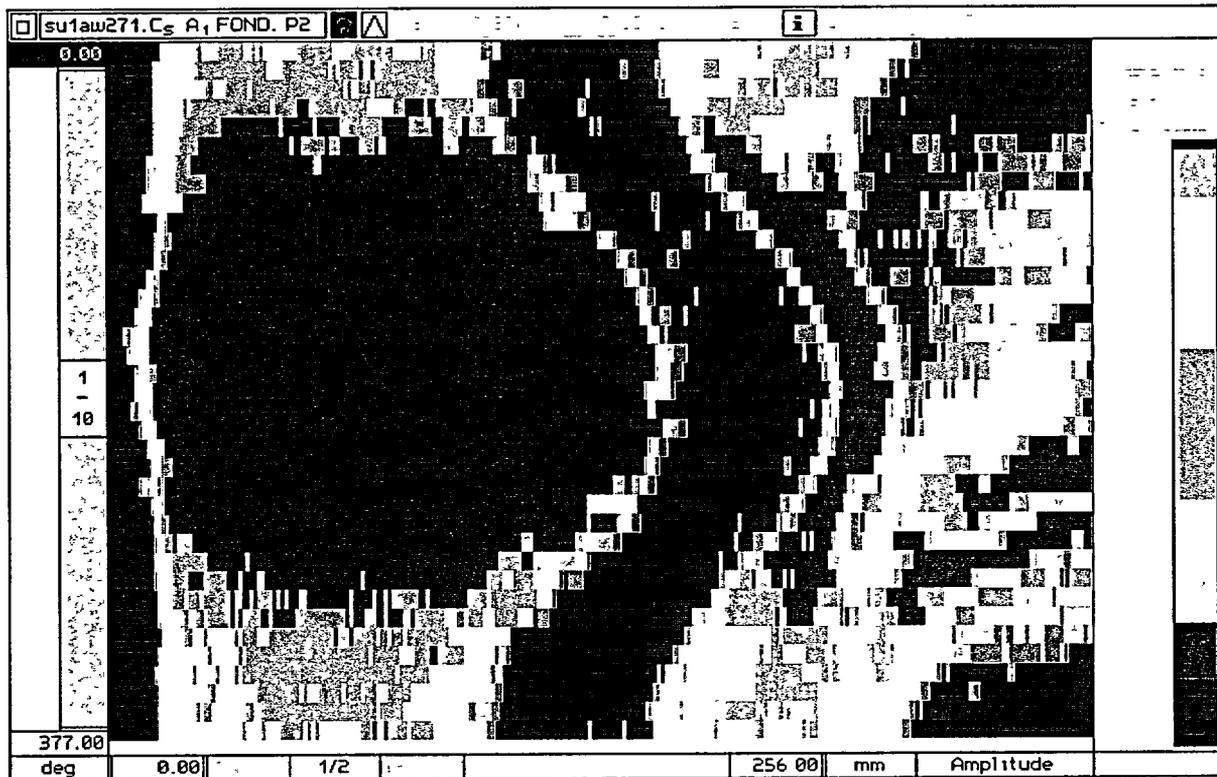
Figure 10 also depicts a leak path through the interference fit on a nozzle that contained a crack in the weld that was not detected with the ultrasonic flaw detection technique.
