MONTICELLO NUCLEAR GENERATING PLANT
Docket No. 50-263 License No. DPR-22

LER 2002-007

Application of Instrumentation Deviation Acceptance Criteria Allowed As-Found Settings For High Drywell Pressure to be Outside Technical Specification Value

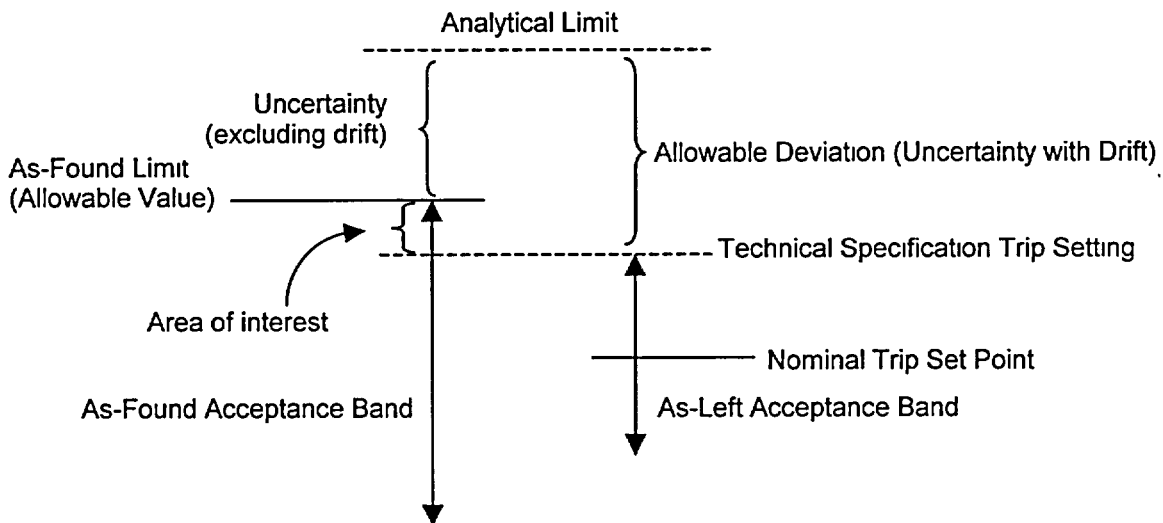
The As-Found Acceptance Band criteria is based on an allowable deviation from the TS trip setting which takes into account drift and uncertainty to assure that analytical limits of the safety analyses are not exceeded. However, the allowable deviations are contained in tables in the Bases of the TS and should not be construed as an allowance to deviate from the TS. The application of the Allowable Deviations (from the Bases) to the Trip Settings (in the TS) is illustrated below.

For all four channels evaluated during the surveillance, the as-found value was within the Allowable Value, and as-left settings were adjusted if necessary and verified to be within the TS trip setting. Since the as-found condition was within the Allowable Value, the safety function of each channel was not affected since the analytical limit could not have been exceeded. Therefore, while the as-found condition did not meet TS requirements, the safety function of the instruments was not affected.
