**TENNESSEE VALLEY AUTHORITY - BROWNS FERRY NUCLEAR PLANT (BFN)
- UNIT 3 - DOCKET 50-296 - FACILITY OPERATING LICENSE DPR-68 -
LICENSEE EVENT REPORT (LER) 50-296/2002-004-00**

The enclosed report provides details of an unplanned inoperability condition of the Unit 3 high pressure coolant injection (HPCI) system which resulted from a loss of the system's flow controller power supply. The power supply was lost as a result of a battery charger failure during a maintenance activity.

4. TITLE
Loss of High Pressure Coolant Injection (HPCI) Flow Controller Power Supply

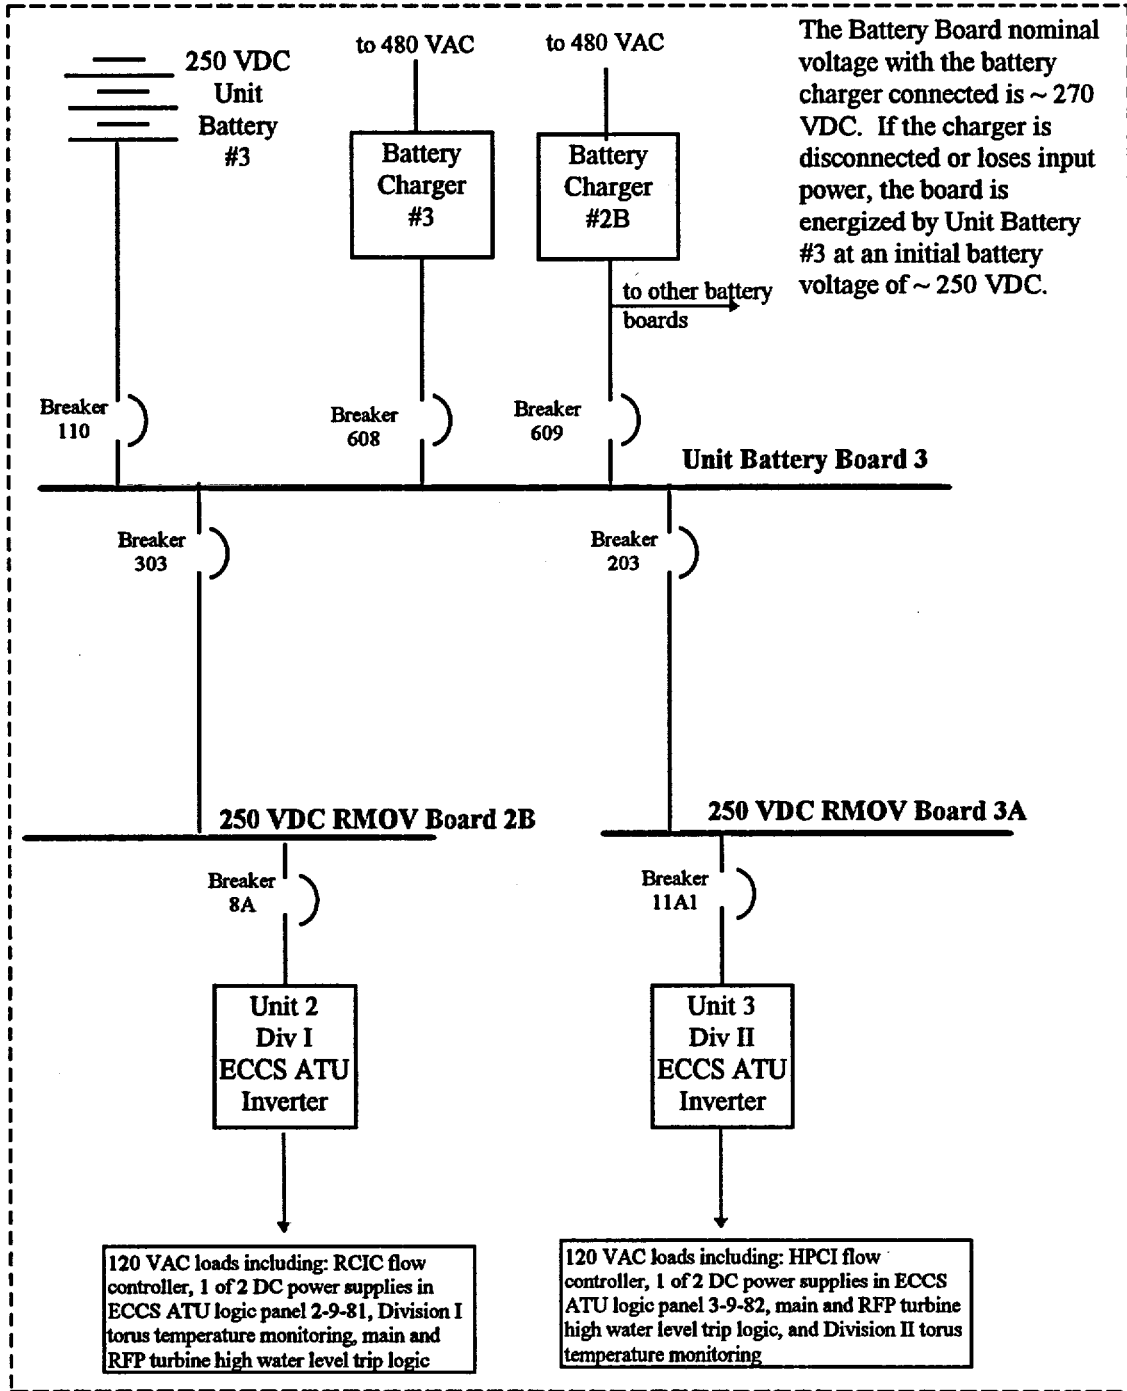
Unit 2	Unit 3
Equipment Affected	With the loss of 2-INV-256-0001, 120 VAC power to the following inverter loads was lost:	With the loss of 3-INV-256-0002, 120 VAC power to the following inverter loads was lost:
Note: None of the Unit 2 equipment which lost power was required for service with the unit shutdown in a mid-cycle outage (Mode 5) with the reactor cavity flooded.	<ul style="list-style-type: none"> • the flow controller for the reactor core isolation cooling (RCIC) system • the A channel of the high reactor water level trip logic for the main turbine and reactor feed pump (RFP) turbines • one of two power supplies which provide 24 VDC power to ECCS ATU logic panel 2-9-81 • Division I of the U2 torus temperature monitoring instrumentation 	<ul style="list-style-type: none"> • the flow controller for the HPCI system • the B channel of the high reactor water level trip logic for the main turbine and reactor feed pump (RFP) turbines • one of two power supplies which provide 24 VDC power to ECCS ATU logic panel 3-9-82 • Division II of the U3 torus temperature monitoring instrumentation

Figure 1 on the following page depicts these loading connections.
