Tennessee Valley Authority, Post Office Box 2000, Decatur, Alabama 35609-2000

**TENNESSEE VALLEY AUTHORITY - BROWNS FERRY NUCLEAR PLANT (BFN)  
- UNIT 3 - DOCKET 50-296 - FACILITY OPERATING LICENSE DPR-68 -  
LICENSEE EVENT REPORT (LER) 50-296/2002-004-00**

**4. TITLE**  
Loss of High Pressure Coolant Injection (HPCI) Flow Controller Power Supply

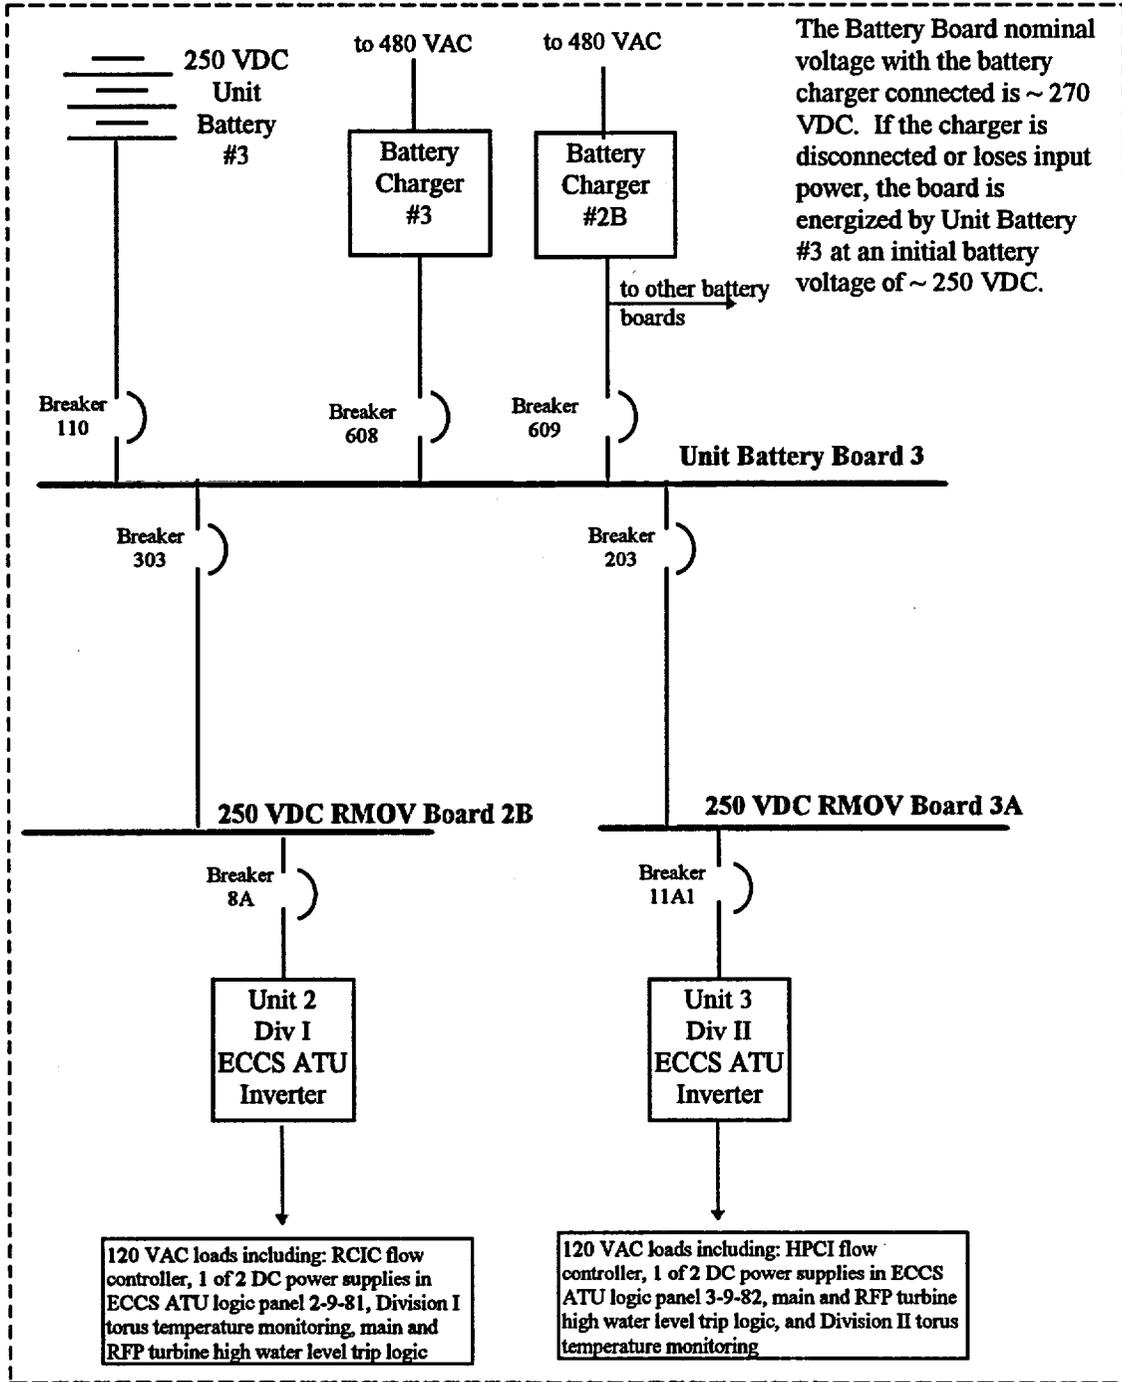
Unit 2	Unit 3
Equipment Affected	With the loss of 2-INV-256-0001, 120 VAC power to the following inverter loads was lost:	With the loss of 3-INV-256-0002, 120 VAC power to the following inverter loads was lost:
Note: None of the Unit 2 equipment which lost power was required for service with the unit shutdown in a mid-cycle outage (Mode 5) with the reactor cavity flooded.	<ul style="list-style-type: none"> <li>• the flow controller for the reactor core isolation cooling (RCIC) system</li> <li>• the A channel of the high reactor water level trip logic for the main turbine and reactor feed pump (RFP) turbines</li> <li>• one of two power supplies which provide 24 VDC power to ECCS ATU logic panel 2-9-81</li> <li>• Division I of the U2 torus temperature monitoring instrumentation</li> </ul>	<ul style="list-style-type: none"> <li>• the flow controller for the HPCI system</li> <li>• the B channel of the high reactor water level trip logic for the main turbine and reactor feed pump (RFP) turbines</li> <li>• one of two power supplies which provide 24 VDC power to ECCS ATU logic panel 3-9-82</li> <li>• Division II of the U3 torus temperature monitoring instrumentation</li> </ul>

Figure 1 on the following page depicts these loading connections.
