Subject: Duke Power Company, Oconee Nuclear Station, Unit 2
Docket No. 50-270
Reactor Vessel Head and Penetration Nozzle Condition Report

**Oconee Unit 2
End-of-Cycle 19 Refueling Outage
Reactor Vessel Head Penetration Nozzle Indication Report**

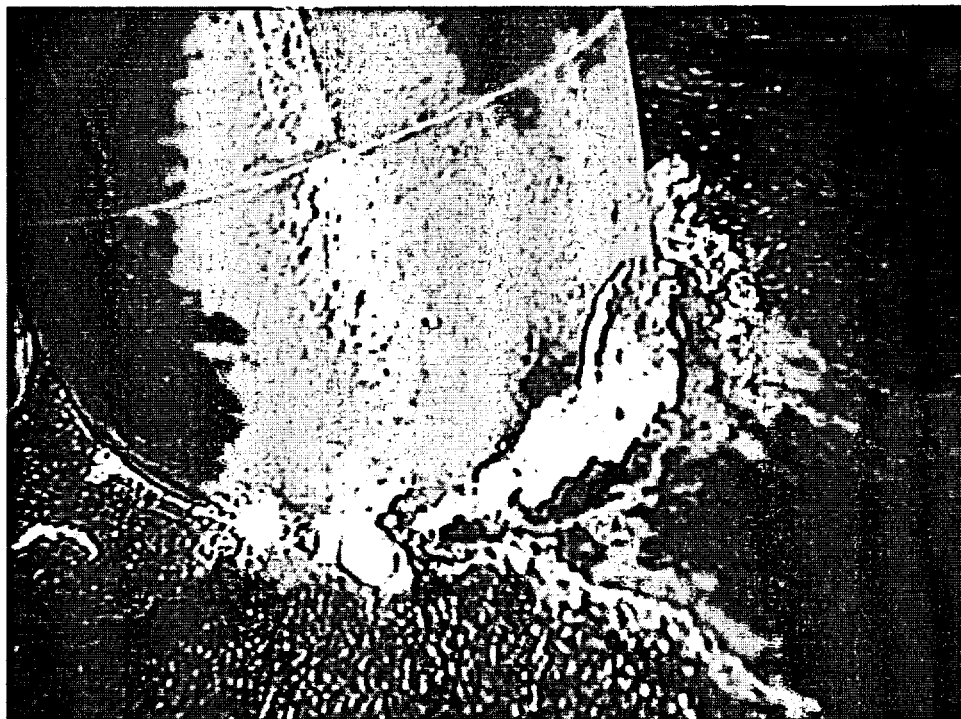
Figure 1 Oconee Unit 2 CRDM Nozzle 19 Identified as Leaking, Top of RV head
Inspection for Boric Acid Crystals, 10/15/02

Fifteen CRDM Nozzles (numbers 1, 8, 9, 11, 15, 19, 21, 24, 31, 36, 38, 42, 60, 63 and 67) were repaired during this outage using the automated Framatome-ANP "ID Ambient Temper Bead" weld repair technique as described in the Relief Request 02-07². Corrective actions taken and future outage plans remain consistent with Duke's NRC Bulletin 2001-01, 2002-01 and 2002-02 submittals. Specifically, RV head replacement is scheduled at the next refueling outages for all three Oconee units (i.e., for ONS-3 in the spring of 2003, ONS-1 in the fall of 2003, and ONS-2 in the spring of 2004).

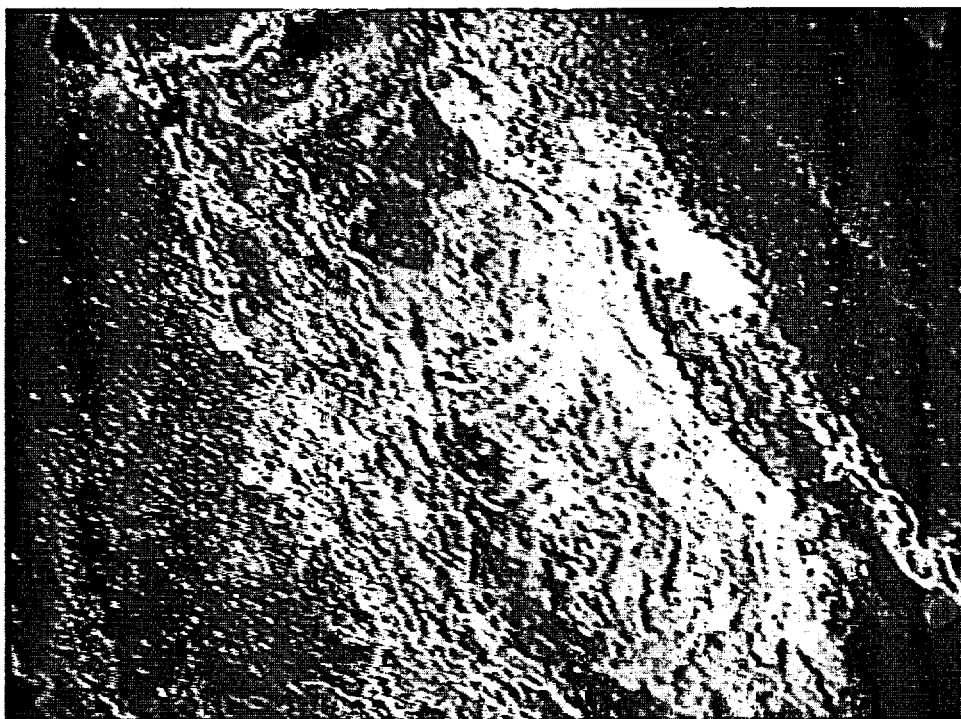
Figure 2 Oconee Unit 2 CRDM Nozzle 31 Identified as Leaking, Top of RV head
Inspection for Boric Acid Crystals, 10/15/02

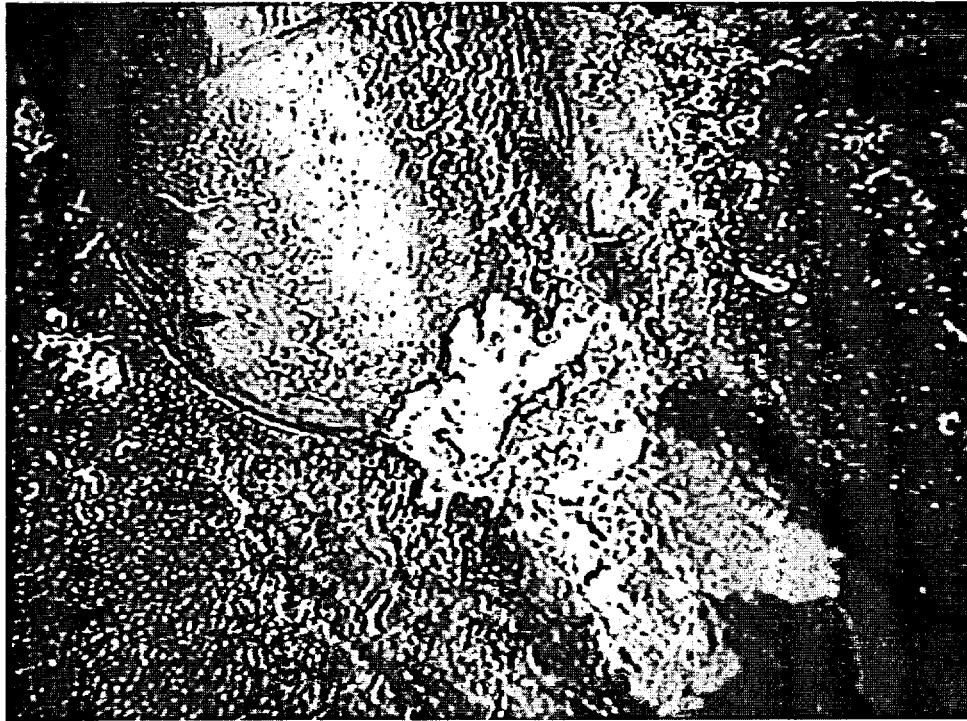
Figure 3 Oconee Unit 2 CRDM Nozzle 42 Identified as Leaking, Top of RV head
Inspection for Boric Acid Crystals, 10/15/02

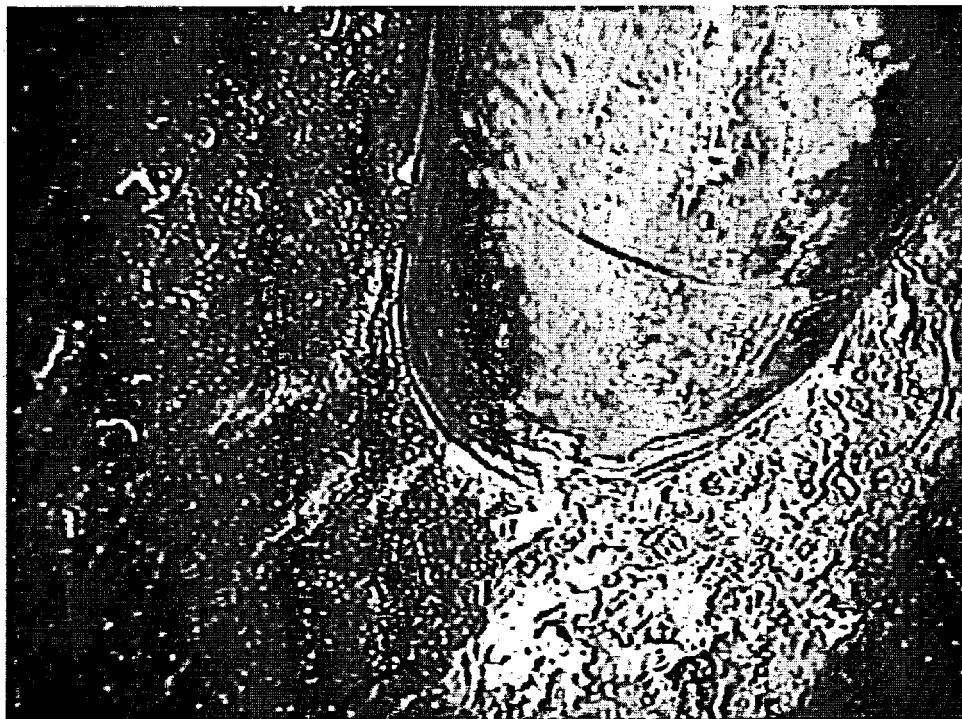
Figure 5 Oconee Unit 2 CRDM Nozzle 60 Identified as Masked, Top of RV head
Inspection for Boric Acid Crystals, 10/15/02

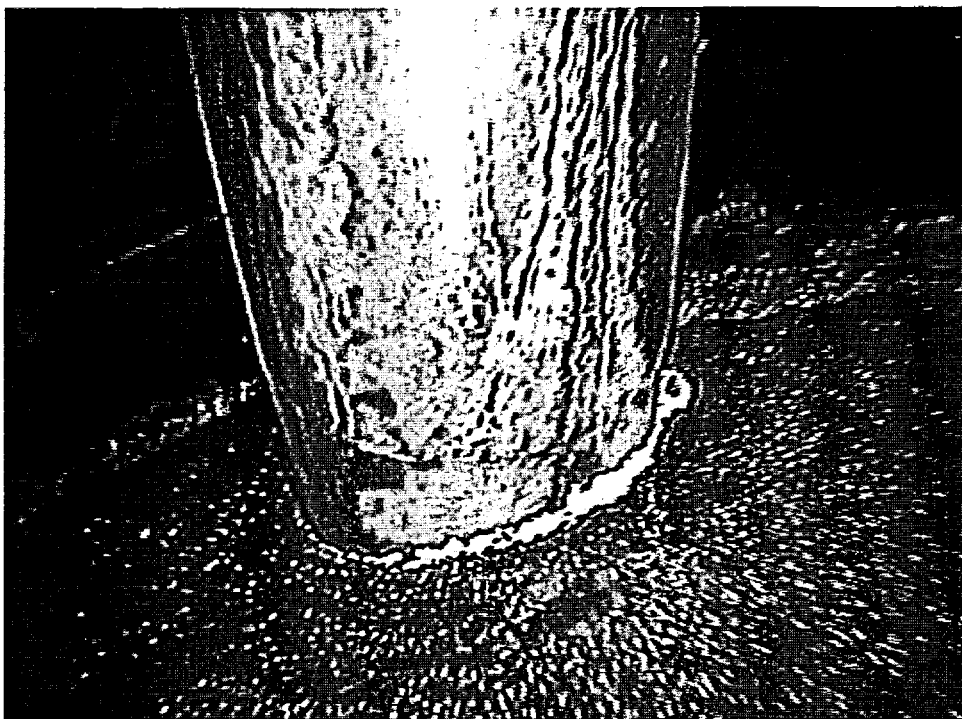
Figure 6 Oconee Unit 2 CRDM Nozzle 63 Identified as Masked, Top of RV head
Inspection for Boric Acid Crystals, 10/15/02

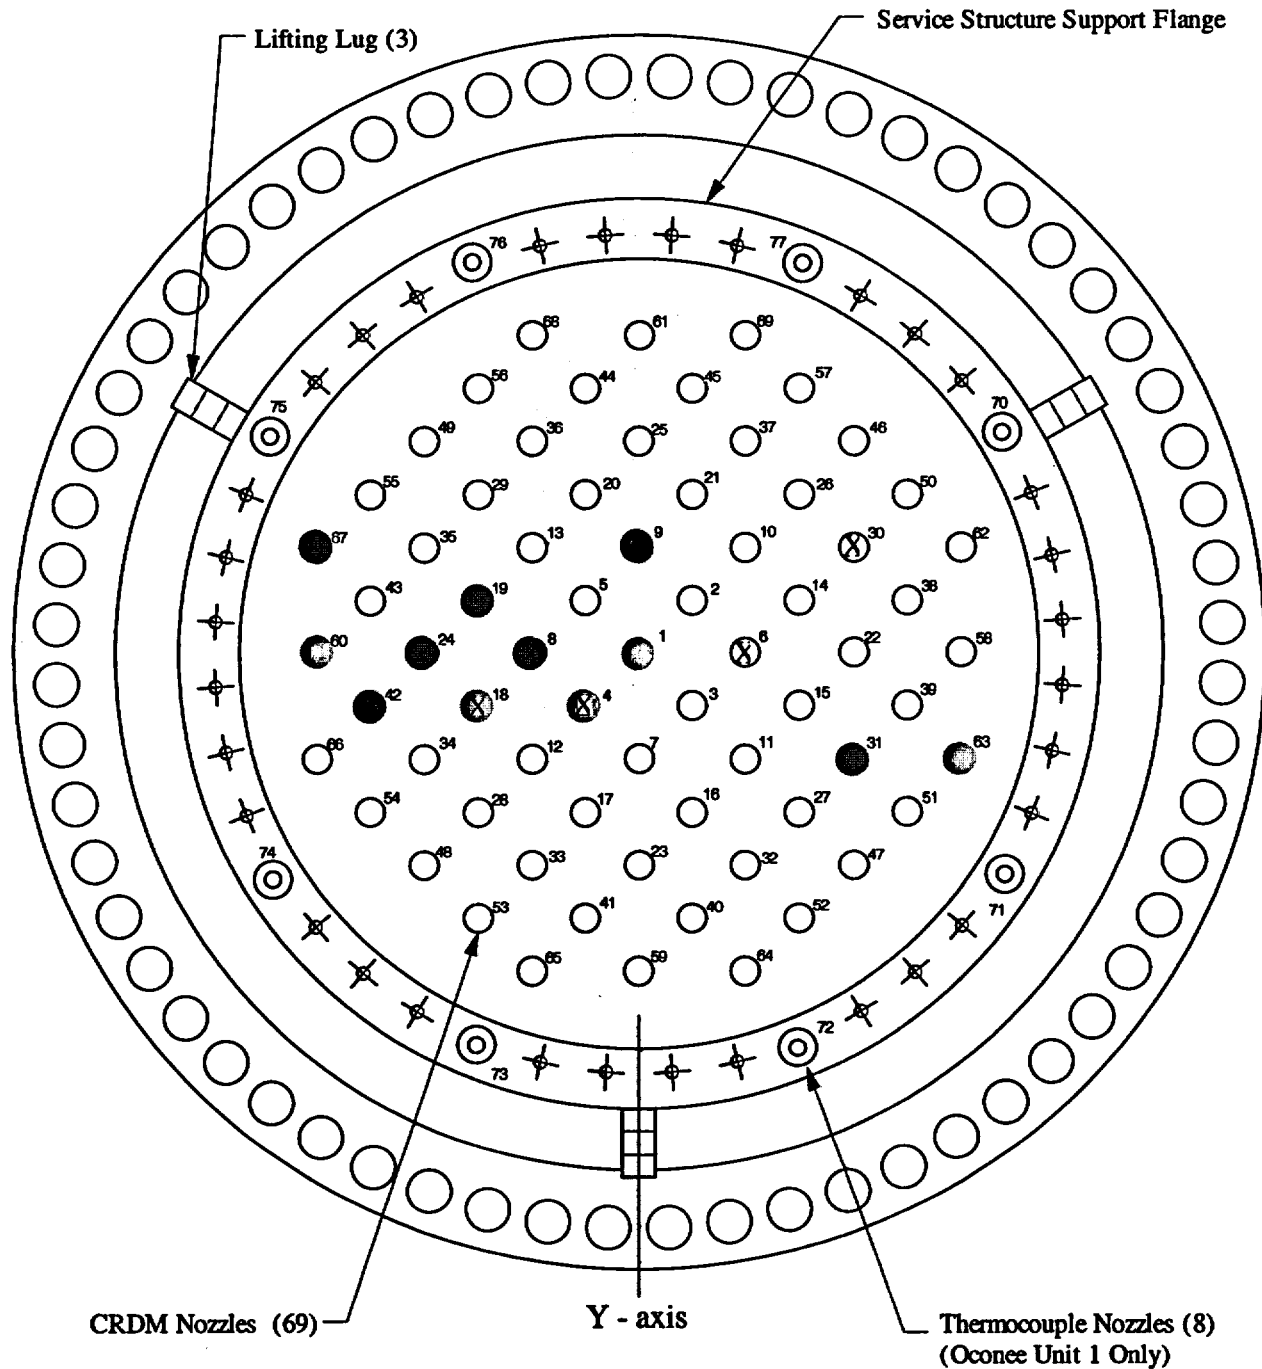
● Nozzles 8, 9, 19, 24, 31, 42 and 67 identified as leaking during EOC-19

⊗ Nozzles 1, 4, 18, 60 and 63 identified as being masked during EOC-19

X Nozzles 4, 6, 18 and 30 were repaired (ID Temper Bead) during EOC-18

Figure 7 Bare metal visual inspections of RV head, Oconee Unit 2 CRDM nozzles identified as suspect, during EOC-19 refueling outage, October 15, 2002

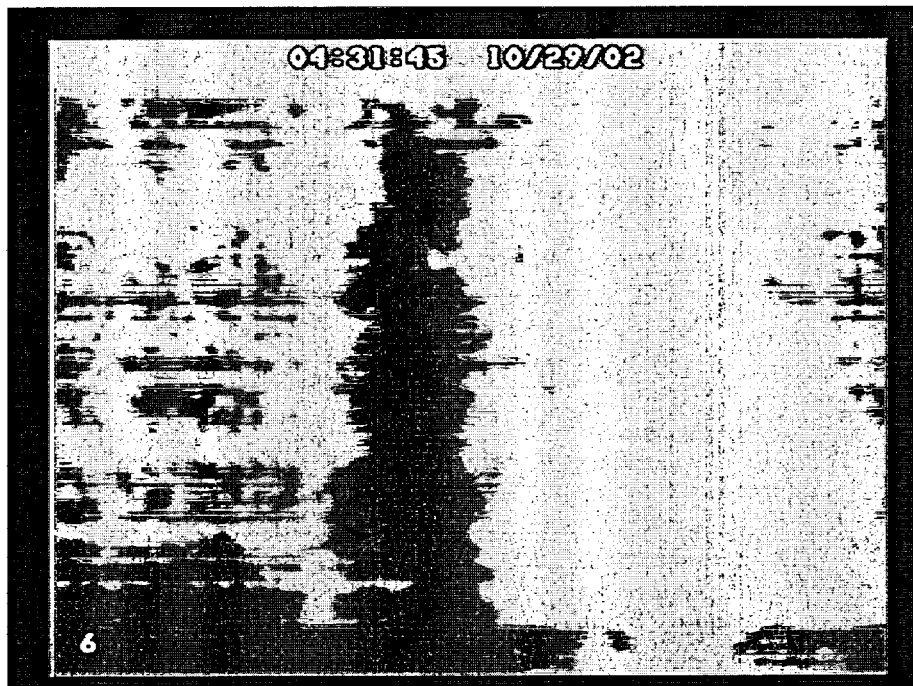
Figure 8 Nozzle 15 axial PT indications, original J-groove weld bore after removal of nozzle, ONS-2 EOC-19

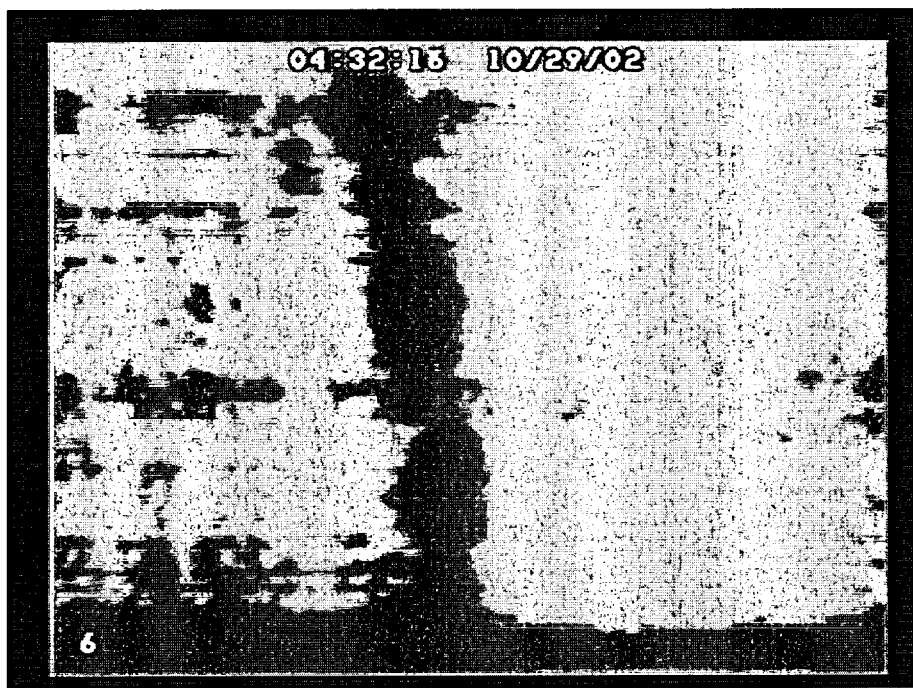
Figure 9 Nozzle 15 continuations of axial PT indications, original J-groove weld bore after removal of nozzle, ONS-2 EOC-19

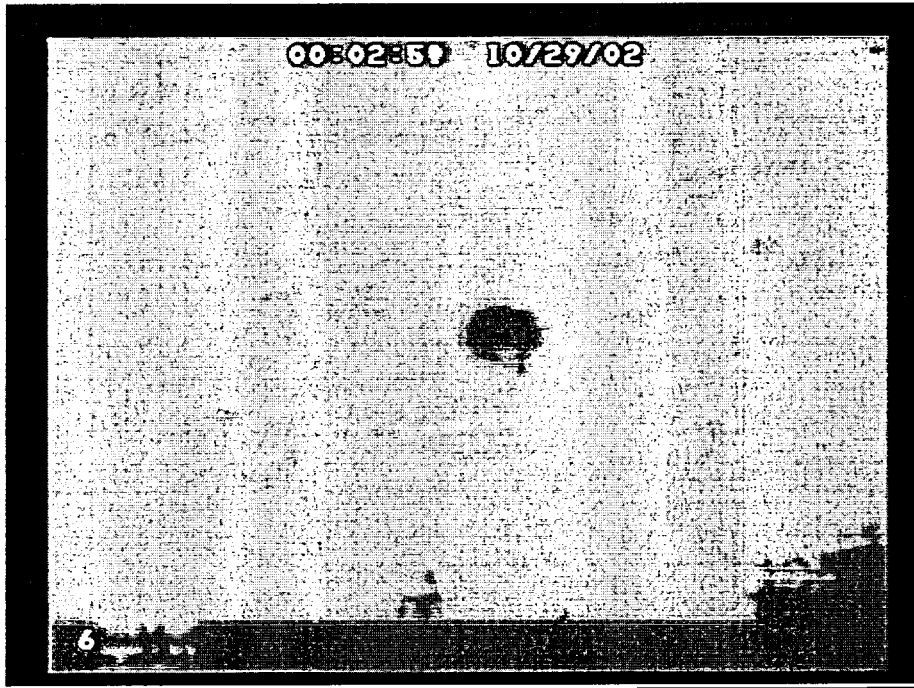
Figure 10 Nozzle 21, rounded PT indications, original J-groove weld bore after removal of nozzle, ONS-2 EOC-19
