**RE: Irigaray-Christensen Operations Annual Inspection Report, Permit No. 478**

## ANNUAL INSPECTION REPORT

**Subject:** COGEMA Mining Inc.'s Irigaray and Christensen Ranch In Situ Uranium Operations

**Permit No.:** 478

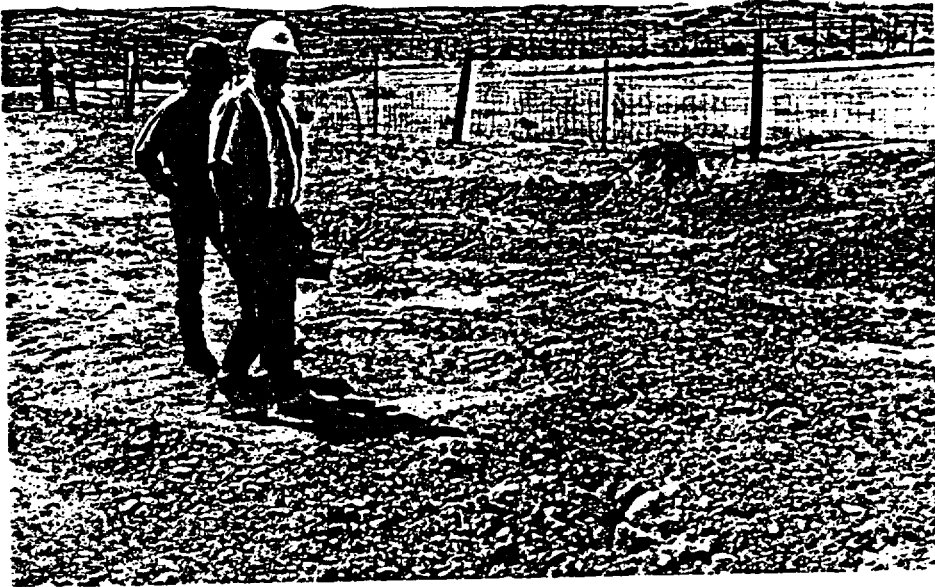
Some gravel has been removed from the 5I7 site, but considerably more needs to be removed. Some remaining gravel is between 6 and 8 inches thick and was planned atop native topsoil back when the site was active in the mid-1970's (Photo No. 1). When most of the gravel has been removed, Mr. Vasein said he would have the site tilled to remove compaction and prepare a good seed bed. Any removed gravel can easily be disposed by placing it on the nearby main access road.

**Photo No. 1**  
Looking west at area on western side of 5I7 site where some gravel has been removed from in-place topsoil. The main access road and fenced pond area are partially visible in right distance.

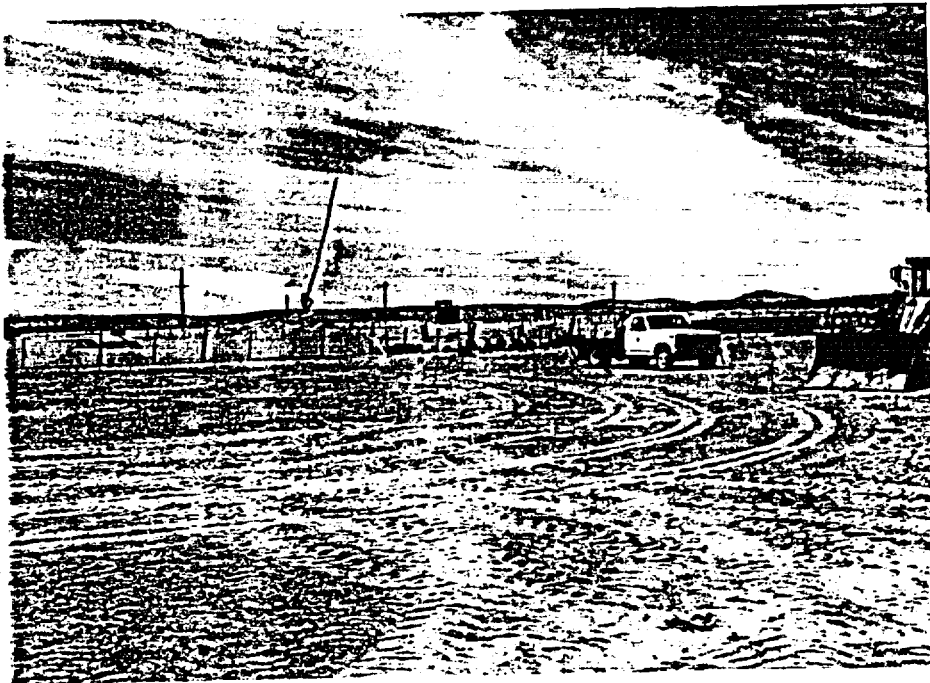
Mr. Vasein indicated that he would like to dispose of a quantity of concrete from the foundations of the nearby USMT plant building in the excavated disposal pit (Photo No. 2). With removal of the contaminated material there is room in the hole for burial of the concrete. A pending NonSignificant Revision (TFN 3 3/389) would require that concrete so buried would have to be buried at least four feet deep, exclusive of the thickness of any replaced topsoil.

**Photo No. 2**  
Looking north at western end of 5I7 site where clean-up work is in progress. Arrow points to concrete rubble from USMT plant foundation. Plans are now to dispose of non-radiolocally - contaminated concrete in 5I7 site.

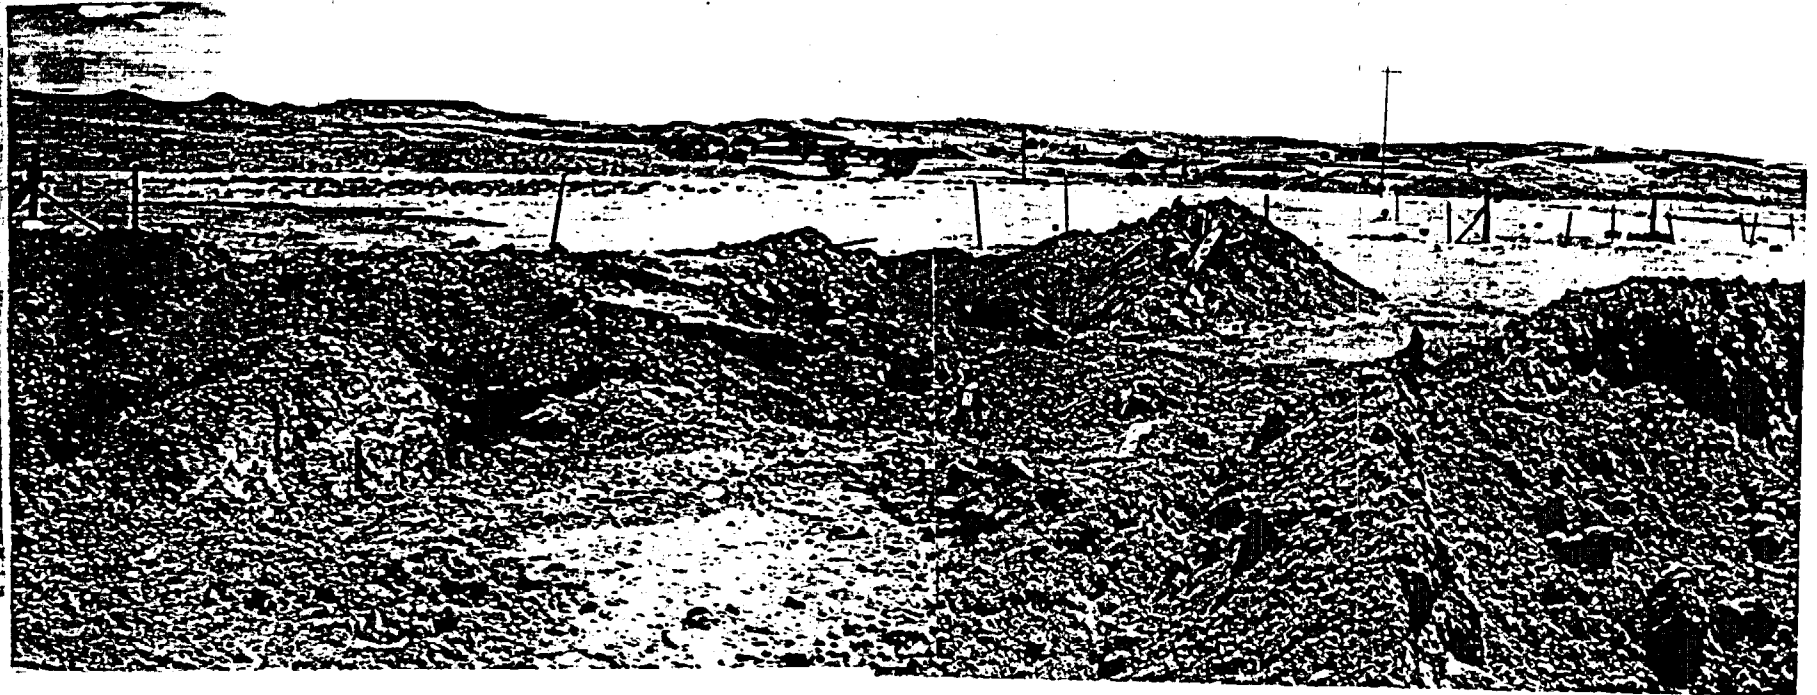
**Photos Nos. 3, 4, 5 and 6**

Also in the 5I7 site area, an old waste pit has been excavated and surveyed. A quantity of radiologically contaminated material was removed and shipped to Shirley Basin (Photos Nos. 3, 4 and 5). This material was generated during operation of the 5I7 plant back in the 1970's.

Looking east to southeast at partially excavated disposal pit on eastern side of 5I7 site. Some radiologically contaminated trash has been found here and some has been already hauled to Shirley Basin for permanent disposal. The Irigaray plan building is visible in the upper right distance.
