The State
of Wyoming

RE: Irigaray-Christensen Operations Annual Inspection Report, Permit No. 478

ANNUAL INSPECTION REPORT

Subject: COGEMA Mining Inc.'s Irigaray and Christensen Ranch In Situ Uranium Operations

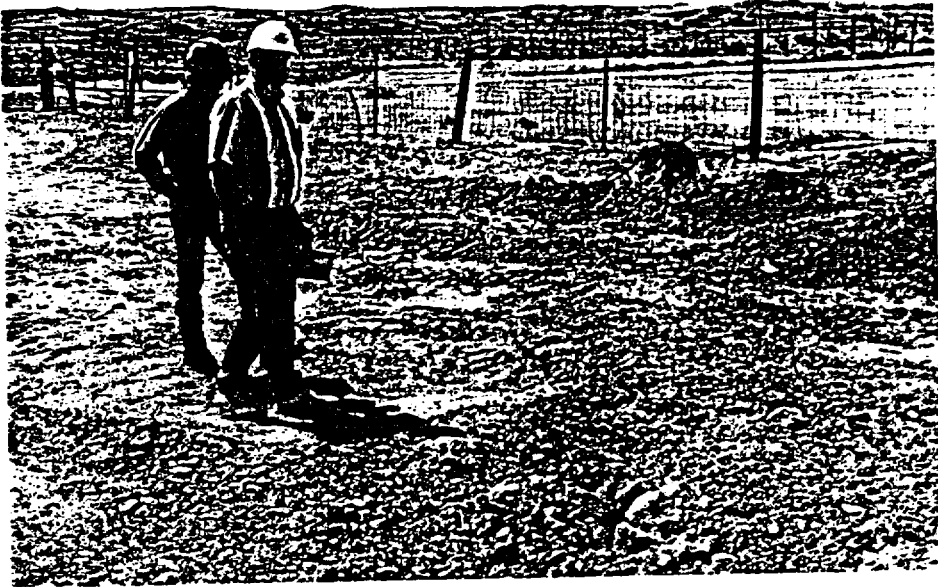
Photo No. 1

Some gravel has been removed from the 5I7 site, but considerably more needs to be removed. Some remaining gravel is between 6 and 8 inches thick and was planned atop native topsoil back when the site was active in the mid-1970's (Photo No. 1). When most of the gravel has been removed, Mr. Vasein said he would have the site tilled to remove compaction and prepare a good seed bed. Any removed gravel can easily be disposed by placing it on the nearby main access road.

Looking west at area on western side of 5I7 site where some gravel has been removed from in-place topsoil. The main access road and fenced pond area are partially visible in right distance.

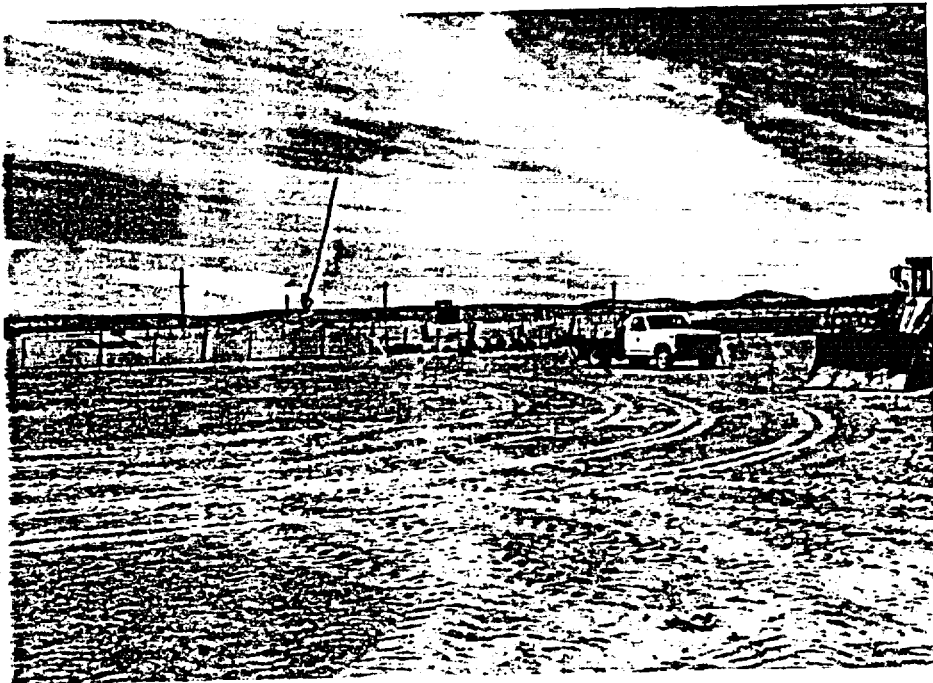
Photo No. 2

Mr. Vasein indicated that he would like to dispose of a quantity of concrete from the foundations of the nearby USMT plant building in the excavated disposal pit (Photo No. 2). With removal of the contaminated material there is room in the hole for burial of the concrete. A pending NonSignificant Revision (TFN 3 3/389) would require that concrete so buried would have to be buried at least four feet deep, exclusive of the thickness of any replaced topsoil.

Looking north at western end of 5I7 site where clean-up work is in progress. Arrow points to concrete rubble from USMT plant foundation. Plans are now to dispose of non-radiologically - contaminated concrete in 5I7 site.
