**TENNESSEE VALLEY AUTHORITY - BROWNS FERRY NUCLEAR PLANT (BFN) -
UNIT 3 - DOCKET 50-296 - FACILITY OPERATING LICENSE DPR-68 -
LICENSEE EVENT REPORT (LER) 50-296/2002-004-00**

1. FACILITY NAME Browns Ferry Nuclear Plant Unit 3					2. DOCKET NUMBER 05000296			3. PAGE 1 OF 8			
4. TITLE Loss of High Pressure Coolant Injection (HPCI) Flow Controller Power Supply

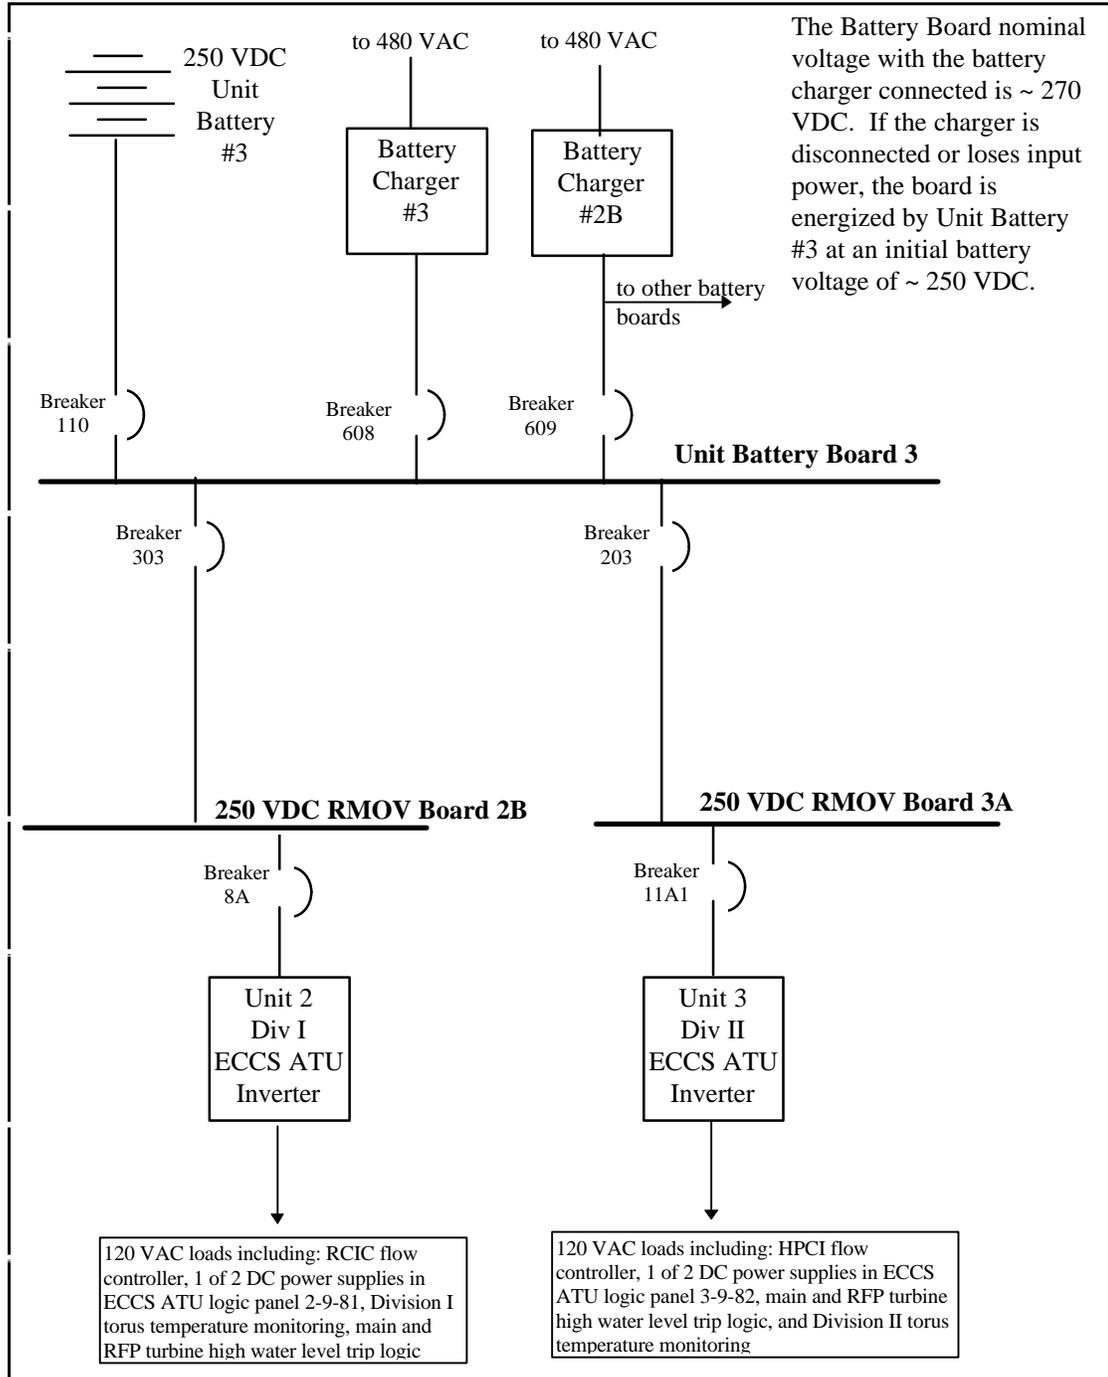
With the loss of 2-INV-256-0001, 120 VAC power to the following inverter loads was lost:

- the flow controller for the reactor core isolation cooling (RCIC) system
- the A channel of the high reactor water level trip logic for the main turbine and reactor feed pump (RFP) turbines
- one of two power supplies which provide 24 VDC power to ECCS ATU logic panel 2-9-81
- Division I of the U2 torus temperature monitoring instrumentation

With the loss of 3-INV-256-0002, 120 VAC power to the following inverter loads was lost:

- the flow controller for the HPCI system
- the B channel of the high reactor water level trip logic for the main turbine and reactor feed pump (RFP) turbines
- one of two power supplies which provide 24 VDC power to ECCS ATU logic panel 3-9-82
- Division II of the U3 torus temperature monitoring instrumentation

Figure 1 on the following page depicts these loading connections.
