UNITED STATES
NUCLEAR REGULATORY COMMISSION
OFFICE OF NUCLEAR REACTOR REGULATION
WASHINGTON, DC 20555-0001

NRC INFORMATION NOTICE 2003-01: FAILURE OF A BOILING WATER REACTOR
TARGET ROCK MAIN STEAM SAFETY/RELIEF
VALVE

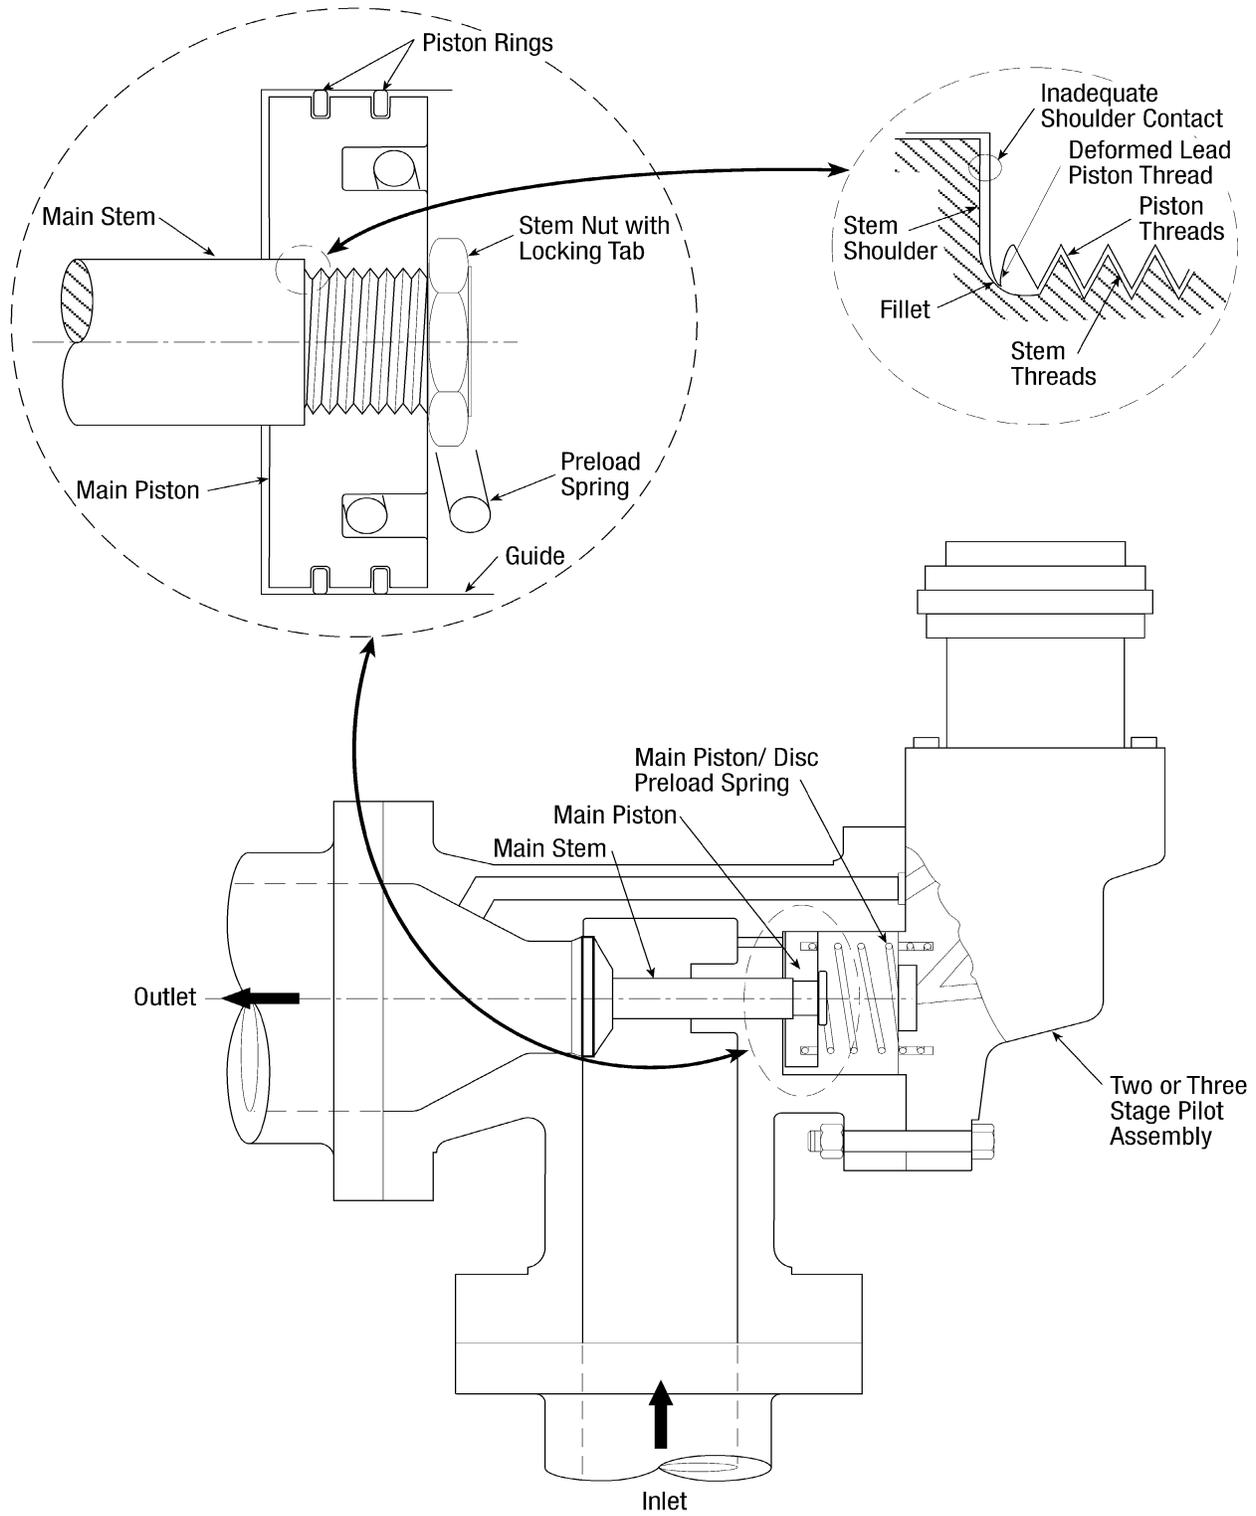
Figure 1 Target Rock Safety/Relief Valve

The S/RVs installed in Unit 1 are Target Rock two-stage S/RVs. The main stage valve internals (shown in attached Figure 1) are assembled by screwing the main piston onto the main stem so that the piston moves inside the guide, installing a locking tab washer, and installing the stem nut against the washer's locking tab. The piston is torqued to 100 ft-lbs, the stem nut is torqued to 50 ft-lbs, and the locking tab is bent to capture the stem nut. During the S/RV inspection after the April 2002 shutdown, the failed valve was found to have a .003-inch clearance between the main disc and its seat. When the valve was disassembled, the stem nut and the

piston were found to be loose. The stem nut was removed by hand and the piston was also unthreaded by hand from the stem. However, the threads on the stem were severely damaged. The piston was unthreaded by working it up to the good threads under the stem nut and threading it onto this portion of the stem. The inside of the guide was heavily grooved and was also worn by the piston edge wearing on the guide. The piston was visibly cocked on the valve stem.

Following the failure of the 1J S/RV, the licensee closely examined three valves which had been removed during the April 2002 refueling outage. The stem nuts and pistons of all three valves had lost torque, the stems of two of the valves showed significant wear on the valve threads, and one valve exhibited some thread wear. All three valves showed signs of damage on the stem shoulder, which is designed to contact the piston. In October 2002, the licensee removed three additional S/RVs from Unit 1 for testing, disassembly, and inspection. All three valves successfully stroked with steam pressure but when disassembled and inspected, were found to have lost torque on both the stem nut and the piston. Two valves had fairly good threads and the final valve (1F) had significant thread damage and a visibly cocked piston. All three valve stems showed varying degrees of damage in the shoulder area.

The licensee believes the loss of torque and damage of the valve internals can be attributed to the manufacturing tolerances of the valve stem and piston and to the lengthy service time without adequate inspection and maintenance. The valve is designed so the valve stem screws into the piston. The stem has a shoulder that seats against the piston shoulder. For the valves that show little to no thread damage, the stem apparently seats properly against the piston and most of the valve actuation force is carried by the stem and piston shoulders. For the valves with thread damage, the licensee believes that the end of the lead thread of the piston contacts the fillet that is machined into the shoulder of the valve stem. As shown in Figure 1, when this occurs, the shoulder of the stem does not properly seat against the shoulder of the piston. Thread damage starts with the first actuation on the test stand, resulting in a loss of torque. Over time, vibration from normal plant operations causes fretting and wear of the valve stem shoulder and threads. The piston rocks in the guide and wears grooves where the piston rings contact the guide. Eventually the piston could significantly cock on the stem and wedge in the guide during valve actuation, which would prevent proper opening or closing of the valve. The licensee has not been able to determine the time in operation required to damage a valve to the point of failure. The licensee believes the failed 1J valve and the damaged 1F valve were in service for approximately 20 years without maintenance. The licensee is currently removing several S/RVs during each plant outage to ensure that all installed S/RVs are inspected and maintained at least every 6 years. There are 11 S/RVs installed in each unit.

The above-described circumstances emphasize the importance of periodic inspection of S/RV main stage components to identify deficiencies and necessary corrective actions. All Target Rock two-stage and three-stage S/RVs have similarly designed main stage components. Currently 11 BWR plants in the U.S. have two-stage S/RVs, and 11 BWR plants have three-stage S/RVs.
