UNITED STATES  
NUCLEAR REGULATORY COMMISSION  
OFFICE OF NUCLEAR REACTOR REGULATION  
WASHINGTON, DC 20555-0001

January 15, 2003

NRC INFORMATION NOTICE 2003-01: FAILURE OF A BOILING WATER REACTOR  
TARGET ROCK MAIN STEAM SAFETY/RELIEF  
VALVE

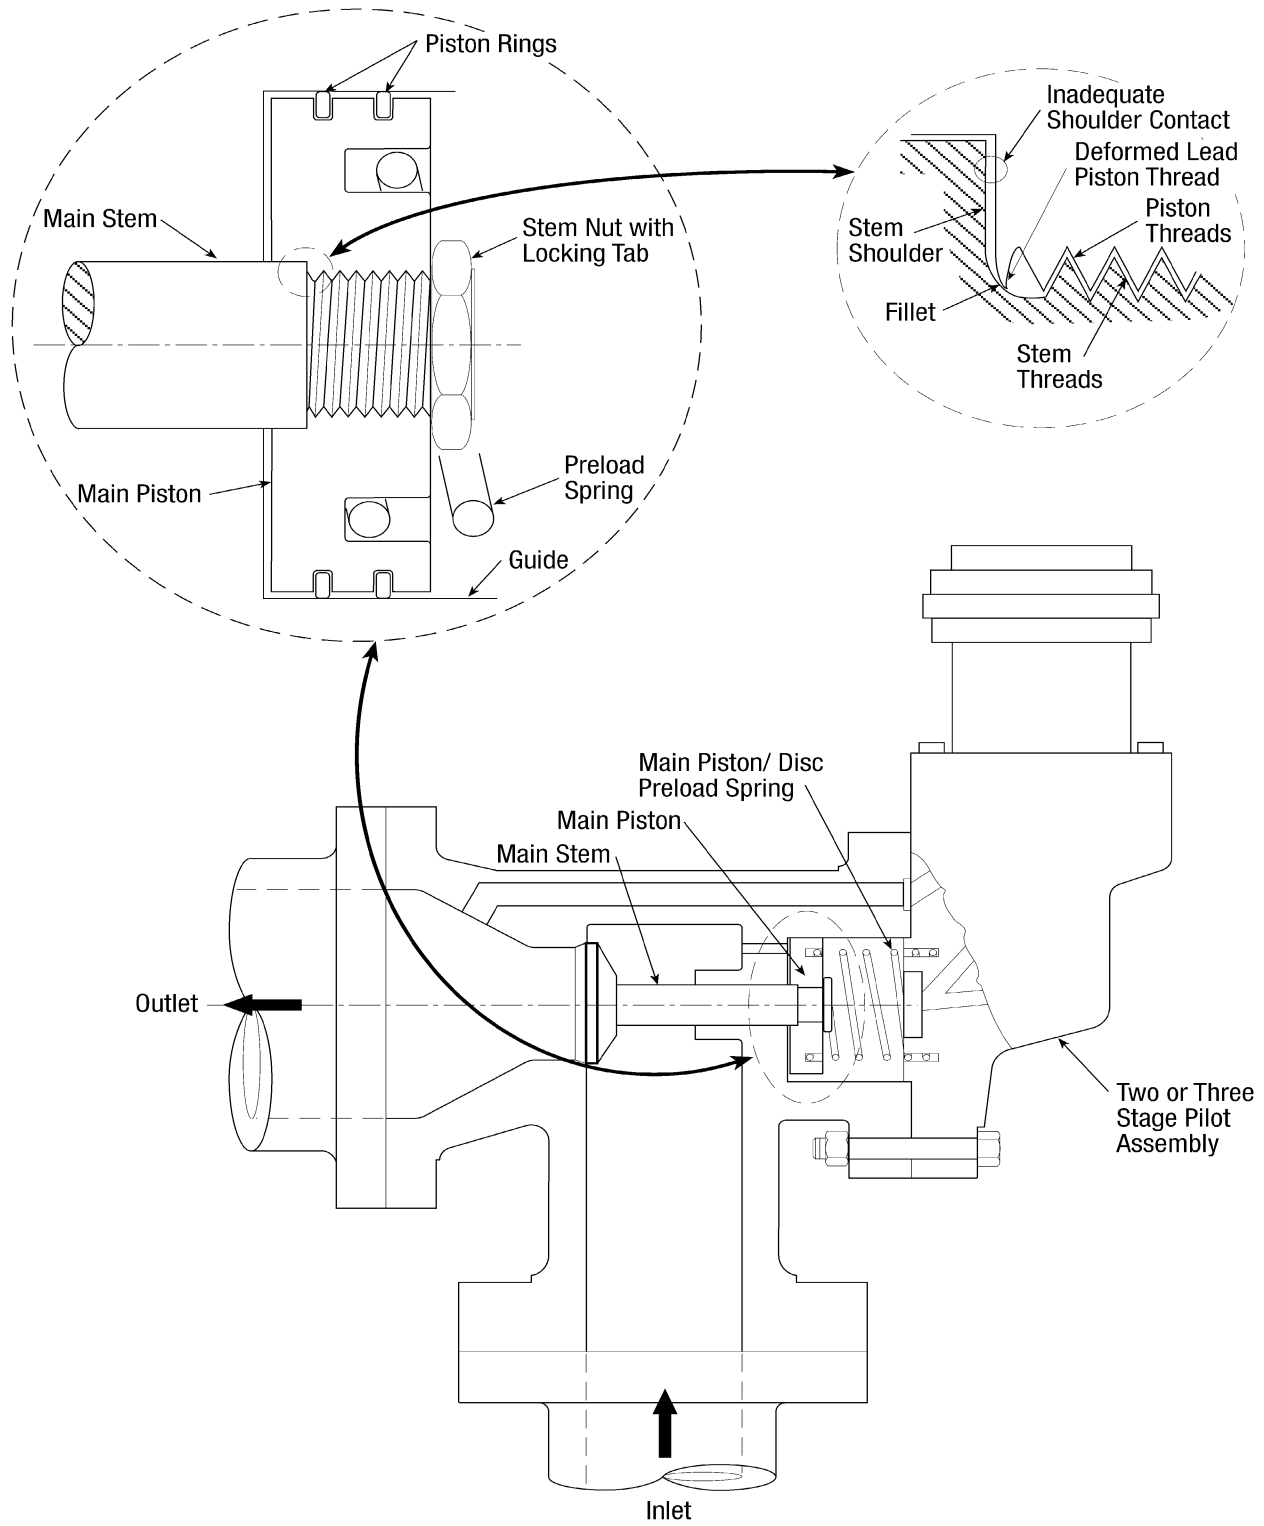
Figure 1 Target Rock Safety/Relief Valve

The S/RVs installed in Unit 1 are Target Rock two-stage S/RVs. The main stage valve internals (shown in attached Figure 1) are assembled by screwing the main piston onto the main stem so that the piston moves inside the guide, installing a locking tab washer, and installing the stem nut against the washer's locking tab. The piston is torqued to 100 ft-lbs, the stem nut is torqued to 50 ft-lbs, and the locking tab is bent to capture the stem nut. During the S/RV inspection after the April 2002 shutdown, the failed valve was found to have a .003-inch clearance between the main disc and its seat. When the valve was disassembled, the stem nut and the

piston were found to be loose. The stem nut was removed by hand and the piston was also unthreaded by hand from the stem. However, the threads on the stem were severely damaged. The piston was unthreaded by working it up to the good threads under the stem nut and threading it onto this portion of the stem. The inside of the guide was heavily grooved and was also worn by the piston edge wearing on the guide. The piston was visibly cocked on the valve stem.

Following the failure of the 1J S/RV, the licensee closely examined three valves which had been removed during the April 2002 refueling outage. The stem nuts and pistons of all three valves had lost torque, the stems of two of the valves showed significant wear on the valve threads, and one valve exhibited some thread wear. All three valves showed signs of damage on the stem shoulder, which is designed to contact the piston. In October 2002, the licensee removed three additional S/RVs from Unit 1 for testing, disassembly, and inspection. All three valves successfully stroked with steam pressure but when disassembled and inspected, were found to have lost torque on both the stem nut and the piston. Two valves had fairly good threads and the final valve (1F) had significant thread damage and a visibly cocked piston. All three valve stems showed varying degrees of damage in the shoulder area.

The licensee believes the loss of torque and damage of the valve internals can be attributed to the manufacturing tolerances of the valve stem and piston and to the lengthy service time without adequate inspection and maintenance. The valve is designed so the valve stem screws into the piston. The stem has a shoulder that seats against the piston shoulder. For the valves that show little to no thread damage, the stem apparently seats properly against the piston and most of the valve actuation force is carried by the stem and piston shoulders. For the valves with thread damage, the licensee believes that the end of the lead thread of the piston contacts the fillet that is machined into the shoulder of the valve stem. As shown in Figure 1, when this occurs, the shoulder of the stem does not properly seat against the shoulder of the piston. Thread damage starts with the first actuation on the test stand, resulting in a loss of torque. Over time, vibration from normal plant operations causes fretting and wear of the valve stem shoulder and threads. The piston rocks in the guide and wears grooves where the piston rings contact the guide. Eventually the piston could significantly cock on the stem and wedge in the guide during valve actuation, which would prevent proper opening or closing of the valve. The licensee has not been able to determine the time in operation required to damage a valve to the point of failure. The licensee believes the failed 1J valve and the damaged 1F valve were in service for approximately 20 years without maintenance. The licensee is currently removing several S/RVs during each plant outage to ensure that all installed S/RVs are inspected and maintained at least every 6 years. There are 11 S/RVs installed in each unit.

As the result of the 1J valve failure, the licensee performed a root cause analysis following the event and contracted an independent engineering firm to perform a separate root cause analysis. The licensee believes that the failure of the S/RV is related to the manufacturing tolerances of the valve stem and piston assembly and to the lengthy service time without adequate inspection and maintenance. The independent root cause analysis determined that the lead thread of the piston was contacting the fillet of the shoulder, preventing shoulder-to-shoulder contact. Since the piston was not adequately attached to the stem, operational vibration and valve actuation caused thread damage and eventual valve failure. The valve vendor (Curtiss Wright Flow Control Corporation) has developed changes to the inspection and refurbishment procedures to ensure proper shoulder-to-shoulder contact during valve assembly. The BWR vendor (GE Nuclear Energy) is issuing a Service Information Letter (SIL) to address the degradation found in the Hatch S/RVs.

The above-described circumstances emphasize the importance of periodic inspection of S/RV main stage components to identify deficiencies and necessary corrective actions. All Target Rock two-stage and three-stage S/RVs have similarly designed main stage components. Currently 11 BWR plants in the U.S. have two-stage S/RVs, and 11 BWR plants have three-stage S/RVs.
