SUBJECT: Power Shield Tap Block Solder Joints
10CFR Part 21 Report

NOTIFICATION BY: ABB Inc.
Allentown site
7036 Snowdrift Road
Allentown, PA 18106
Dennis Haring
Quality Assurance

Power Shield Tap Block Solder Joints
10CFR Part 21 Report
Attachment A
November 20, 2002

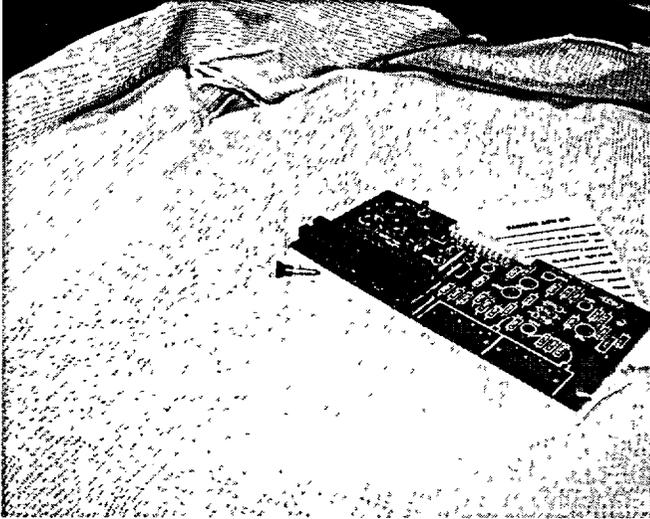
Photo #1 shows a Short Time board with the red tap blocks and a tap block pin removed.

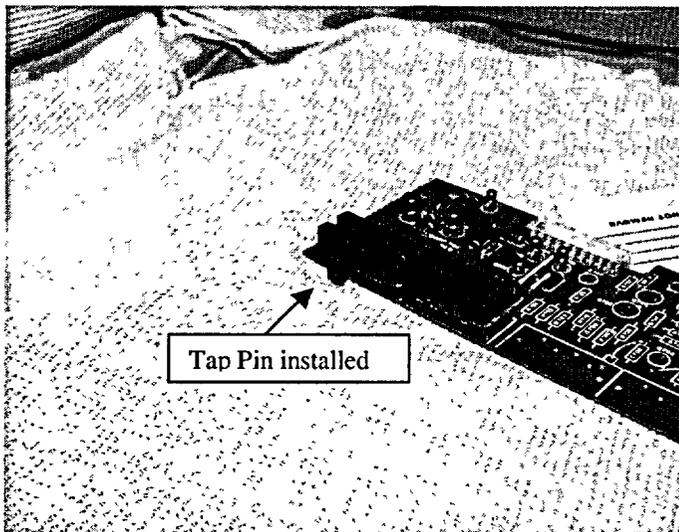
Photo #2 shows a Short Time board with red tap blocks and a tap block pin inserted.

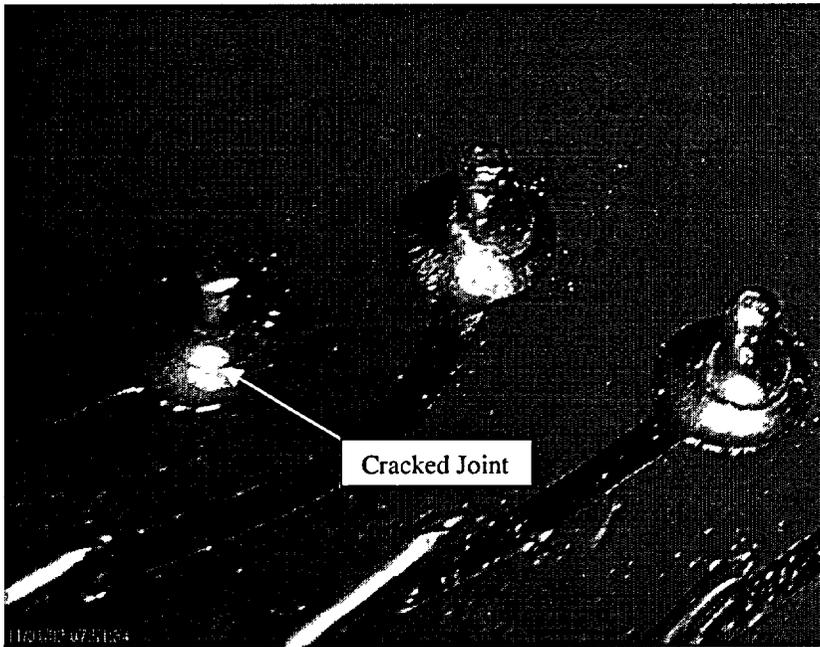
On June 25, 2002 the Virgil C. Summer Nuclear Station reported that they found broken solder joints (crack in solder joint) on some pins on the tap blocks of ABB Inc.'s Power Shield trip devices in the 30000 serial number range. Two Power Shield printed circuit assemblies were sent to ABB Inc. for review. The cracked solder connections look similar to the cracked solder connections found on the connectors reported via Part 21 on November 20th, 1995. The most likely cause of the cracked solder joints is from normal mechanical stress on the tap block pins.

All of the returns with broken solder joints were manufactured using single-sided printed circuit boards. Power Shields manufactured after serial number 80,000 (year 1990) contain a technical improvement, namely double sided solder pads and plated through printed circuit board holes which increases the mechanical strength of the solder joints. This improved design prevents deflection and fatigue failure of the solder connection. There is no likelihood of similar failures at tap block pins in the new printed circuit board design.

Photo #3 shows cracked solder connections on three tap block pins (underneath tap block).

There are two options for resolving the reported defect in Power Shield trip devices with serial numbers below 80,000. Option one is to inspect and if necessary, repair Power Shields per attachment A of the attached 10CFR Part 21 report. This assures a reliable present condition and is considered an effective repair measure.

Option two is to replace the Power Shield trip device. This is considered a permanent solution.

1. Inspect the solder connections on the tap block pins on the Short-Time / Ground And Long-Time / Inst printed circuit assemblies. Martin Marietta, IPC 610-A-610 Class 3 or the photographs provided by ABB should be used when inspecting these solder connections. All cracked or defective solder connections found, should be repaired by qualified personnel familiar with electronic circuit board repair. ABB Inc. recommends the following method be used:
 - 1a. The defective solder connection must be completely desoldered by using a good quality desoldering tool or solder wick. Care must be used when desoldering the joint as excessive heat will cause the printed circuit pad to

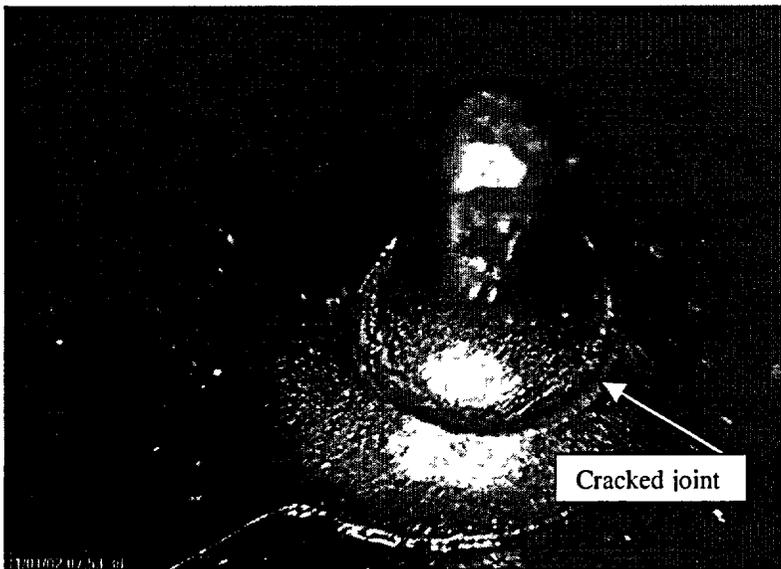
Photo #4 shows a tap block pin solder joint with a 360 degree crack.
