**SUMMARY OF FACTS AND STATEMENT OF OPINION  
F-16 MID-AIR ACCIDENT  
7 JAN 98**

AIR COMBAT MANEUVERING INSTRUMENTATION (ACMI) PRESENTATION

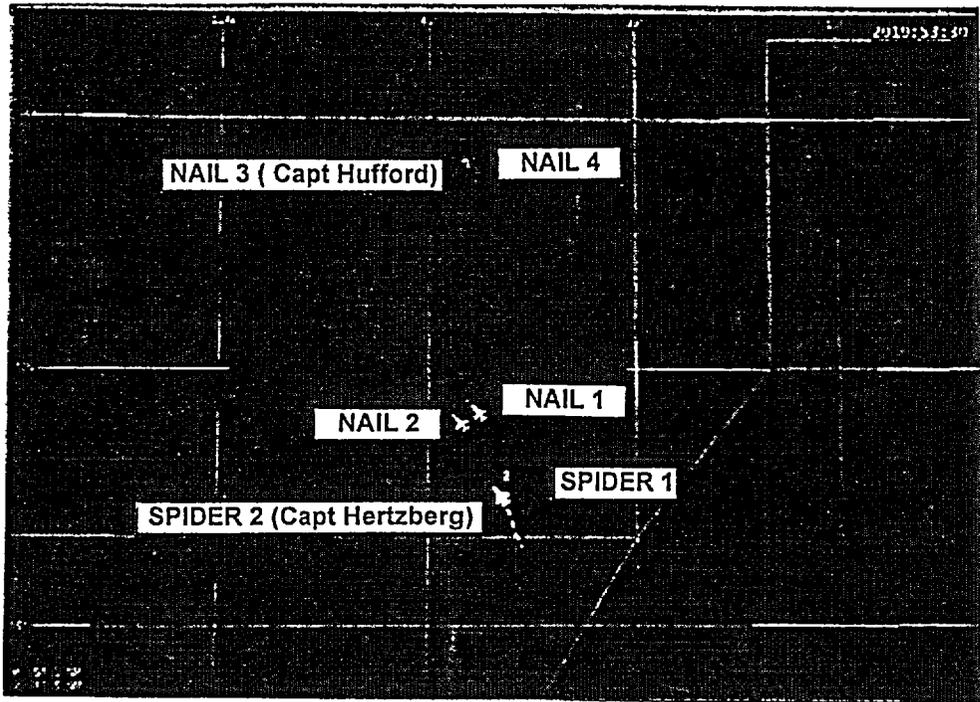
FIGURE 1 (ABOVE) - 20 NAUTICAL MILES (NM) APART

(4) The mishap intercept began with Nail 3 and 4 in the north. Nail 1 and 2 and Spider 1 and 2 were in the south (Tab Z-3) (see fig. 1 and 2 on pg. 2). The four ship target presentation was two groups with a five mile range split in the 25,000-29,000 (ft) block and wingman in a line abreast formation. Nail 1 and 2 were in the front of the presentation in the high part of the block and Spider 1 and 2 were the trailing group in the lower half of the 25,000-29,000 block. The wingmen, Nail 2 and Spider 2, were located on the west side of the formation and both groups, as per the coordination brief, were non-maneuvering on a heading of 320 degrees (Tab V-5.7, Z-3, and N-10) (see fig. 1 and 2 on pg. 2).

formation. The attackers, Nail 3 (Capt Hufford) and Nail 4, initially maneuvered toward the south. After the commit, Nail 4 moved to a 6,000 - 9,000 foot line abreast formation and was on the east side of Nail 3 (Tab Z-3) (see fig. 1 and 2 on pg. 2).

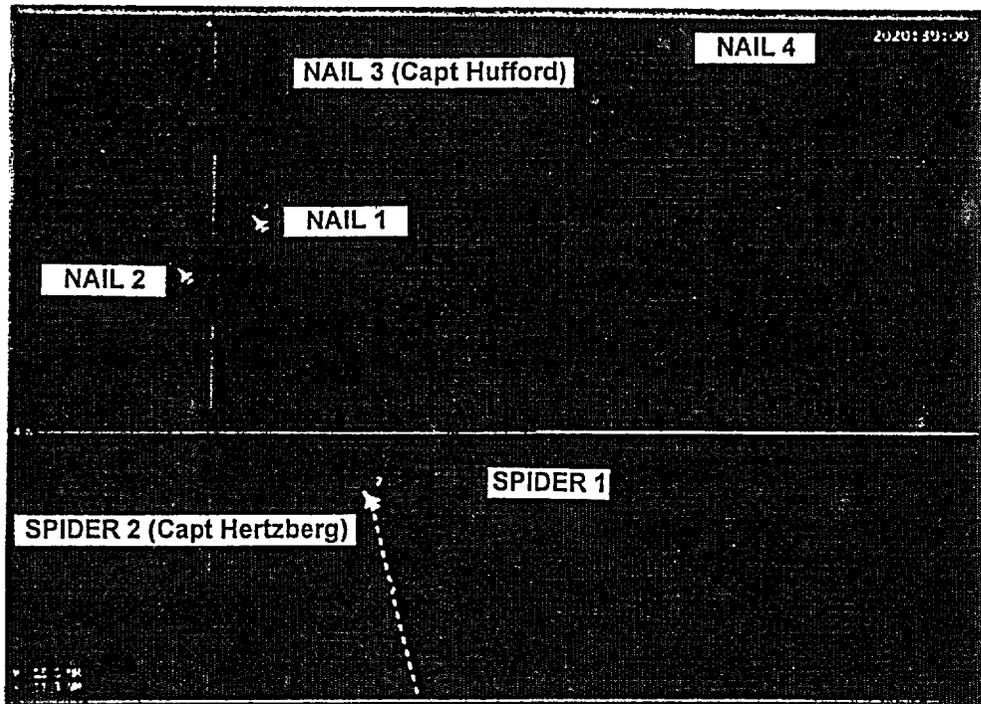
FIGURE 2 (ABOVE) - 7.6 NAUTICAL MILES (NM) APART  
SPIDER 2 (CAPT HERTZBERG) TALLY 2 (SAW NAIL 3 & 4) RADIO CALL

(6) As the intercept began, Clover (GCI) accurately portrayed the red-air formation and Nail 3, in accordance with the prebriefed plan, used his radar to monitor the movement of the lead group (Nail 1 and Nail 2). Because of the red-air formation and Visual Identification (VID) situation required prior to shooting, Nail 3 (Capt Hufford) and Nail 4 had to bypass the lead group and engage the trail group (Tab V-3.10 thru 3.11). At 10 miles from the lead group, Nail 3 (Capt Hufford) told his wingman to monitor the trail group with his radar (Tab N-5). About the same time and just prior to losing radar contact of the lead group off the right side of his (Capt Hufford) radar scope, Nail 3 (Capt Hufford) told Clover (GCI) to monitor the lead group (Tab N-5) (see Fig. 2, on pg. 2).

(7) When Spider 2 was 7.6 miles away from Nail 3, Spider 2 (Capt Hertzberg) obtained the tally (visual sighting) on both Nail 1 and 2 (Tab Z-7 and N-11). Shortly after this, Spider 1 called tally two (Tab N-11). As per the coordination brief, Spider flight was required to have tally-two and 3/9 o'clock passage (passing the wingline) before they could react (Tab O-30) (see fig. 2 on pg. 2).

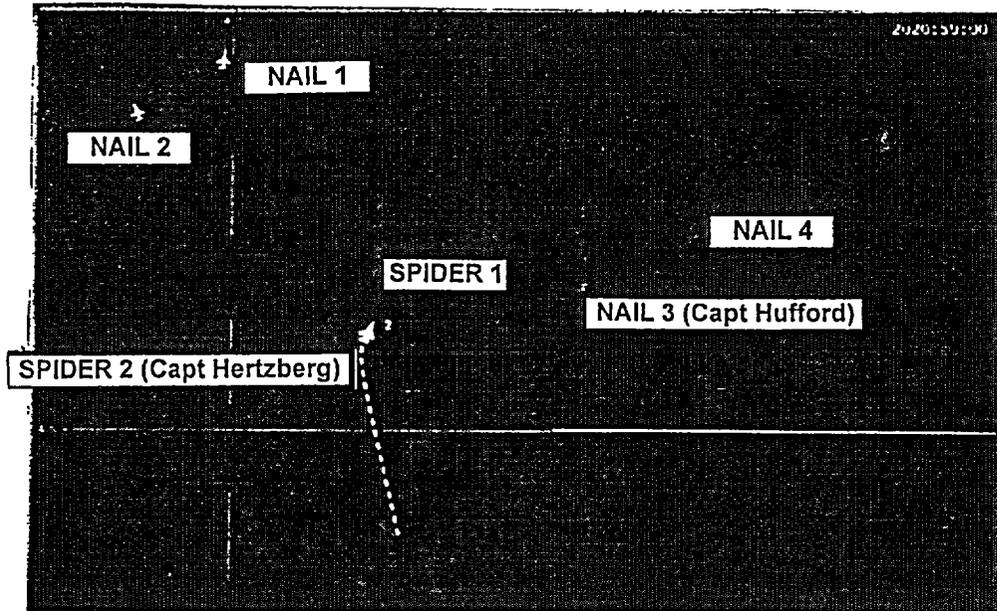
FIGURE 3 (ABOVE) - 3.5 NAUTICAL MILES (NM) APART  
 NAIL 3 (CAPT HUFFORD CONVERTING - CLIMBING RIGHT TURN)  
 SPIDER 2 (CAPT HERTZBERG - HARD DESCENDING RIGHT TURN)

(8) At 5.6 miles from Spider flight, Nail 3 (Capt Hufford) called "engaged" and told his wingman to deploy to the prebriefed weapons employment zone (wez)-in-depth (1.5 to 3.0 NM trail) formation (Tab Z-8 and V-3.11). Nail 3 (Capt Hufford) then began his conversion to intercept (right turn) and identify Spider 1 and 2 flight. As Nail 3 (Capt Hufford) passed Spider flight's 3 o'clock position (4.5 miles away), Spider 1 directed Spider flight to break right (turn hard to the right) (Tab Z-10). At the time of the hard right break turn, Spider 1 and 2 testified that they saw both Nail 3 and 4. Also, Nail 3 (Capt Hufford) saw both Spiders (Tab V-1.6, V-3.11, V-5.7). The Spiders began the break turn from a line abreast formation and as a result of the maneuver (approximately 90 degrees), Spider 2 (Capt Hertzberg) was now 5,600 feet in trail of his flight lead, Spider 1. During this maneuver Spider 2 lost altitude and left his altitude block (below 25,000); however, he saw both members of the opposing flight. Both flights (Nail 3-4 and Spider 1-2) were now high aspect (approximately 180 degrees) to one another (head-to-head) and remained head-to-head until the mishap occurred. (Tab Z-11) (see fig. 3 and 4 on pg. 3).

(9) During the conversion turn, Nail 3 (Capt Hufford) turned right and pointed his aircraft toward Spider 1 so he could pass close aboard. As Nail 3 (Capt Hufford) approached Spider 1, and when he (Nail 3) was at 2.2 miles from Spider 2, Nail 3 (Capt Hufford) started to reverse his turn to the left (Tab Z-18, Z-18.1). Spider 2 (Capt Hertzberg), after completing a descending right break turn, pointed his aircraft at Nail 4 in an attempt to get a boresight radar lock. Because Nail 4 was 2 miles directly in trail of Nail 3 (Capt Hufford) and because of the search pattern of the boresight mode, the radar locked onto Nail 3 (Capt Hufford) not to Nail 4 (Tab Z-10 thru Z-18.1). Spider 2 (Capt Hertzberg) testified that he took a no-lock boresight AIM-9 shot (simulated) on Nail 4 when he was 2.2 NM from Nail 3 (Capt Hufford) (Tab V-2.4). This was the same range that Nail 3 (Capt Hufford) reversed his turn direction to the left in an attempt to pass to the south of Spider 2 (Capt Hertzberg). After the shot (simulated),

Spider 2 (Capt Hertzberg) began a climbing turn to the right in an attempt to pass to the south of Nail 3 (Capt Hufford); i.e., Spider 2 (Capt Hertzberg) maneuvered right in an attempt to lag Nail 3's expected flight path (Tab V-1.6). Spider 2 (Capt Hertzberg) testified that he was just outside of 1.5 miles from Nail 3 (Capt Hufford) when he started this maneuver to the south (Tab V-2.4). By doing this, Spider 2 (Capt Hertzberg) put Nail 3 (Capt Hufford) under his nose and out of view. Just prior to this, Spider 2 (Capt Hertzberg) thought he saw Nail 3 (Capt Hufford) in a climbing right hand turn. Since Spider 2 (Capt Hertzberg) was focusing his attention on taking his shot (simulated) on Nail 4, he may have not recognized that Nail 3 (Capt Hufford) who was directly in front of him, had reversed his turn direction to the left. Spider 2 (Capt Hertzberg) testified that he anticipated that Nail 3 (Capt Hufford) would continue turning right. At the start of Spider 2's (Capt Hertzberg's) maneuver, Air Combat Maneuvering Instrumentation (ACMI) data shows that Spider 2 (Capt Hertzberg) was 5 degrees nose low and in 48 degree right bank. ACMI lost track of Spider 2 (Capt Hertzberg) when he was 1.9 miles from Nail 3 for about 0.6 NM. However, when ACMI regained track on Spider 2 (Capt Hertzberg), the track was a zero filter (excellent) ACMI track. Even though the zero track was only for a moment the data was reliable and accurate. The track then converted to a one filter track, which is still good data with some positional drift [i.e., the aircraft attitude (bank angle/pitch) airspeed, Gs, etc are still good] (Tab V-19.3, Z-2.2)]. At the zero filter track, Spider 2 (Capt Hertzberg) was 1.3 NM from Nail 3 (Capt Hufford), who was also on a zero filter track. ACMI showed that Spider 2 (Capt Hertzberg) had only changed his heading by two degrees from 1.9 NM to 1.3 NM and now he was in a left hand turn; i.e., he had reversed his turn directly towards Nail 3 (Capt Hufford). The ACMI also showed, that Spider 2 (Capt Hertzberg) had lost 213 feet of altitude during his maneuver (Tab V-2.3 and Z-20 thru 26.1). Capt Hertzberg testified that after leveling off from his initial turn away from Nail 3 (Capt Hufford), he started a bank to the left and a slight unload to check Nail 3's position (Tab Z-25, Z-25.1). This fact is substantiated by ACMI with Spider 2 (Capt Hertzberg) in a 35 degree left bank (Tab Z-25, Z-25.1) (see fig. 3 and 4 on pg. 3).

(10) Nail 3 (Capt Hufford) testified after making a hostile call, "I do a quick check to my 7 o'clock to see where my wingman is; Bryan (Nail 4) is kind of a new guy and we've been trying to work on his wez-in-depth" (Tab V-3.12, Z-25, Z-25.1). After locating his wingman, Nail 3 (Capt Hufford) looked forward, went to air combat mode (ACM) on his radar and thought about taking a boresight lock on Spider 2 (Capt Hertzberg) (Tab V-3.12). ACMI data showed that Nail 3 (Capt Hufford) was 1.3 miles from Spider 2 (Capt Hertzberg) after the hostile call. ACMI data also showed the closure velocity between Spider 2 (Capt Hertzberg) and Nail 3 (Capt Hufford) to be 1,021 NM per hour (1,725 feet per second). According to these parameters, the collision would occur in approximately 4.5 seconds. Human reaction time studies show this approaches the minimal reaction time required to avoid the collision (Tab DD). Nail 3 (Capt Hufford) looked away from Spider 2 (Capt Hertzberg) at approximately 1.3 NM. Nail 3 (Capt Hufford) was still in slight climb and still in a left bank, approximately 180 degrees aspect (head to head) with Spider 2 (Capt Hertzberg). ACMI data also confirms an apparent attempt to take a boresight lock with a zero/zero (accurate data) track, showing an unload maneuver when Nail 3 (Capt Hufford) is 1.2 NM from Spider 2 (Capt Hertzberg) (Tab Z-27 thru 31.1, V-19.2). Nail 3 (Capt Hufford) realized he was too close for a lock-on and "bails on the concept of getting a lock" (Tab V-3.12) (see fig. 3 and 4 on pg. 3).

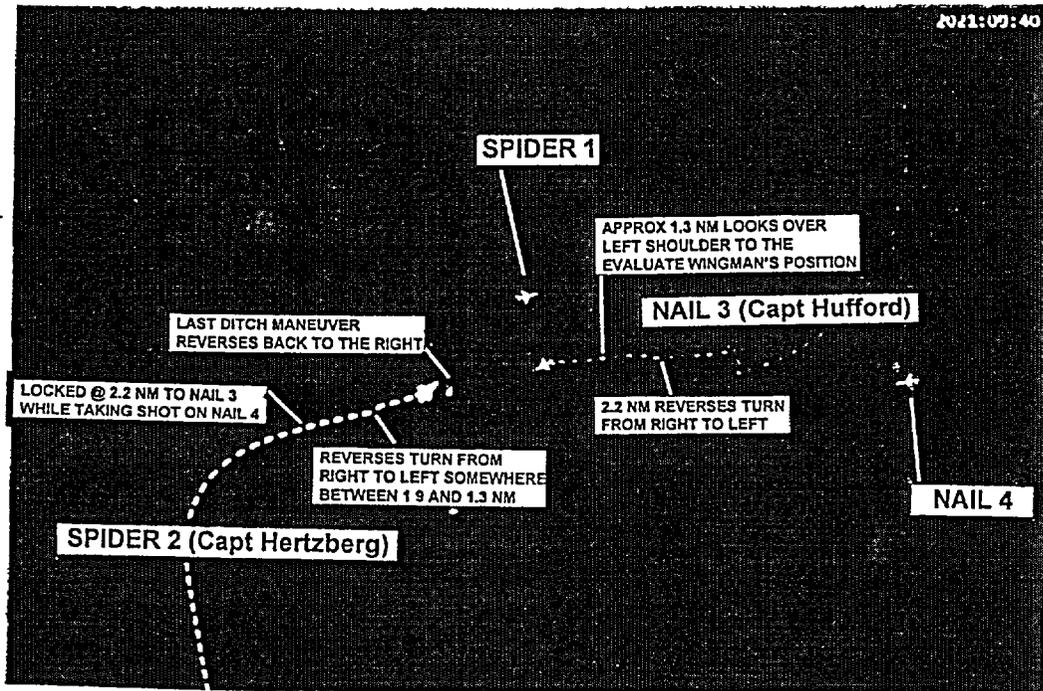
FIGURE 4 (ABOVE) - APPROXIMATELY 4300 FEET APART  
 NAIL 3 (CAPT HUFFORD CLIMBING LEFT BANK)  
 SPIDER 2 (CAPT HERTZBERG - DESCENDING LEFT BANK)  
 SPIDER 2 (CAPT HERTZBERG) JUST STARTING TO REVERSE TURN TO THE RIGHT

(11) Spider 2 (Capt Hertzberg) continued to bank slightly nose low to the left, and was looking left (9-10 o'clock) for Nail 3 (Capt Hufford). Spider 2 (Capt Hertzberg) was maneuvering his aircraft towards Nail 3 without seeing him. ACMI showed Nail 3 (Capt Hufford) was slightly low and directly in front of Spider 2 (Capt Hertzberg) (Tab Z-26, Z-26.1) (see fig. 4 on pg. 3).

(12) Nail 3 (Capt Hufford), after aborting his attempt to lock Spider 2, noticed that there was no line of sight movement in the HUD (meaning that they are on a collision course) (Tab V-3.12). Nail 3 (Capt Hufford) testified that he "basically froze" because he thought if he maneuvered hard left or right, it may have matched Spider 2's (Capt Hertzberg's) collision avoidance maneuver. Capt Hufford's (Nail 3) continued testimony adds, "About two-seconds prior to impact, I realize he is not doing anything and there is absolutely no line of sight in my HUD. So at that point I roll to about a 120 degrees of bank (to the left) and I see basically the belly of his aircraft, his centerline bag passes over my head" (Tab V-3.13) (see fig. 4 on pg. 3).

(13) As Spider 2 (Capt Hertzberg) regained the tally on Nail 3, he expected to see Nail 3 (Capt Hufford) going by to the north (left side), instead, he "saw an F-16 coming straight uphill at me" (Tab V-1.7). Spider 2 (Capt Hertzberg) saw the imminent collision and reacted by selecting full afterburner and "pulling as hard as I could (to the right)" (Tab V-1.7). By turning right, Spider 2 (Capt Hertzberg) reversed his turn and ended up moving in the same direction as Nail 3's last-ditch collision avoidance maneuver (see fig. 4, pg. 3).
