**HOLTEC PRESENTATION TO NRC**

**TECHNICAL ISSUES MEETING**

**January 9, 2003**

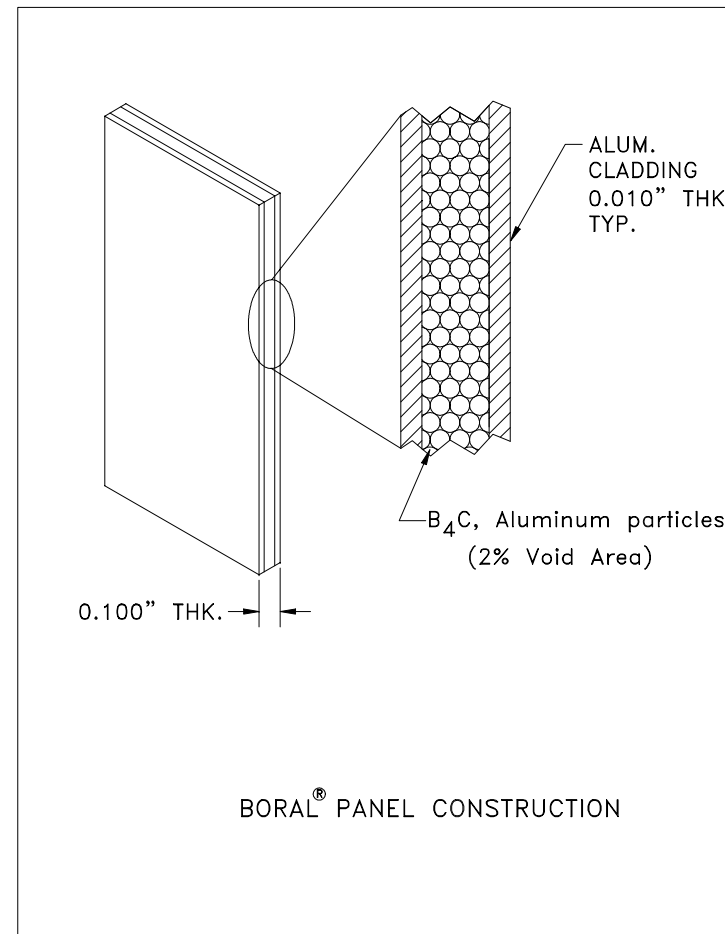
- Al Cladding
- B<sub>4</sub>C/Al core

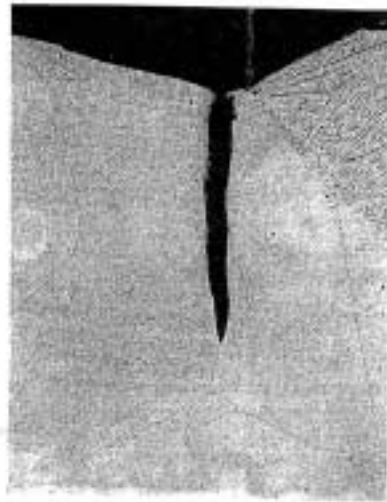
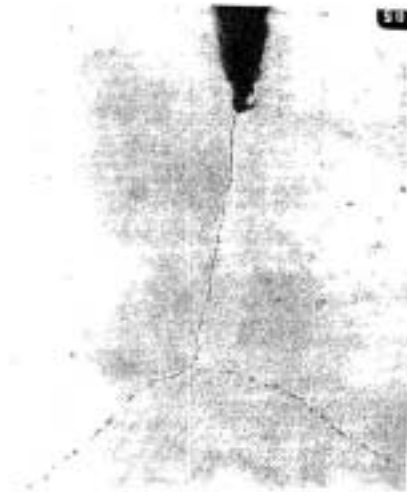
Figure 2. Photomicrographs of cracks in Gulf Coast Sample 2FB15,  
etchant: acetic/nitric acid/HCl/glycerol

- Large grain size ( $\geq$  "00" ASTM E-112) of lid forgings makes the lid susceptible to liquation cracking (grain boundary cracking in the base metal)
- Subject lids met all ASME requirements for mechanical properties and chemistry
- Lids already in service are unaffected based on satisfactory weld inspection

- Liquation Cracking (cont'd)
  - Lack of cohesion between grain boundaries initiates cracks aided by tensile stresses resulting from contraction of weld
  - Cracks were determined to be “micro-fissures” limited in length to 400 microns (roughly the grain size)
