**UNITED STATES  
NUCLEAR REGULATORY COMMISSION  
REGION IV  
611 RYAN PLAZA DRIVE, SUITE 400  
ARLINGTON, TEXAS 76011-4005**

February 7, 2003

**SUBJECT: NRC SPECIAL INSPECTION REPORT 50-458/02-07**

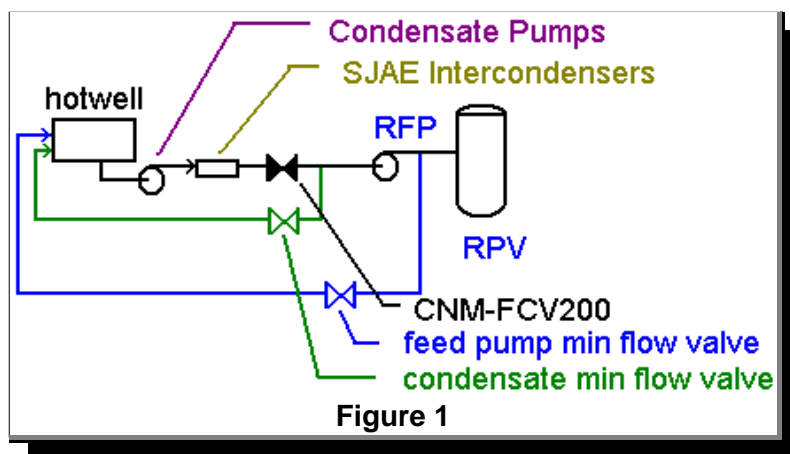
Following the scram, the feedwater flow control valves opened in response to lowering reactor water level. This increased feedwater flow caused Condensate Prefilter Vessel Bypass Flow Control Valve CNM-FCV200 to close unexpectedly (Figure 1).

The closure of Valve CNM-FCV200 isolated flow to the RFPs and they tripped on low suction pressure. When Valve CNM-FCV200 closed, condensate system pressure increased to greater than 800 psig for a short duration (less than one second). The gaskets on the SJAE intercondensers failed as a result of the pressure surge. The failed gaskets allowed the condensate pumps to transfer water from the hotwell to the turbine building 95 foot elevation. At 8:33 p.m., the operators shut down the condensate pumps to stop this transfer of water.

Flow in the feedwater system and much of the condensate system stopped when Valve CNM-FCV200 closed, which, in turn, caused the condensate system and RFP minimum flow valves to open. This created a flowpath to vacuum-drag water from the feedwater and condensate systems to the hotwell, which was still under condenser vacuum. Interlocks closed the minimum flow valves when the RFPs tripped and the condensate pumps were shut down.

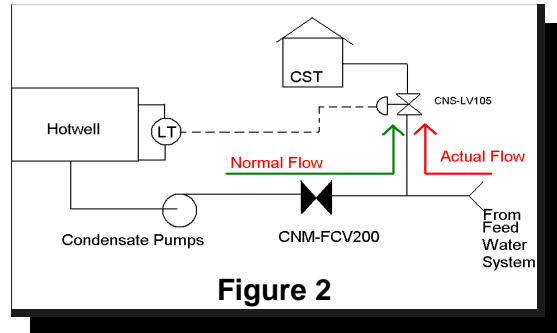
The resulting high hotwell level caused condenser hotwell reject level control Valve CNS-LCV105 to the CST to open. When CNS-LCV105 opened, it created an abnormal and reverse flowpath from the condensate and feedwater systems to the CST (Figure 2).

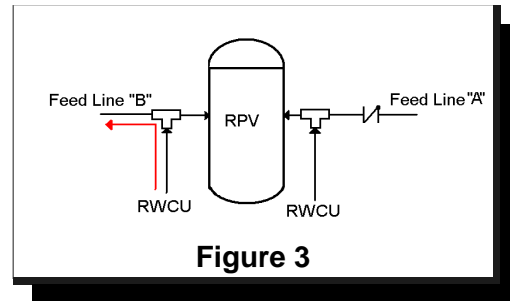
The RWCU system, which takes suction from the reactor recirculation system and discharges to the feedwater lines, was in service at the time of the event. At 8:25 p.m., immediately after the RFPs tripped, RWCU flow increased rapidly. As the feedwater system depressurized (due to RFP and condensate minimum flow valves being open to the main condenser) the flow path for RWCU was from the reactor recirculation system, through RWCU filter demineralizers, backwards through feedwater Line B into the feedwater and condensate systems (Figure 3). A check valve on feedwater Line A prevented a similar flowpath through feedwater Line A. The check valve on feedwater Line A had been installed to prevent reverse flow in the feedwater system during RCIC injection.

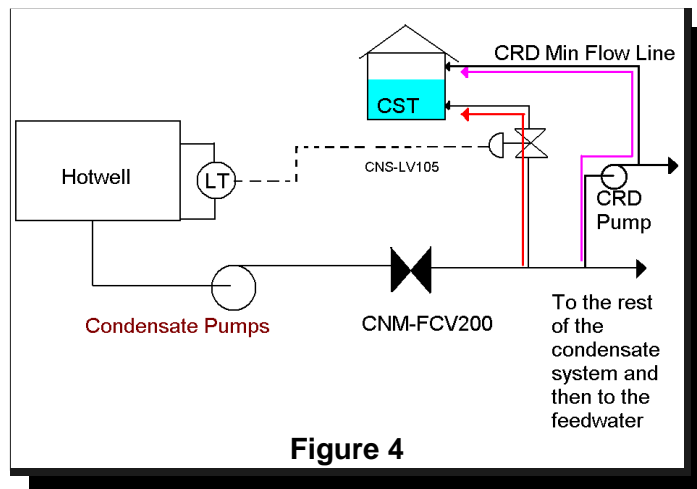
There were two separate flowpaths from the condensate system into the CST discharging 200 psig fluid that was between 356 and 378 °F. One flowpath was through Valve CNS-LV105. This line terminates in the CST below the surface of the water. The water in the CST was cooler and quenched the flashing steam, which accounted for the loud noises. The second flow path was through the control rod drive (CRD) pump's minimum flow line and into the space above the water level in the CST. That fluid was flashing into steam and issuing from the vent on the roof of the CST. The operators closed Valve CNS-LCV105 at 11:30 p.m., which

isolated one of the two flowpaths of water from RWCU to the CST. At 11:36 p.m. the operators closed the low pressure feedwater heater inlet valves to start a condensate pump. This isolated the remaining path of water from RWCU to the CRD to the CST, and temperatures in the condensate and feedwater system began to return to their normal values (Figure 4).

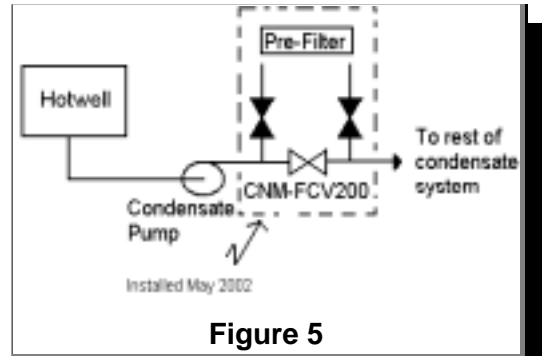
The licensee had previously developed a plant modification to install full flow filtration equipment (prefilters) in the condensate system. The licensee planned to install the modification in two phases. The first phase of the modification was installed in May 2002. The installed portion of the modification included Condensate Prefilter Vessel Bypass Flow Control Valve CNM-FCV200 (Figure 5).

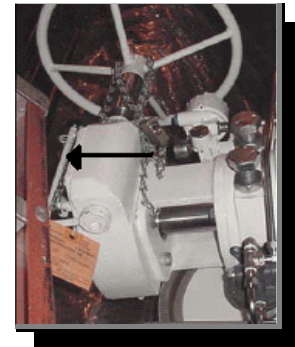
Handwheel engaged

The photos on the right were taken with the handwheel engaged and the handwheel disengaged. When the lever was in the engaged position (moved to the left as shown in the top photo), the handwheel was physically connected to the valve through gears. Chaining the handwheel would then keep the valve from moving. When the lever was in the disengaged position (moved to the right as shown in the lower photo), the valve was not connected to the handwheel.

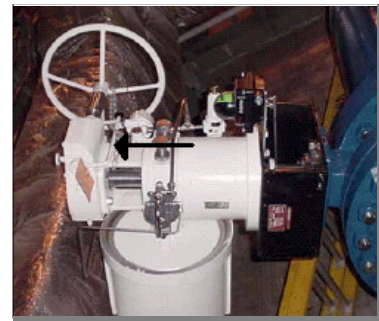
Handwheel Disengaged

Because the handwheel was disengaged, the only thing holding the valve open was friction from the packing and internal components and the weight of the disc. When flow through the valve increased suddenly, as occurred when the feedwater system tried to restore reactor water level following the scram, the force on the disc was enough to cause the valve to go closed.

On September 19, 2002, at 1 a.m. following a reactor scram and loss of feedwater on September 18, 2002, the licensee determined that Valve CNM-FCV200 had not been properly locked open, as required by procedure. This performance deficiency occurred on May 15, 2002, when an individual signed a valve lineup affirming Condensate Prefilter Vessel Bypass Flow Control Valve CNM-FCV200 was locked open. It was not properly locked open and, as a result, the feedwater flow transient resulting from a reactor scram on September 18, 2002, caused Valve CNM-FCV200 to close unexpectedly and cause a complete loss of feedwater. Corrective actions taken or planned by the licensee have been entered into the licensee's corrective action program as Condition Report CR-RBS-2002-1372.

The inspectors reviewed the licensee's assessment of the failure to properly lock open Valve CNM-FCV200 and the corrective action taken. The licensee appropriately used their processes to subsequently provide training to all of the operators, and made the necessary revision to Condensate System Operating Procedure SOP-007.

Technical Specification 5.4.1.a requires written procedures be established, implemented, and maintained covering the applicable procedures recommended in Regulatory Guide 1.33, Revision 2, Appendix A, February 1978. Regulatory Guide 1.33, Revision 2, Appendix A, Item 4.n, requires instructions for operation of the condensate system. System Operating Procedure SOP-0007, "Condensate System," Revision 21, required Condensate Prefilter Vessel Bypass Flow Control Valve CNM-FCV200 to be locked open. On September 18, 2002, Valve CNM-FCV200 was not properly locked opened. This is an apparent violation of Technical Specification 5.4.1.a (50-458/2002-07-01). The licensee has revised Procedure SOP-0007 and trained the operators on the proper operation Valve CNM-FCV200.
