Subject: Arkansas Nuclear One - Units 1 and 2
Docket No. 50-313; 50-368
License No. DPR-51; NPF-6
Inspection Report 50-313; 368/01-06
Significance Determination Process Technical Information

**ATTACHMENT 1
FIRE SDP TECHNICAL INFORMATION**

The following information is provided for input into the SDP associated with Inspection Report 50-313; 368/01-06.

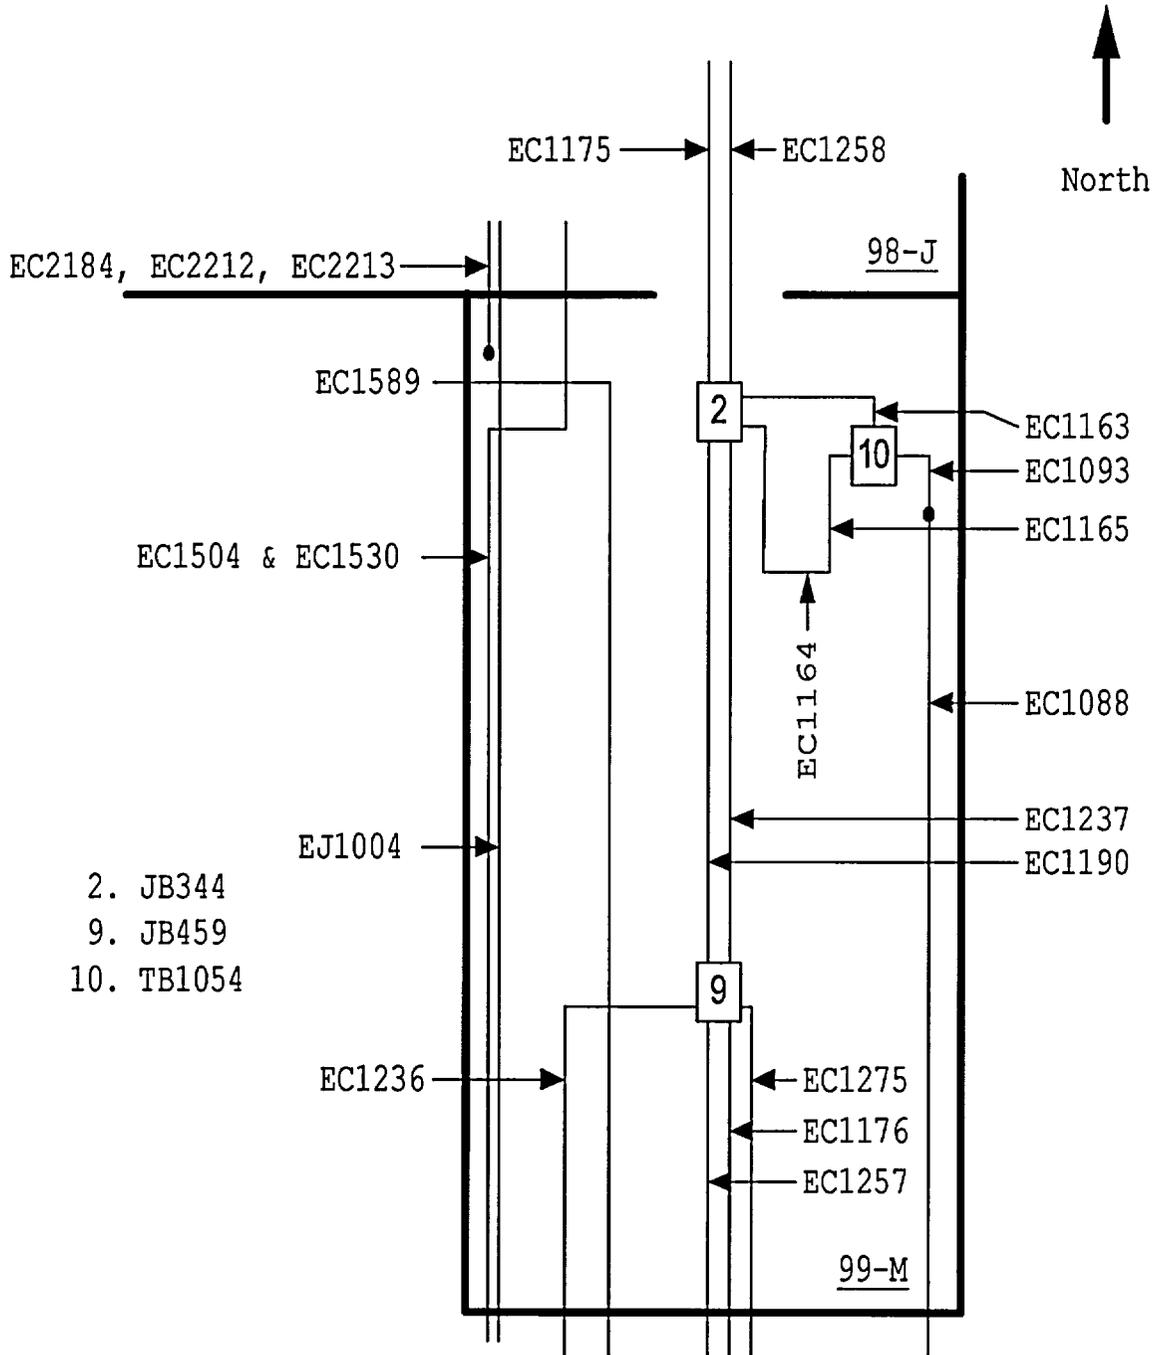
Raceways Located in Zone 99-M

3) Raceway Layout – This following sketch identifies the location of the raceways of interest in Zone 99-M.

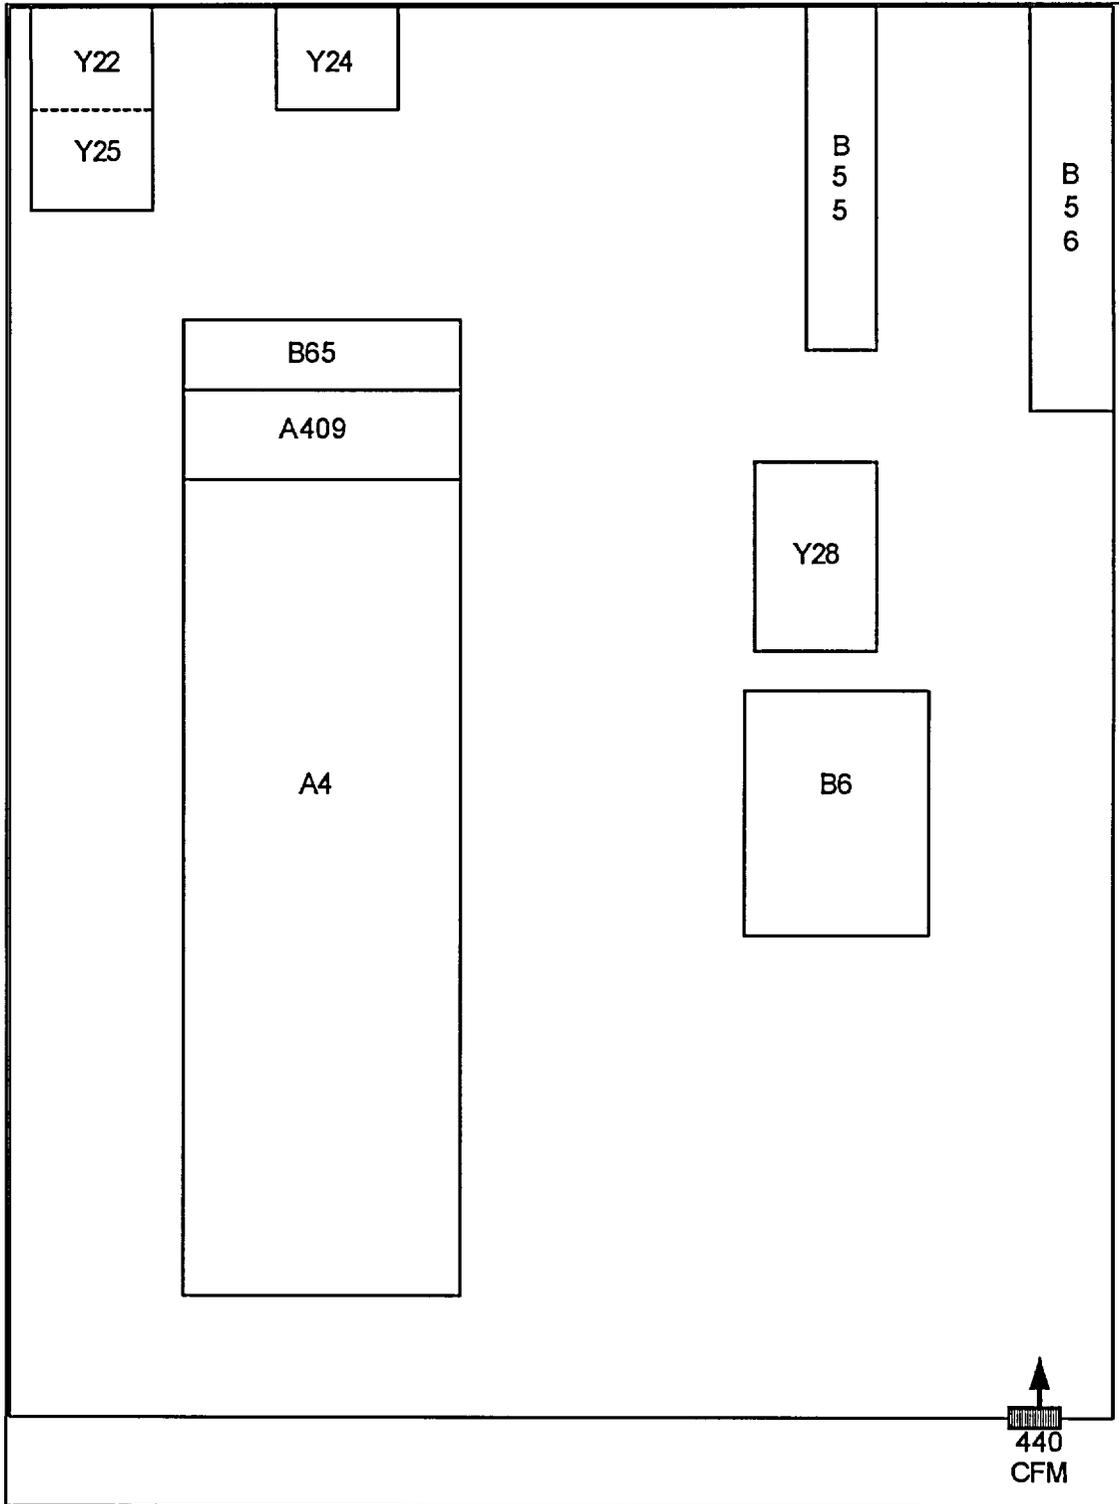
- 4) Ignition Sources – This sketch identifies the relative locations of the electrical cabinets located in Zone 99-M.
