**SEQUOYAH NUCLEAR PLANT (SQN) - UNIT 2 - RESPONSE TO NRC
REQUEST FOR ADDITIONAL INFORMATION REGARDING LICENSEE
IDENTIFIED MATERIAL WASTAGE (TAC NO. MB4579)**

TENNESSEE VALLEY AUTHORITY
SEQUOYAH NUCLEAR PLANT (SQN)
UNIT 2
DOCKET NO. 328

ADDITIONAL INFORMATION REGARDING
LICENSEE IDENTIFIED MATERIAL WASTAGE

PHOTOGRAPHS FROM THE UNIT 2 INSPECTION

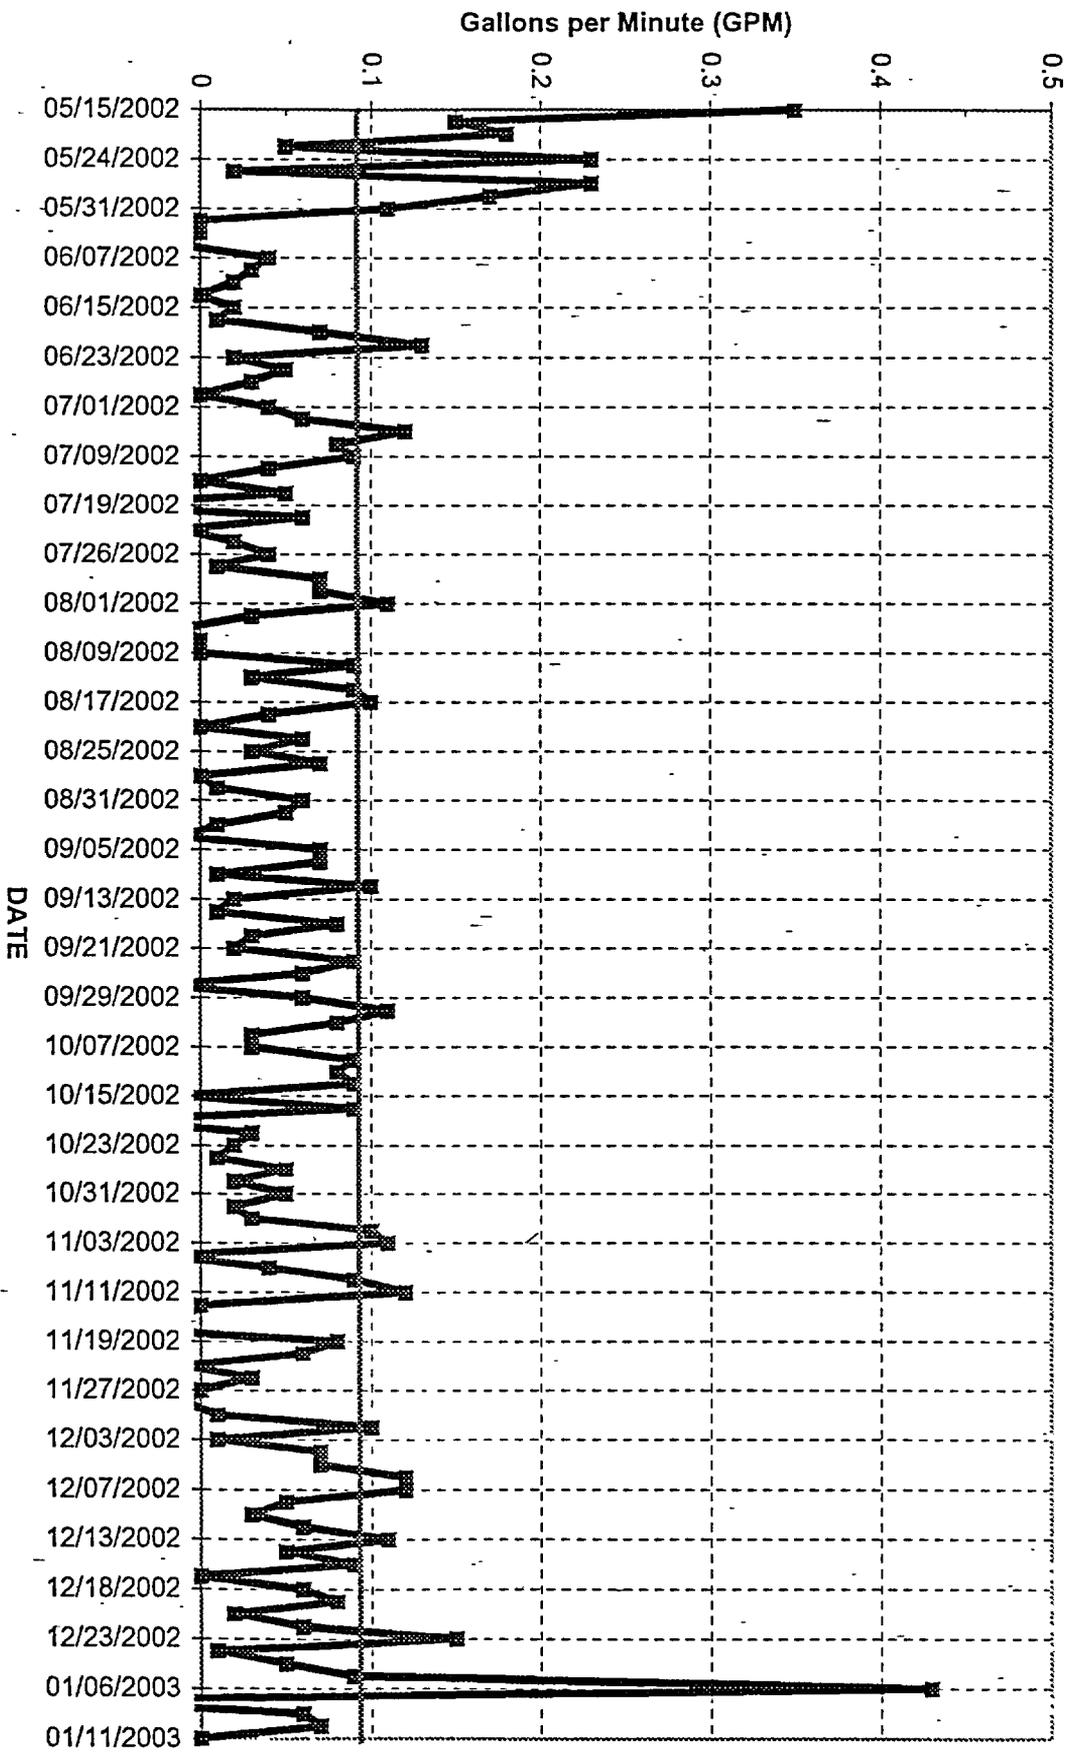
U2C12 RCS UNIDENTIFIED LEAKAGE
 Data obtained from SI-137.0 Performances

Unit 2 unidentified leakage noted since startup following the May 2002 refueling outage has been low (see enclosure 3 and the information in TVA's response to NRC Question 1).
