**The OTSG eddy current inspection scope planned for the Oconee Unit 2  
EOC-19 Refueling Outage:**

Duke Energy Corporation ONS 2 EOC-19 Preliminary Report

Duke Energy Corporation ONS-2 EOC-19 Preliminary Information

ONS 2B Steam Generator  
In-situ - Tube 37-27

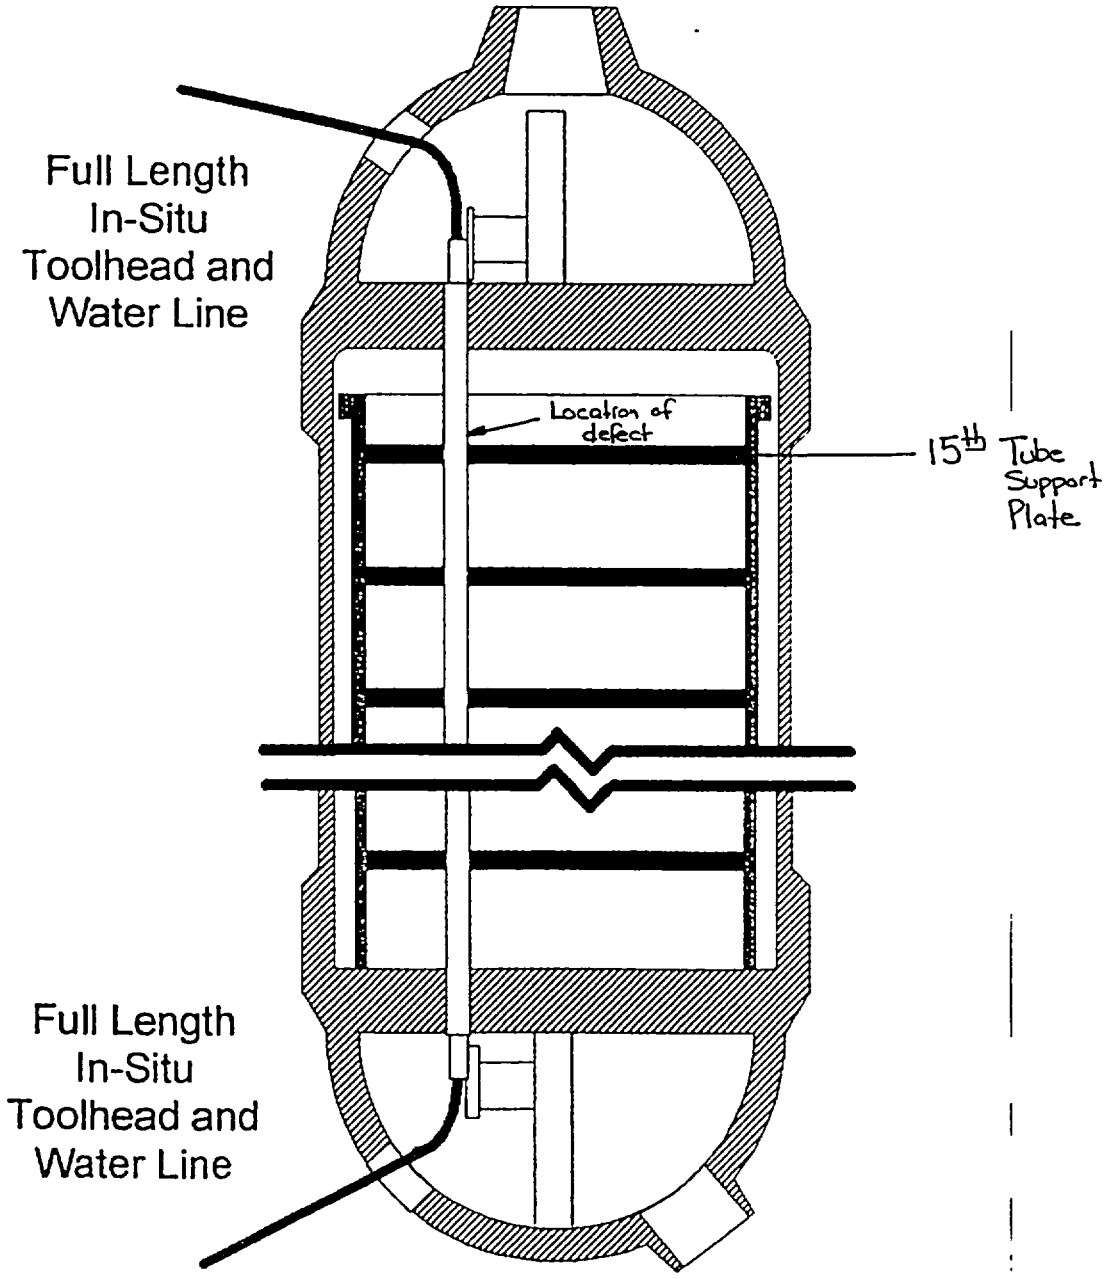
(A)

During in-situ pressure testing on OTSG 2B, Tube 37-27 failed to reach the full test pressure of 4300 psig representing the density corrected test pressure for 3 times normal delta-p. Upon reaching the 3900 psig test plateau, the hold period was just beginning and the leakage rate exceeded the capacity of the test system and pressure rapidly dropped to near zero. The in-situ test was a full length water pressure test. The defect of interest was an axial indication located at 15 TSP + 4.41 inches. The measured depth was 95% TW with a length of 2 inches.

Attachment A: Defect location in relation to S/G TSP locations.

Subsequent visual inspection indicates the axial defect at this location had opened to a gap of approx. 1/16"-1/8". Subsequent testing with a bladder was not deemed possible due to opening size. Subsequent bobbin exam indicates a length of approx 1.5 inches. MRPC exam was not performed due to likelihood that rotating element would not adequately rotate through the defect location.
