RE: Permit to Mine 633
In Situ Uranium Wellfield Release Report
3-5 Area

POWER RESOURCES, INC. SMITH RANCH – HIGHLAND URANIUM PROJECT URANIUM IN SITU WELLFIELD FLUID RELEASE REPORT

FAILURE OF A PREMANUFACTURED HOSE AT WELL 3P-113

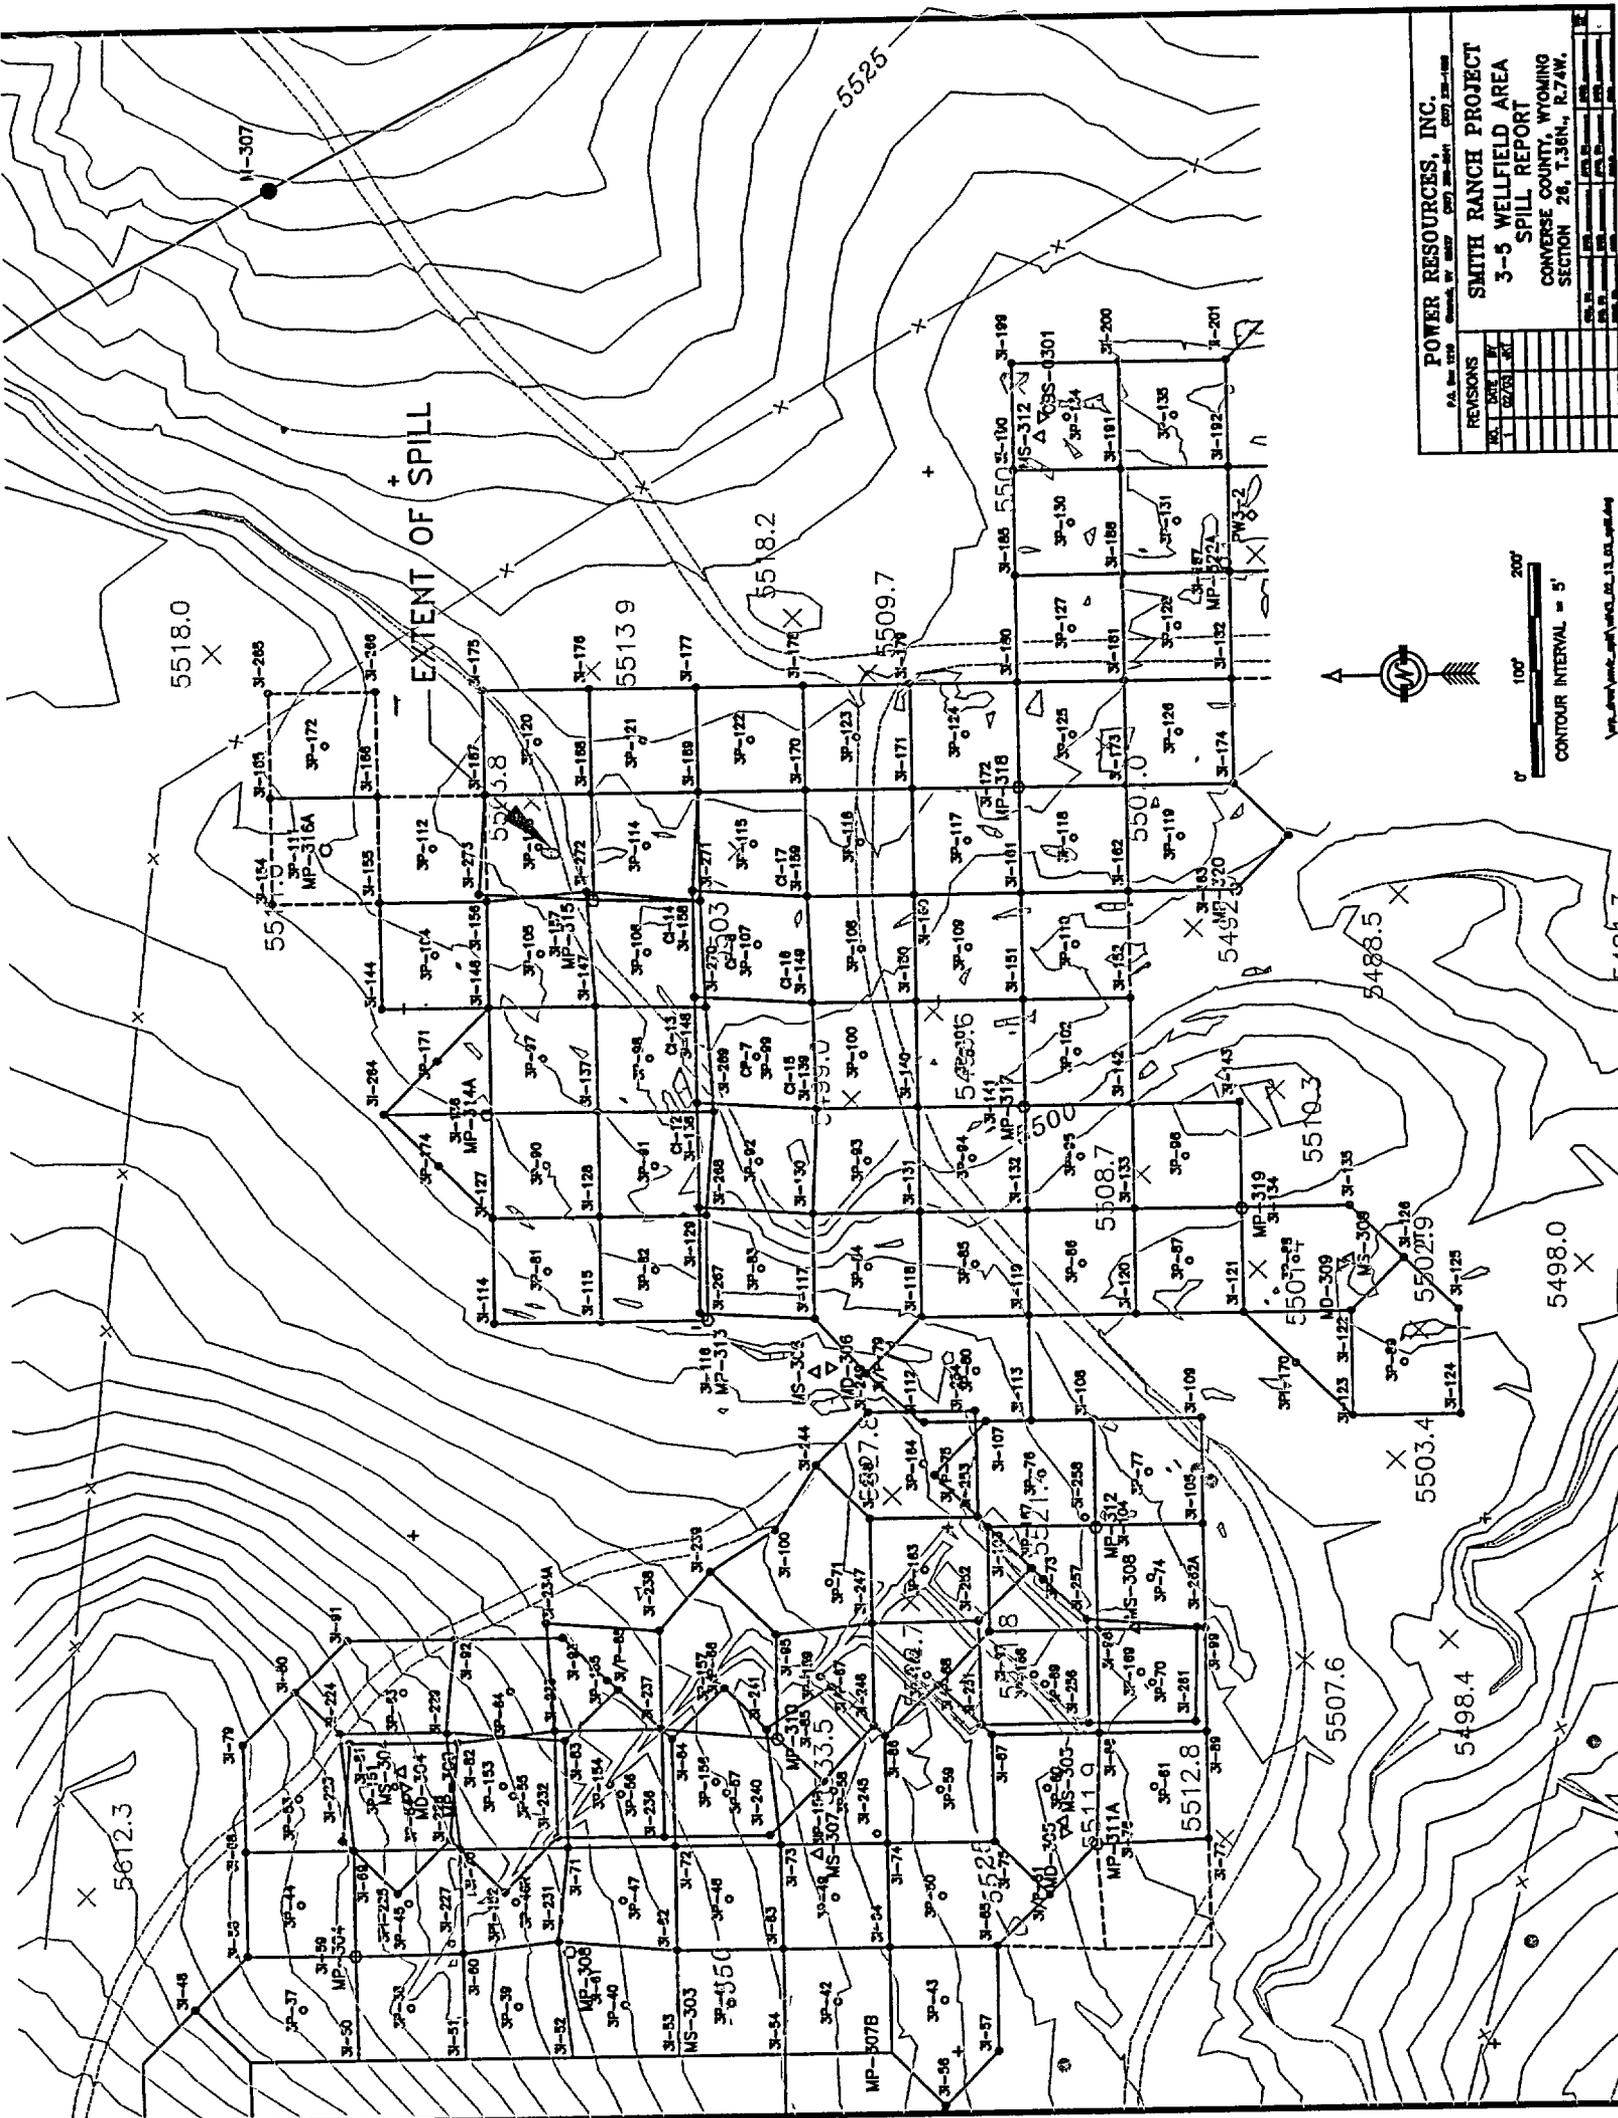
SMITH RANCH PROJECT
3-5 WELLFIELD AREA
SPILL REPORT
 CONVERSE COUNTY, WYOMING
 SECTION 28, T.36N., R.74W.

The release occurred in the NE ¼, SW ¼, Section 26, T36N, R74W and affected approximately 0.01 acres. The released fluid flowed into a dry draw, immediately adjacent to the well, where it ponded and soaked into the ground. The fluid did not exit the fenced wellfield area. Approximately 500 gallons of production fluid were released. All fluid soaked into the ground before it could be recovered. The production fluid contained approximately 2 mg/L of natural uranium. The attached map shows the location and extent of the spill.
