RE: Permit to Mine 633  
In Situ Uranium Wellfield Release Report  
3-5 Area

### POWER RESOURCES, INC. SMITH RANCH – HIGHLAND URANIUM PROJECT URANIUM IN SITU WELLFIELD FLUID RELEASE REPORT

#### FAILURE OF A PREMANUFACTURED HOSE AT WELL 3P-113

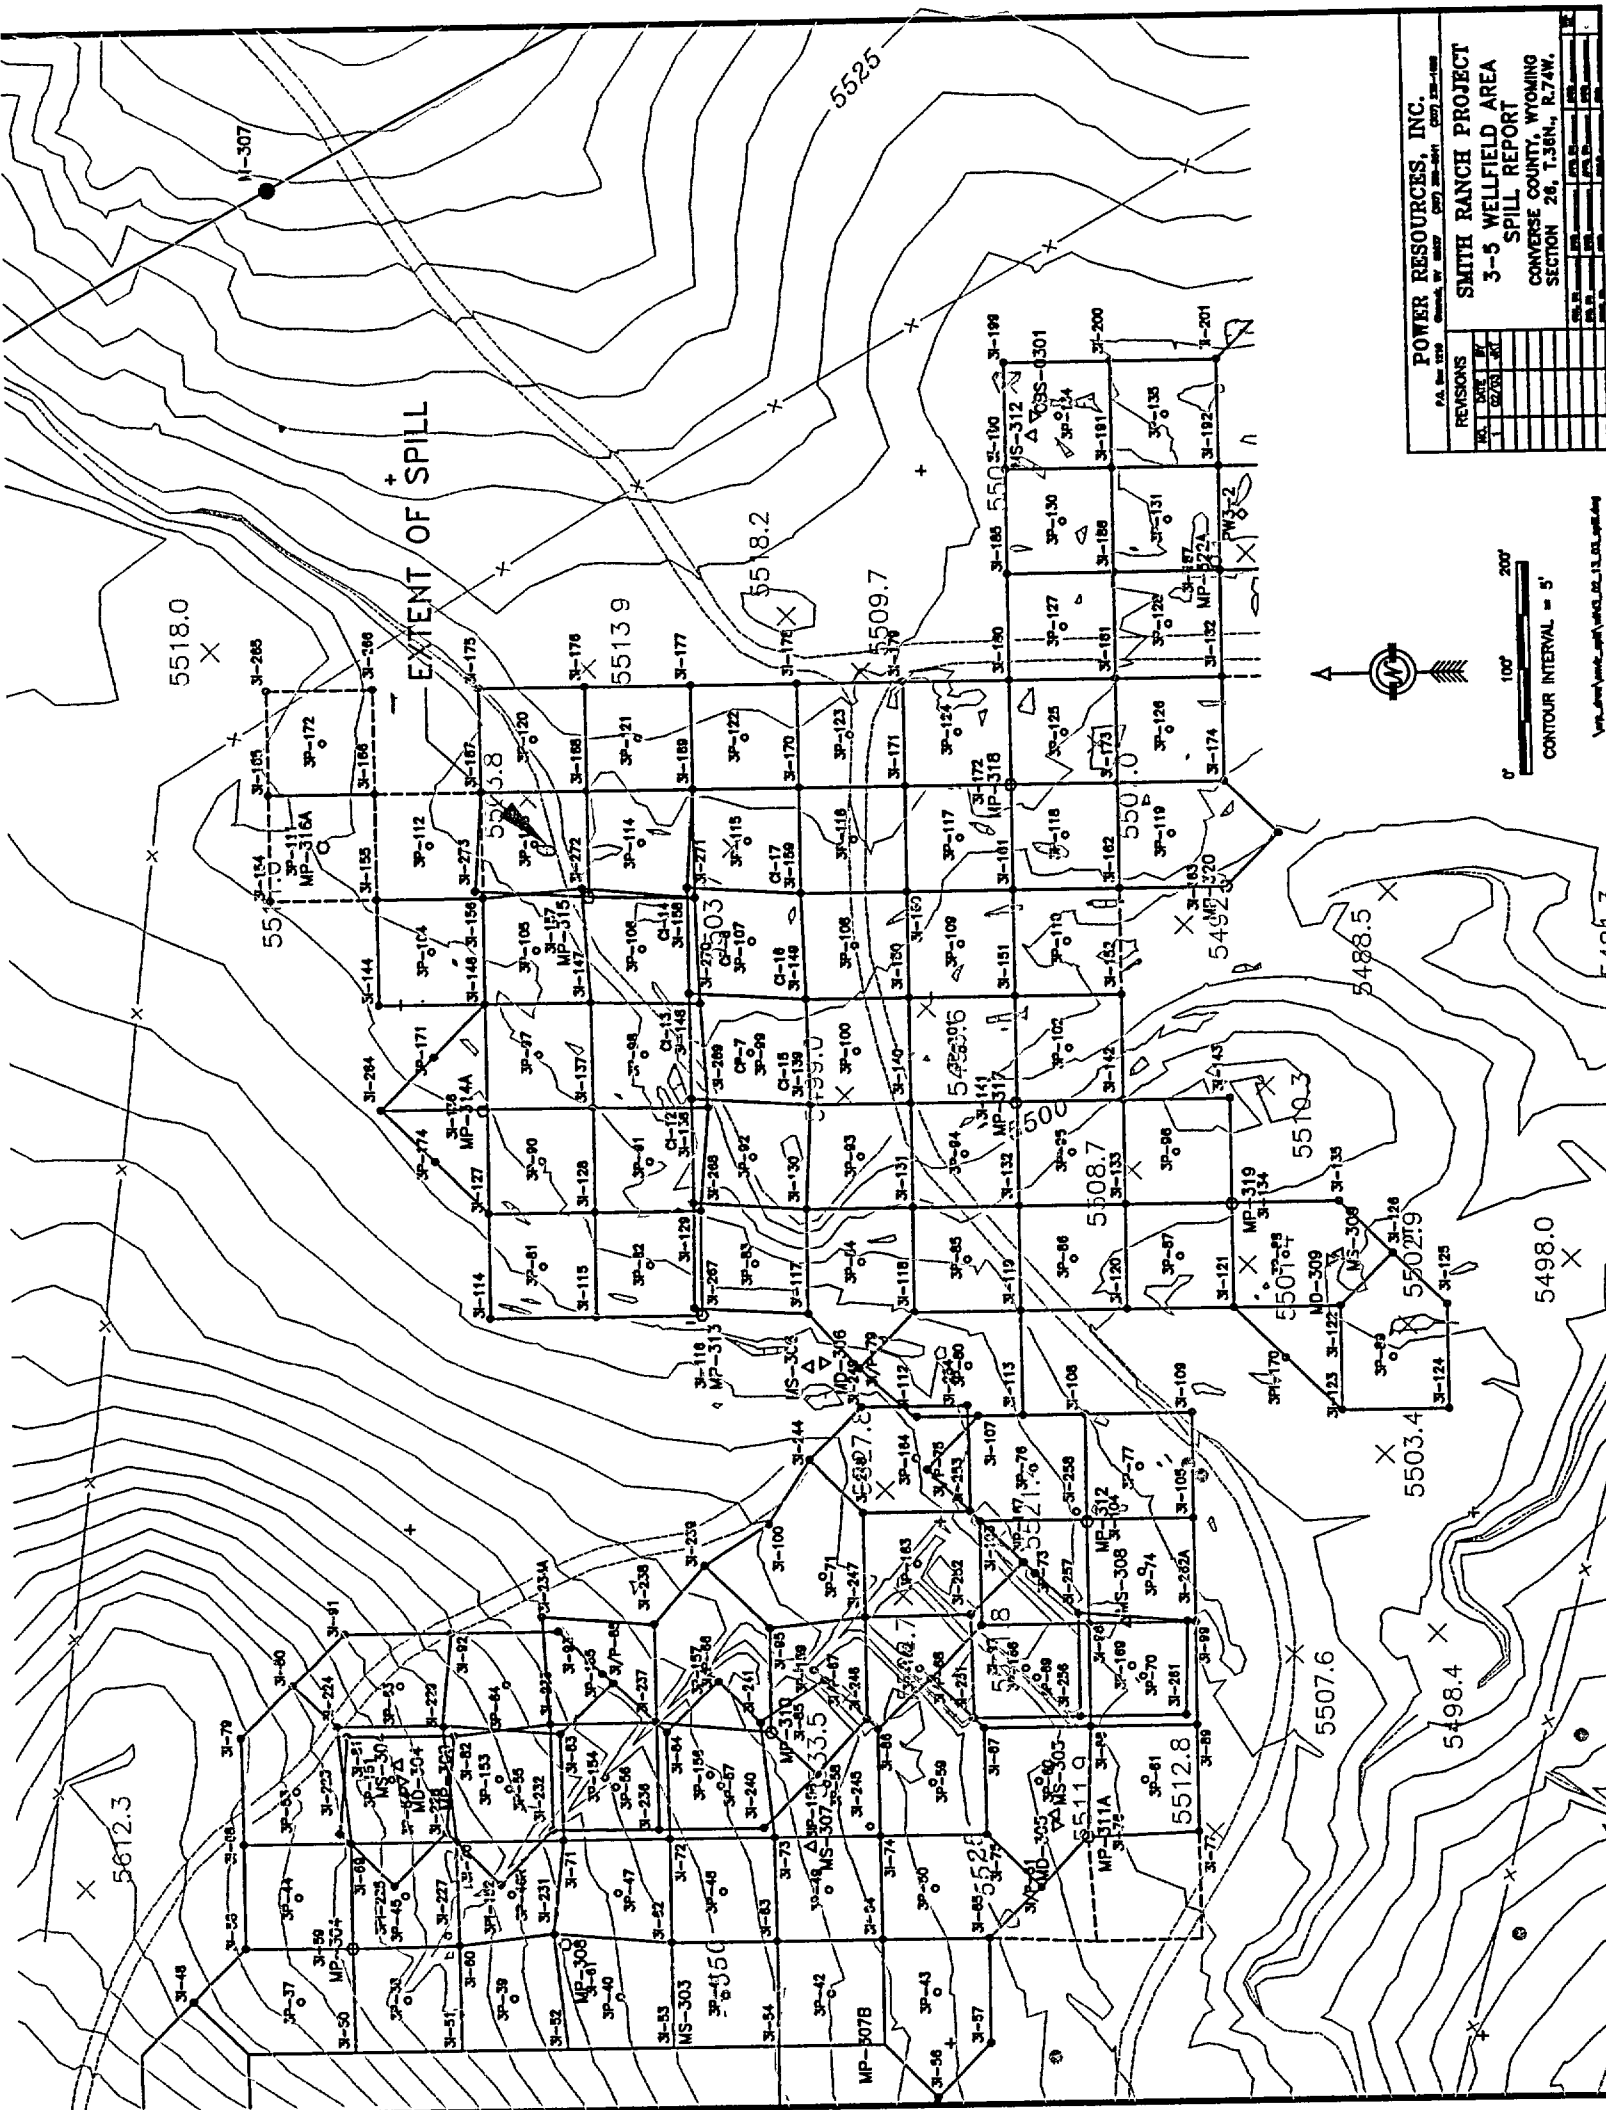
**SMITH RANCH PROJECT**  
**3-5 WELLFIELD AREA**  
**SPILL REPORT**  
 CONVERSE COUNTY, WYOMING  
 SECTION 28, T.36N., R.74W.

The release occurred in the NE ¼, SW ¼, Section 26, T36N, R74W and affected approximately 0.01 acres. The released fluid flowed into a dry draw, immediately adjacent to the well, where it ponded and soaked into the ground. The fluid did not exit the fenced wellfield area. Approximately 500 gallons of production fluid were released. All fluid soaked into the ground before it could be recovered. The production fluid contained approximately 2 mg/L of natural uranium. The attached map shows the location and extent of the spill.
