Smith Ranch - Highland Uranium Project

RE: Permit to Mine 633

In Situ Uranium Wellfield Release Report

FAILURE OF A PREMANUFACTURED HOSE AT WELL 3P-113

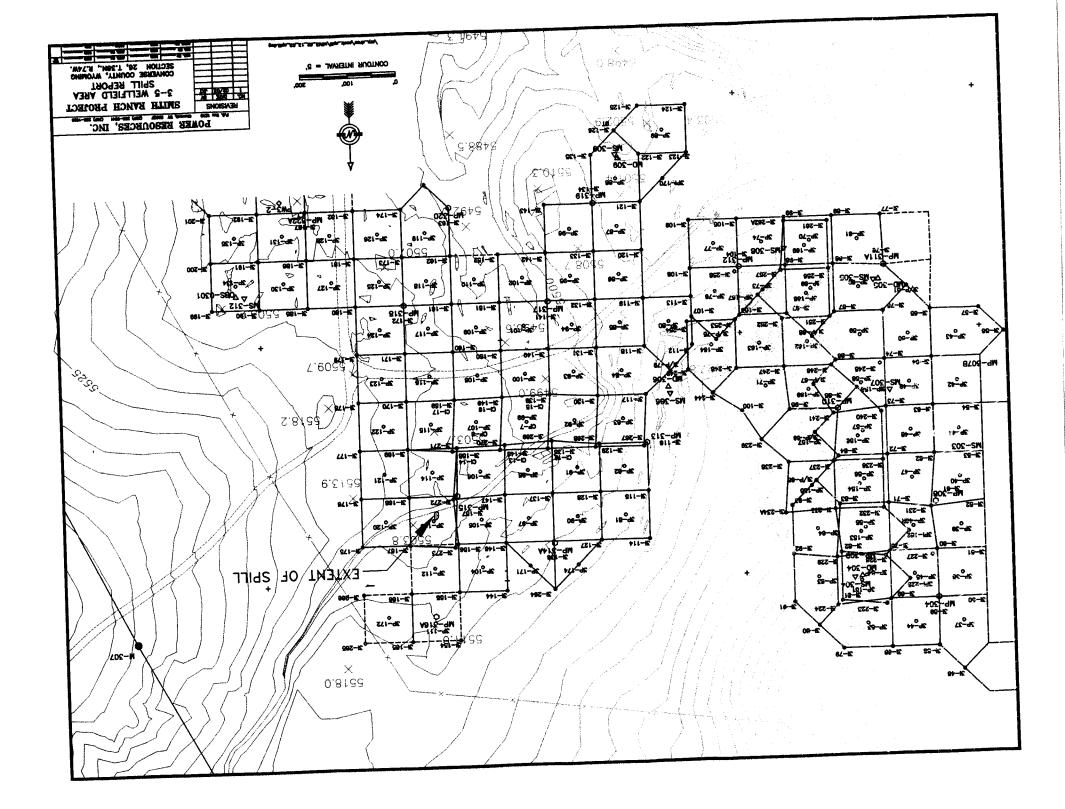
The release occurred in the NE ¼, SW ¼, Section 26, T36N, R74W and affected approximately 0.01 acres. The released fluid flowed into a dry draw, immediately adjacent to the well, where it ponded and soaked into the ground. The fluid did not exit the fenced wellfield area. Approximately 500 gallons of production fluid were released. All fluid soaked into the ground before it could be recovered. The production fluid contained approximately 2 mg/L of natural uranium. The attached map shows the location and extent of the spill.
