**Smith Ranch - Highland
Uranium Project**
P. O. Box 1210
Glenrock, Wyoming USA 82637
Casper: 307-235-1628
Douglas: 307-358-6541
Fax: 307-358-4533

RE: Permit to Mine 633
In Situ Uranium Wellfield Release Report
3-5 Area

POWER RESOURCES, INC. SMITH RANCH – HIGHLAND URANIUM PROJECT URANIUM IN SITU WELLFIELD FLUID RELEASE REPORT

FAILURE OF A PREMANUFACTURED HOSE AT WELL 3P-113

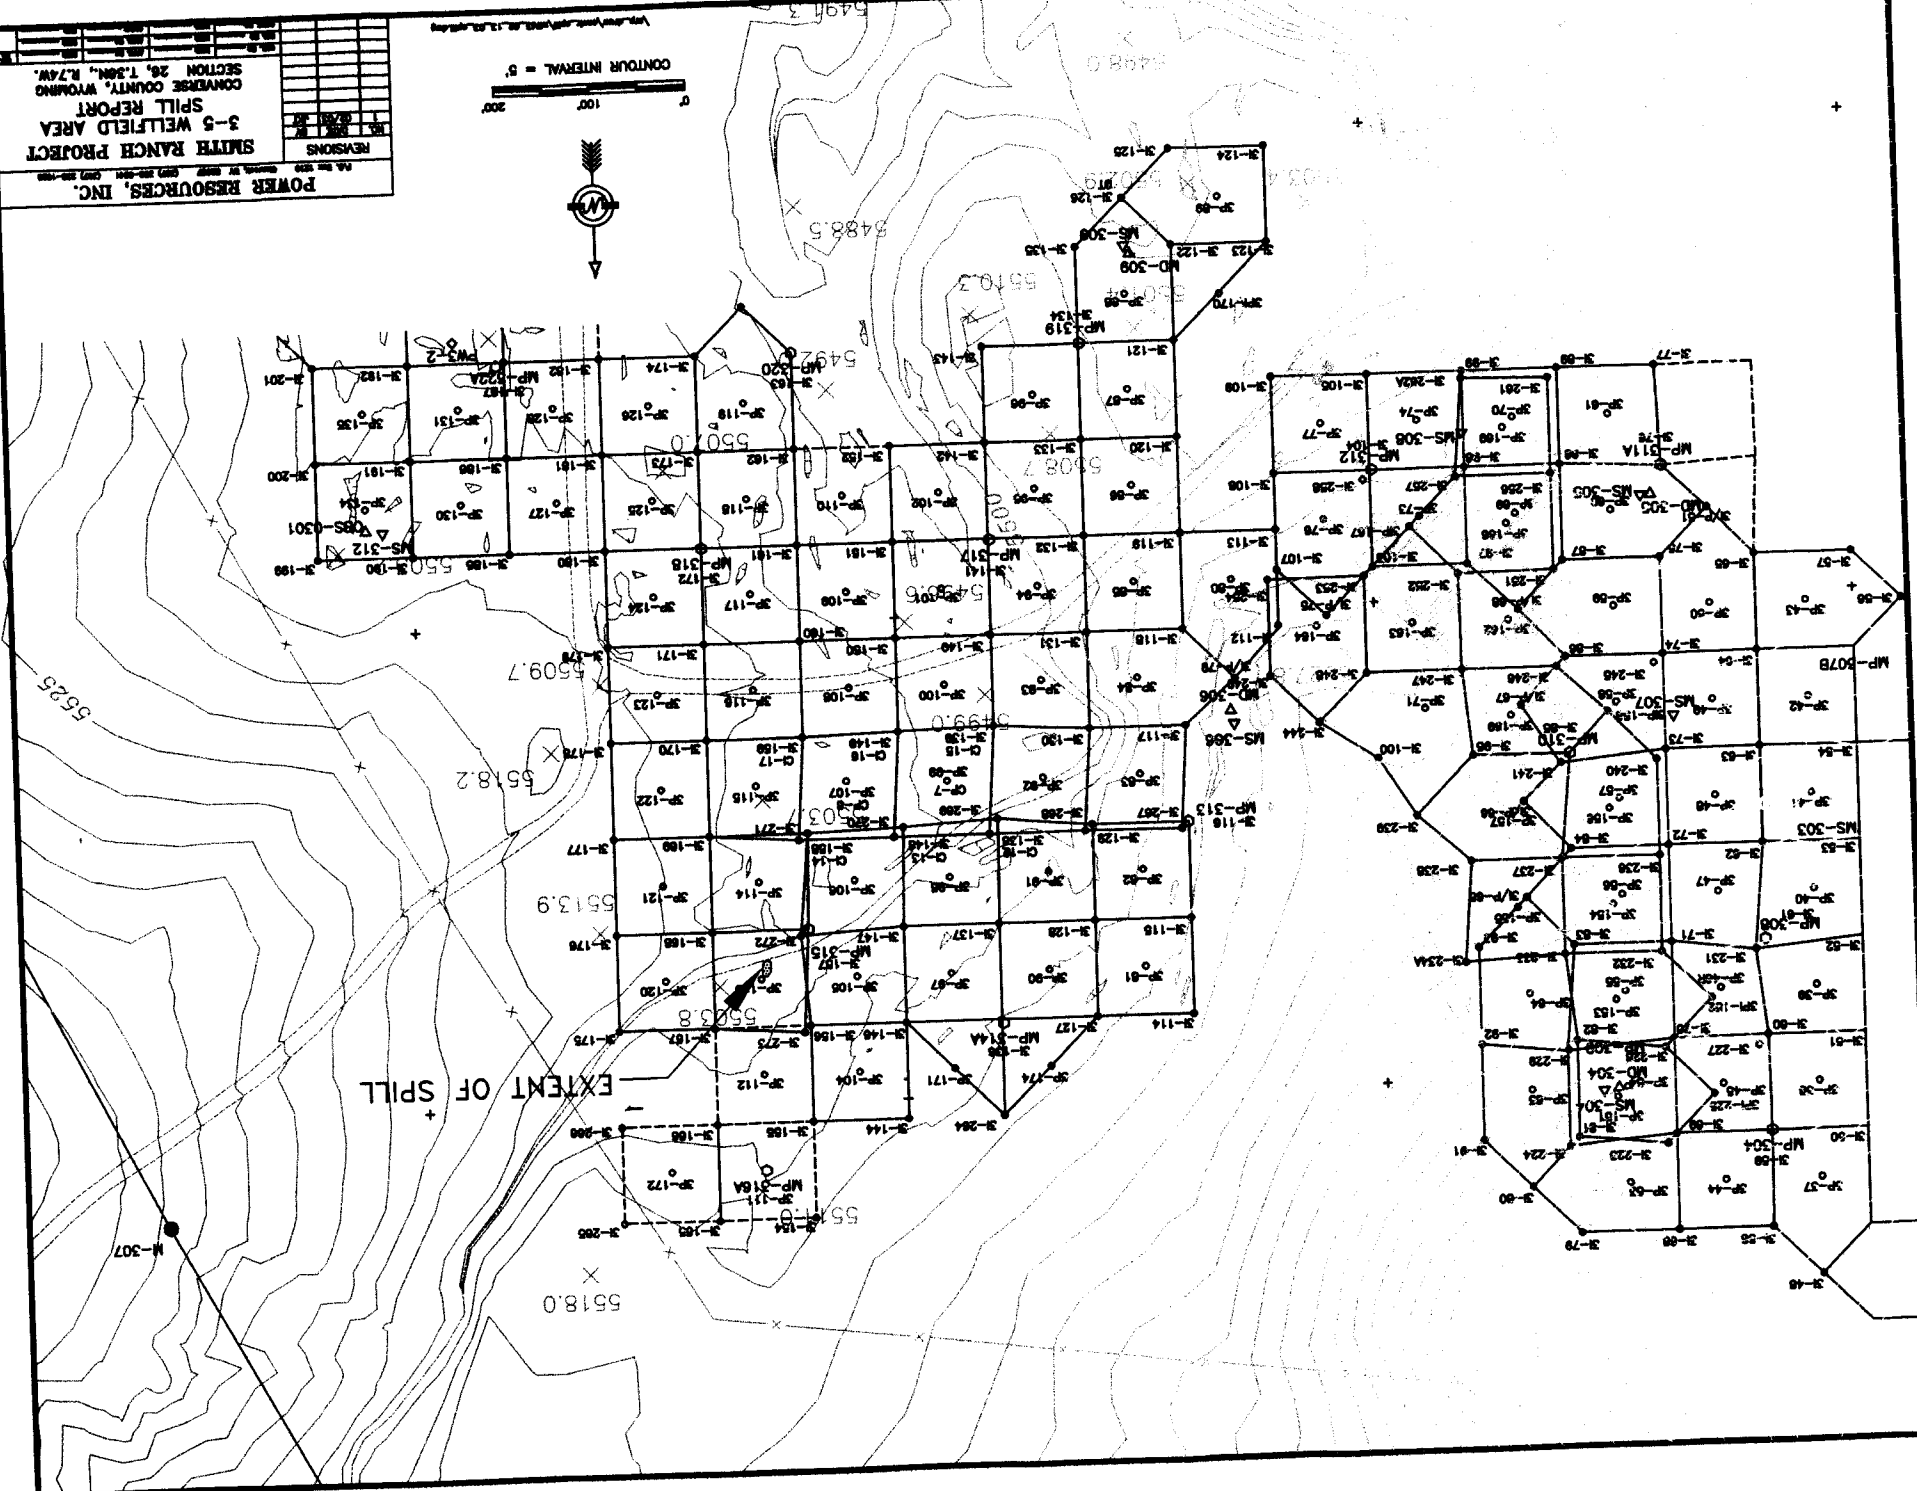
POWER RESOURCES, INC.
 3-5 WELLFIELD PROJECT
 SPILL REPORT
 SECTION 28, T.38N., R.74W.
 CONVERSE COUNTY, WYOMING

The release occurred in the NE ¼, SW ¼, Section 26, T36N, R74W and affected approximately 0.01 acres. The released fluid flowed into a dry draw, immediately adjacent to the well, where it ponded and soaked into the ground. The fluid did not exit the fenced wellfield area. Approximately 500 gallons of production fluid were released. All fluid soaked into the ground before it could be recovered. The production fluid contained approximately 2 mg/L of natural uranium. The attached map shows the location and extent of the spill.
