Subject: *2002 Annual Site Inspection and Monitoring Report for UMTRCA
Title I Disposal Sites*

2002 Annual Site Inspection and Monitoring Report for Uranium Mill Tailings Radiation Control Act Title I Disposal Sites

GJO-2002-392-TAC
GJO-LREP 6.3.1-5

December 2002

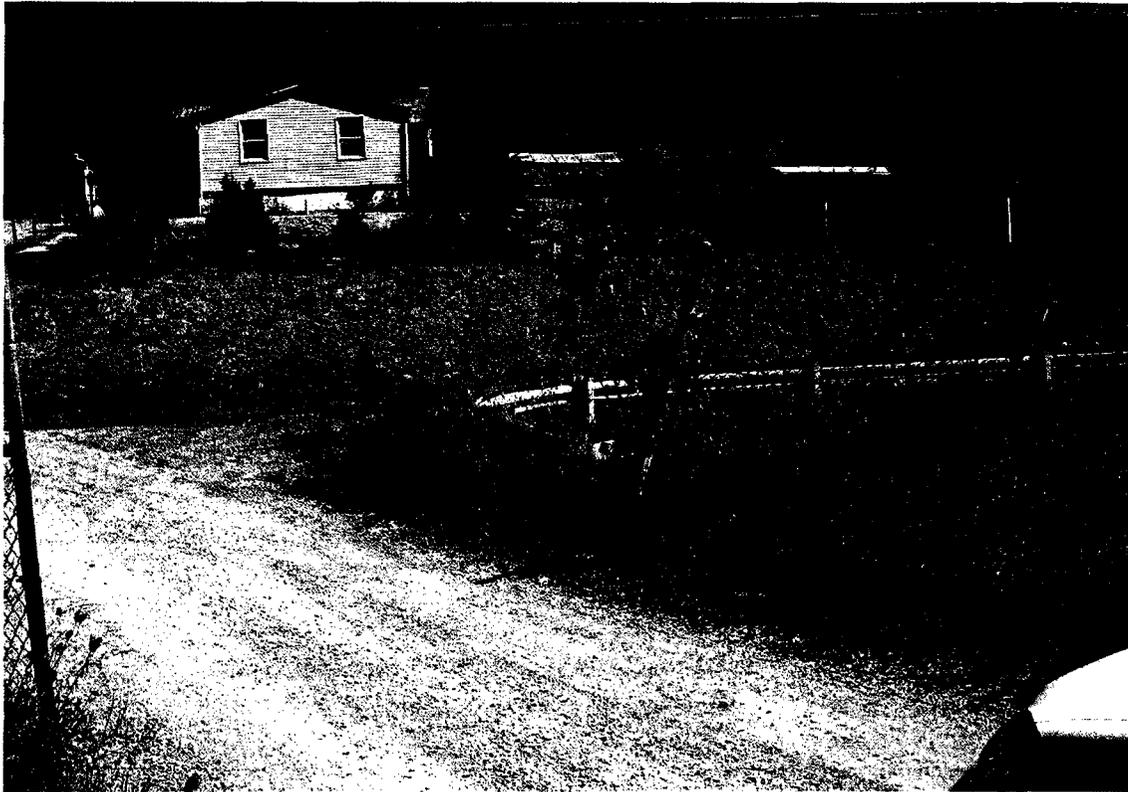
DOE has tried to prevent use of its access road by keeping the gate locked and installing a guardrail along Strangford Road. However, on every site visit since 2000 the gate has been found open. Inspectors found the gate damaged and derelict in 2002 (PL-1 and PL-2).

PL-1. Damaged east gatepost at Strangford Road.

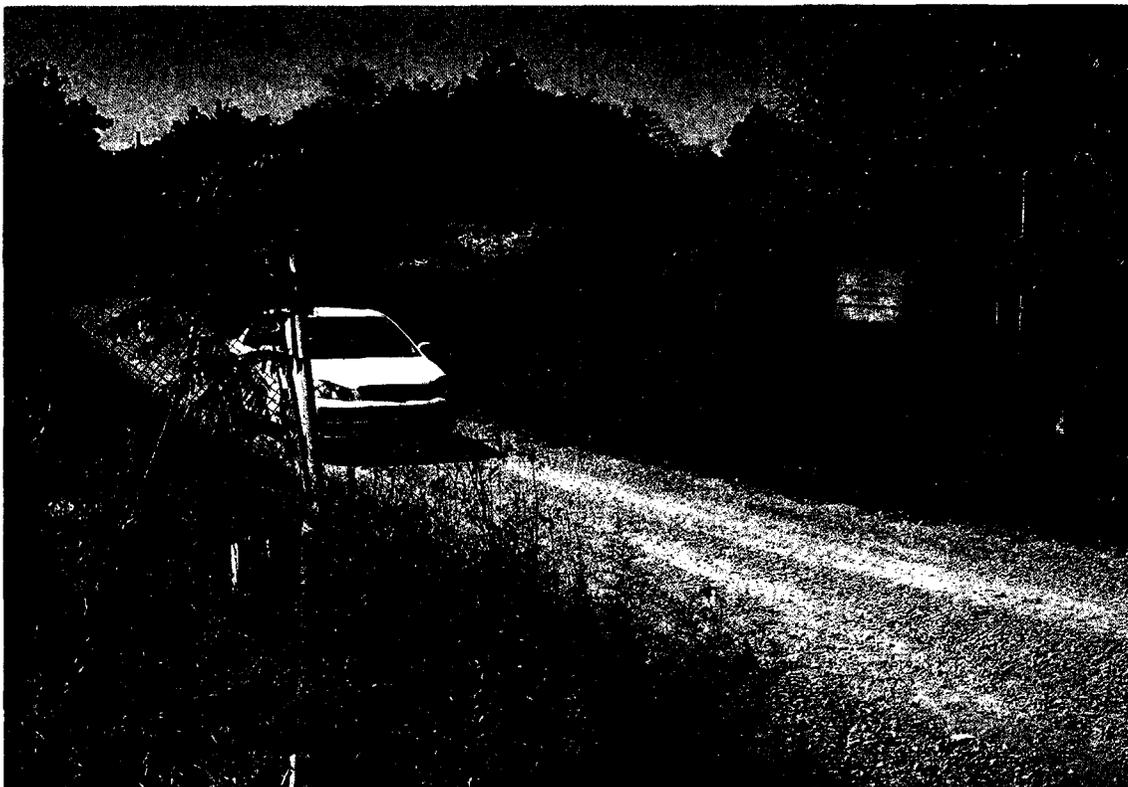
PL-2. Damaged west gatepost at Strangford Road.

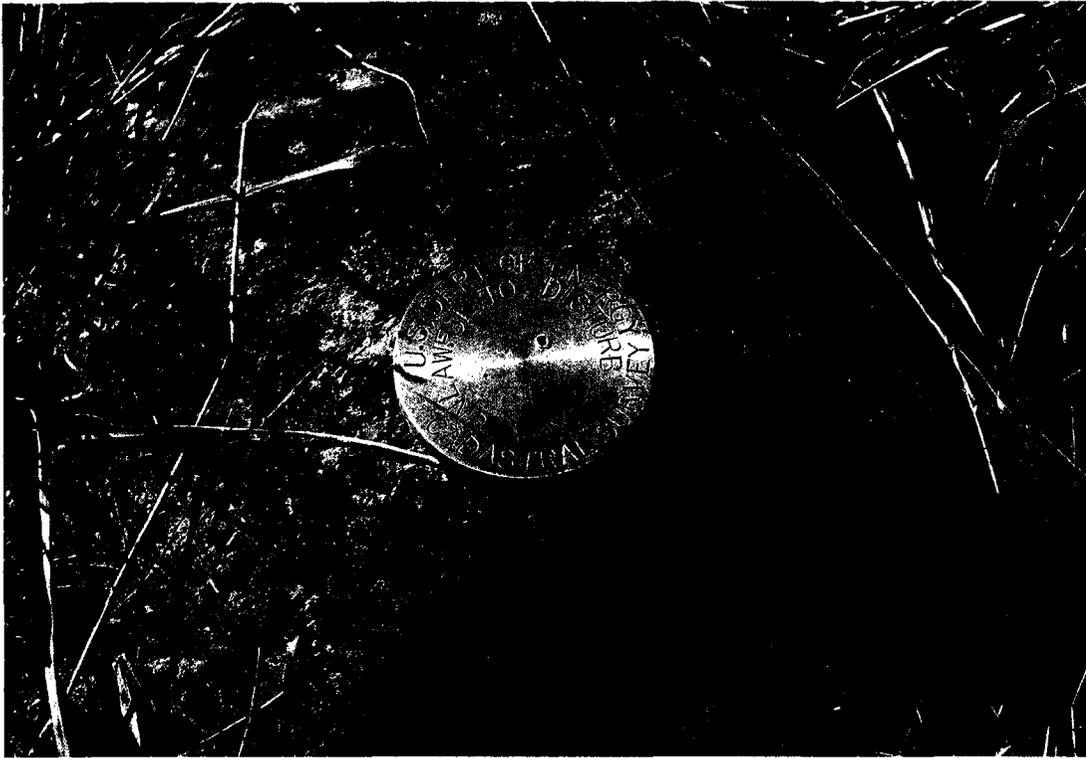
2D The site has three survey monuments (SM-100, SM-101, and SM-102) and seven boundary monuments (BM-1 through BM-7). Because of dense vegetation, inspectors could not locate survey monument SM-1 or boundary monument BM-4. Remaining markers and monuments were undisturbed and in excellent condition. The cap on boundary monument BM-7, found sheared off in 2001, was replaced in December 2001 (PL-3).

PL-3. New cap on boundary monument BM-7.

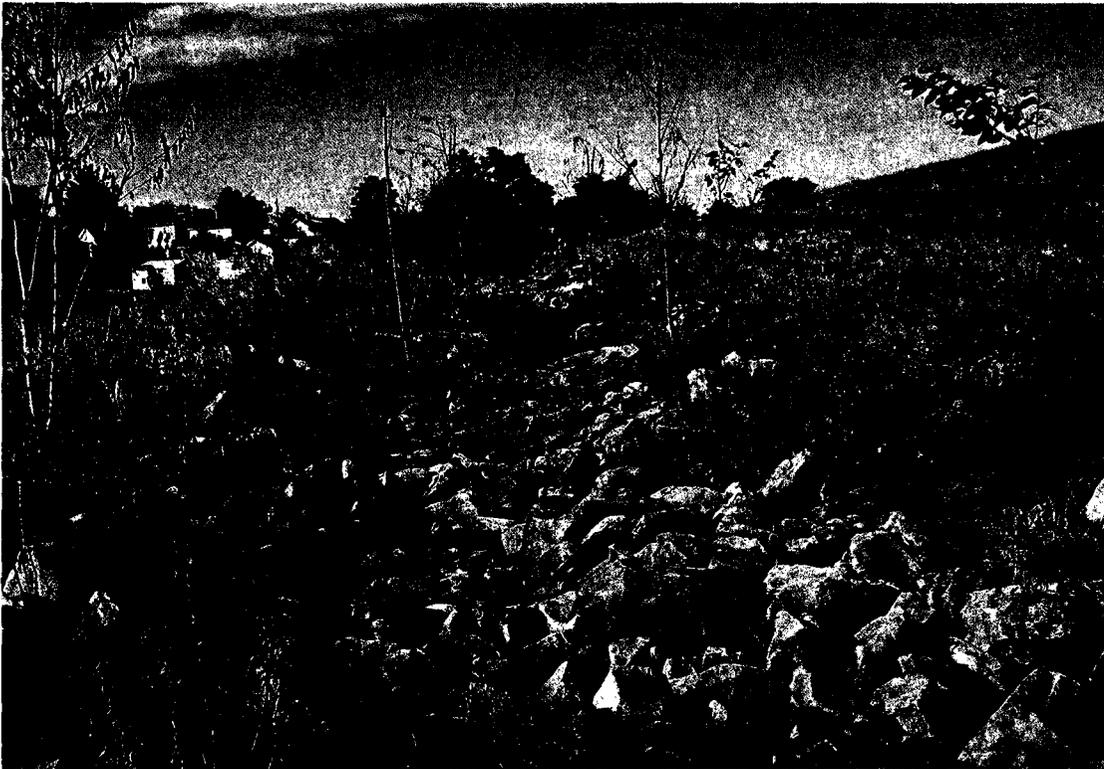
PL-2. Treated vegetation in diversion channel.

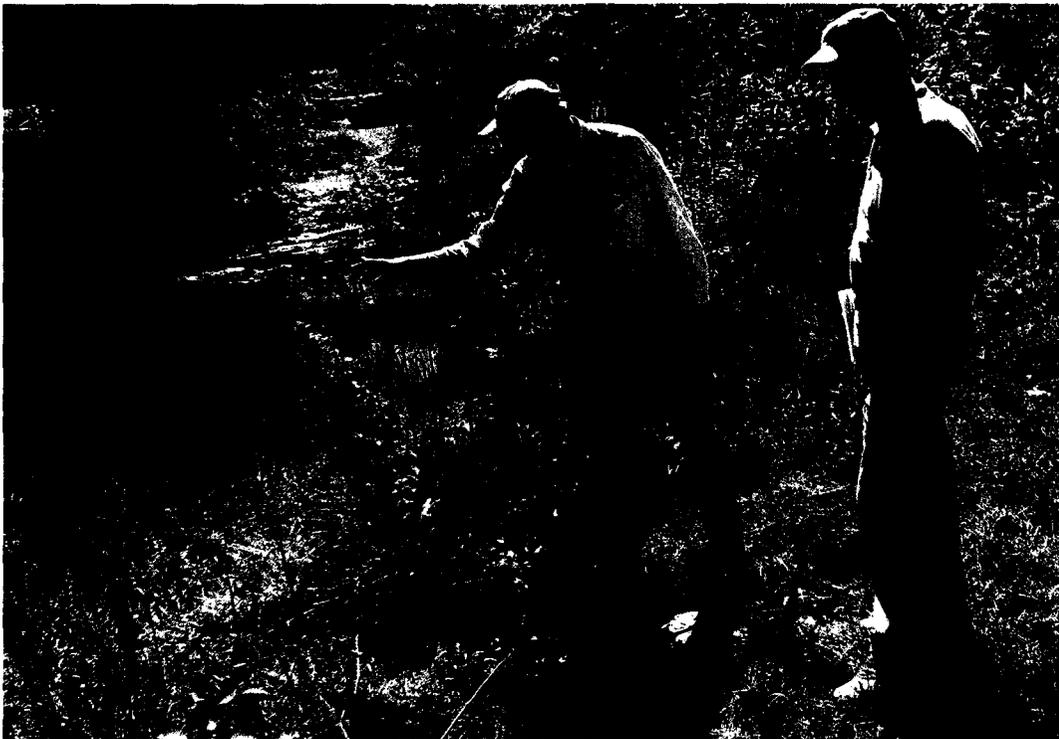
PL-4. Erosion at south end of restored stream bank.

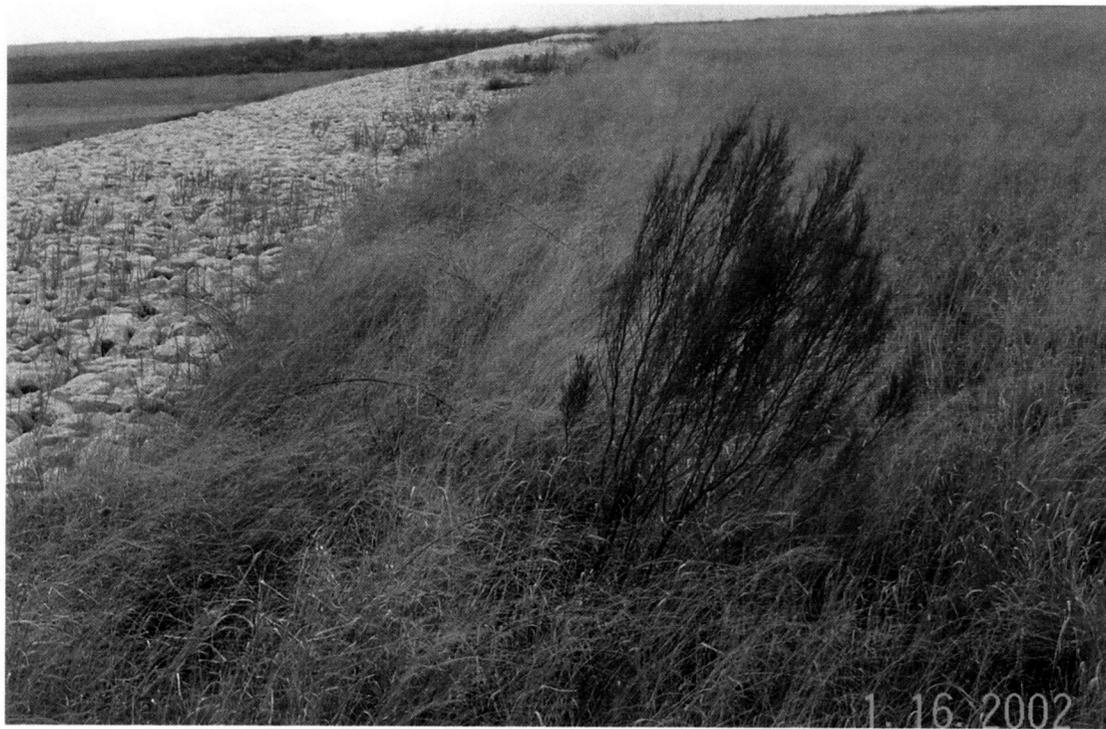
PL-1. Woody vegetation on southeast edge of cell top.

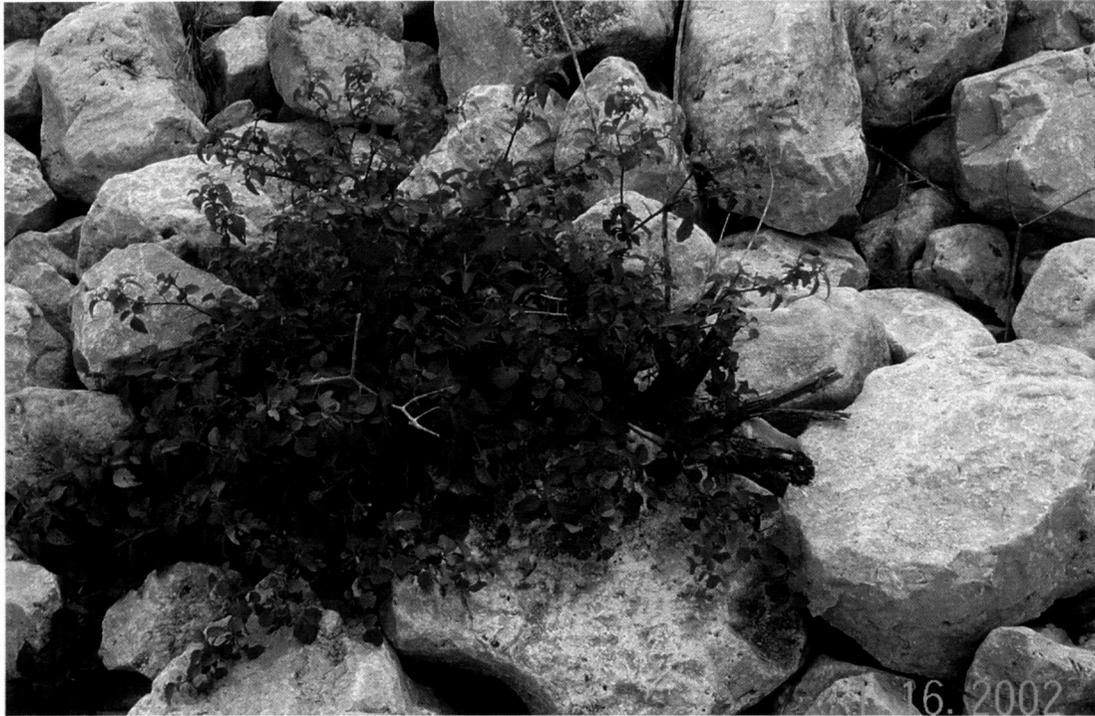
Small scattered trees and bushes that had established on the side slopes were mostly absent. Inspectors sprayed the plants with herbicide in previous years and a local farmer was contracted to eradicate the perennial plants. Greasewood and similar species are concerns because they are deep-rooted. Most vegetation was dead including annual plants and most woody species; however, new growth on some previously treated plants was observed (PL-2). Vegetation control will continue on the side slopes.

PL-2. New growth on previously treated vegetation.

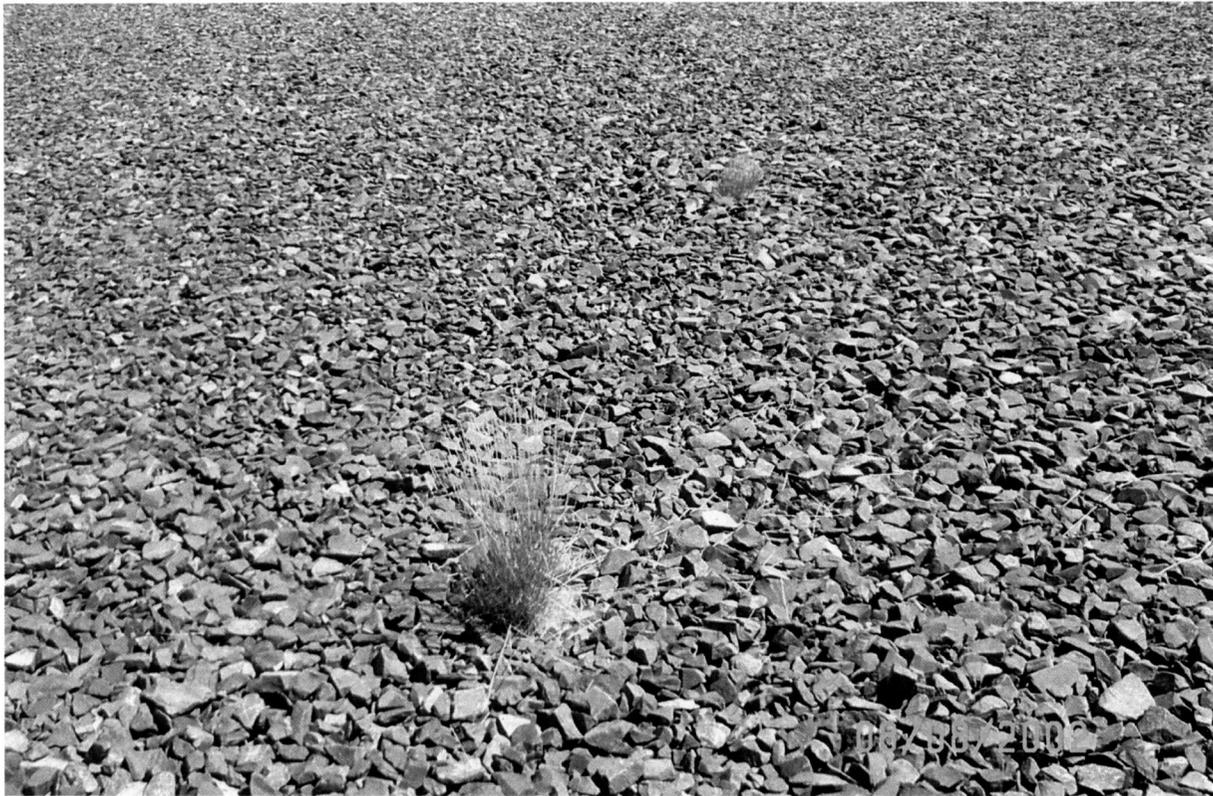
PL-1. Patch of grass on top of cell.

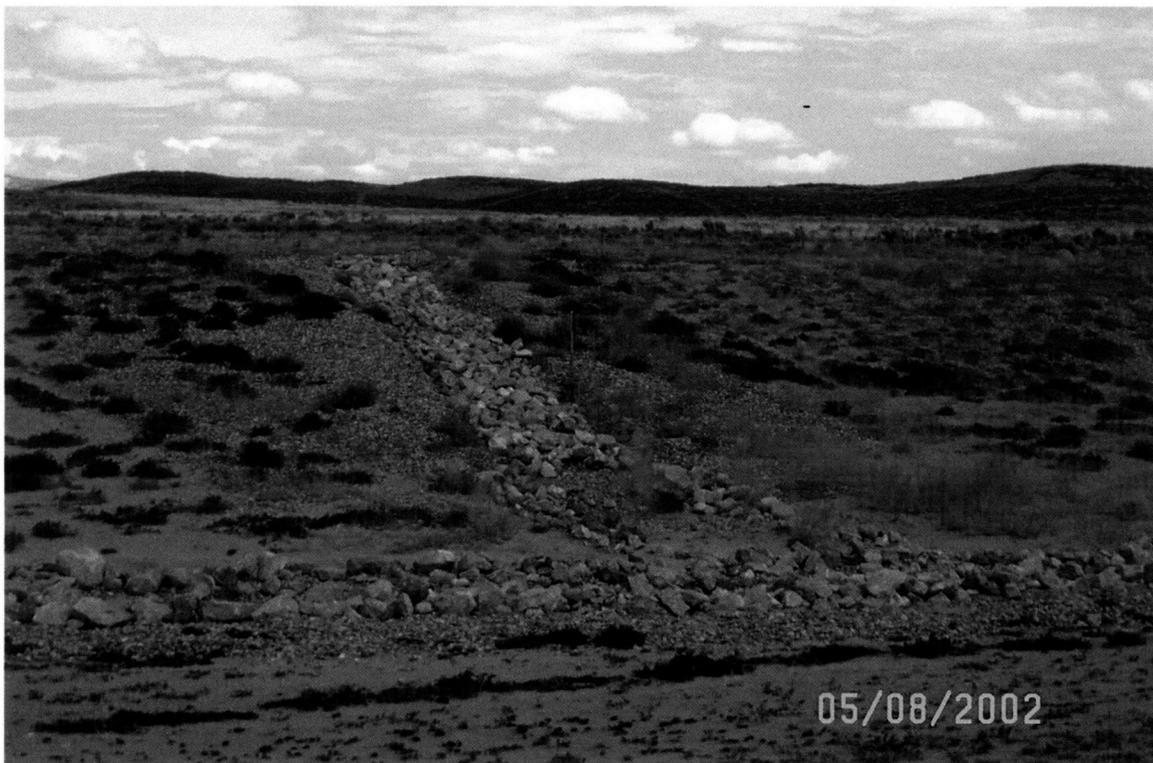
PL-1. Erosion protection rock installed on the north side of Swale Number 1.

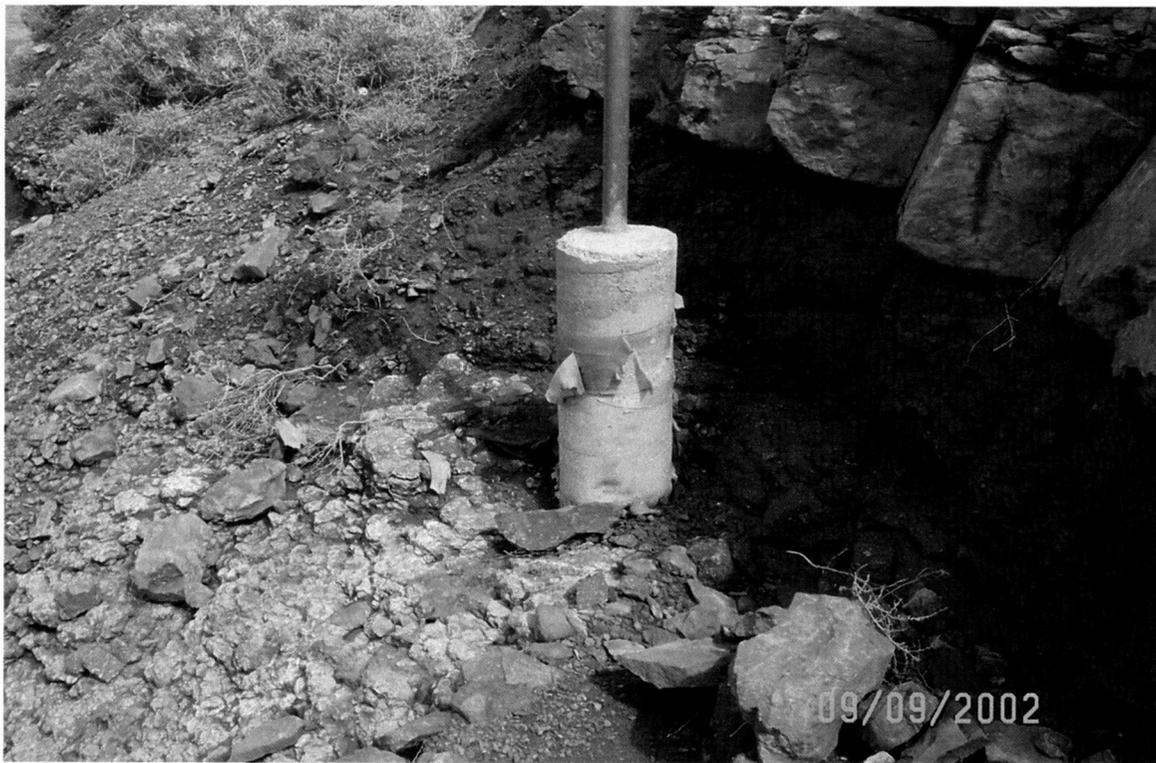
PL-1. Erosion around perimeter sign P4.

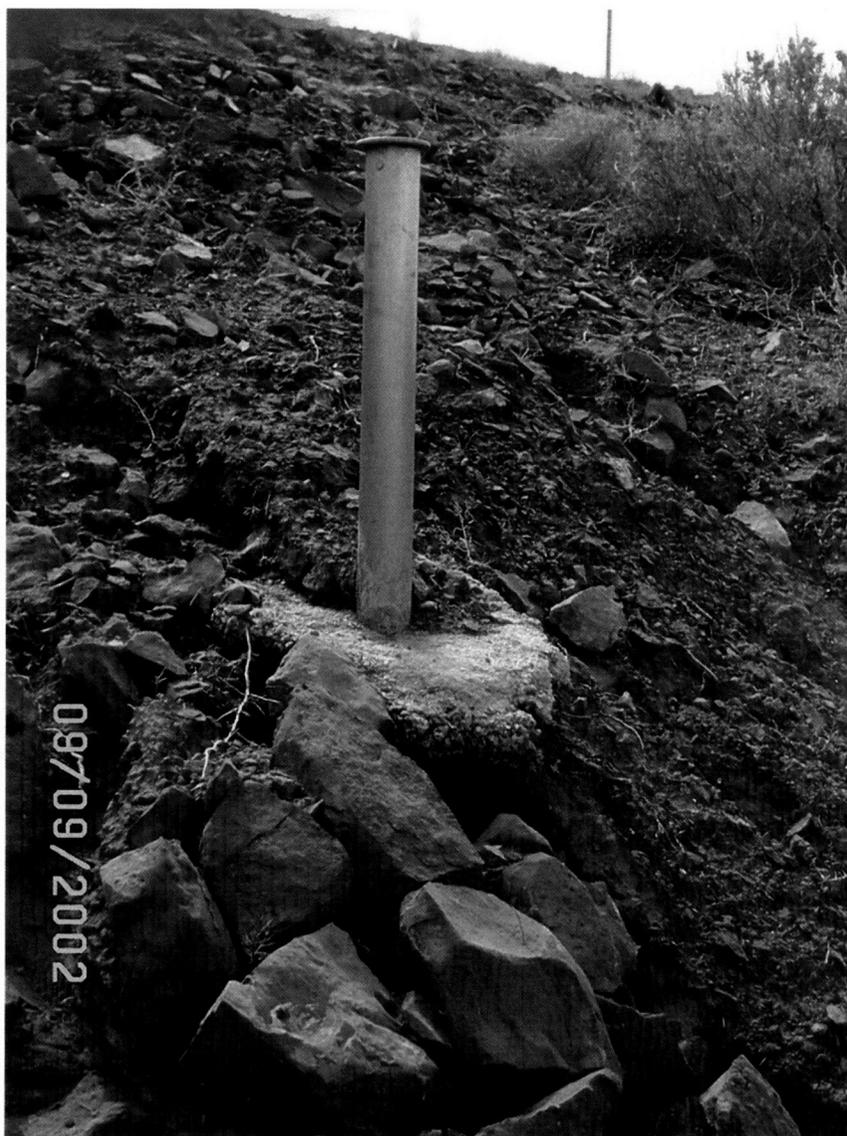
PL-2. Erosion around boundary monument BM-11.

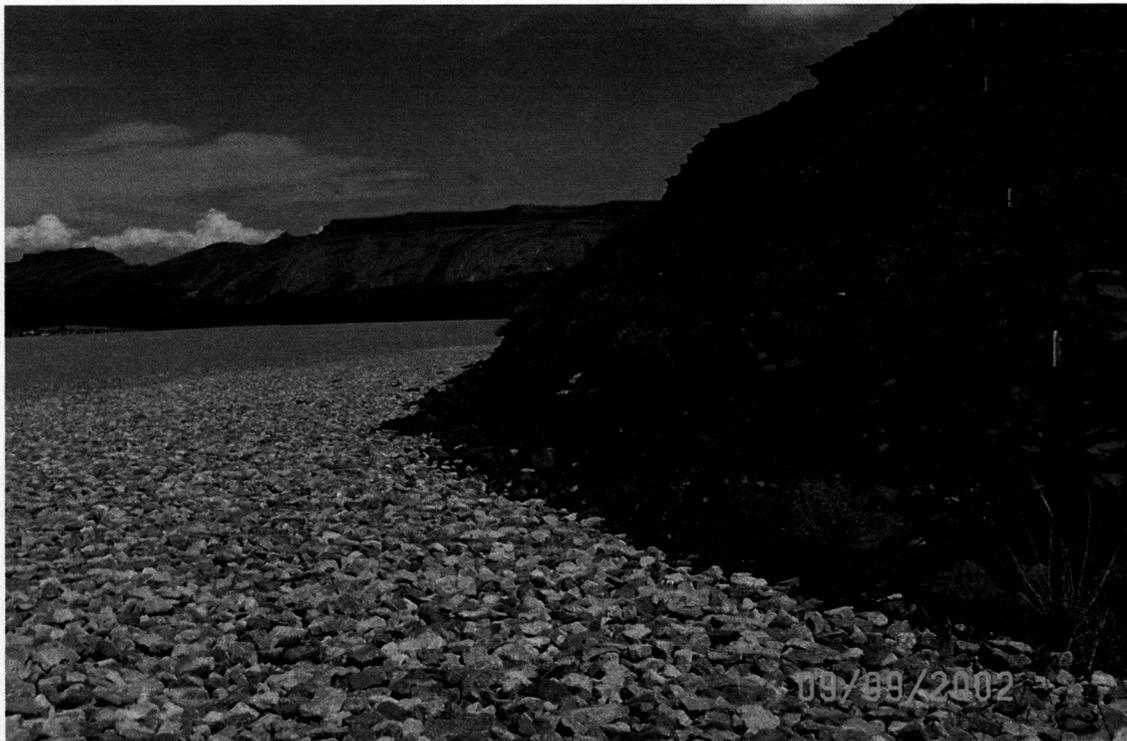
PL-3. Rock and soil accumulation on south apron.

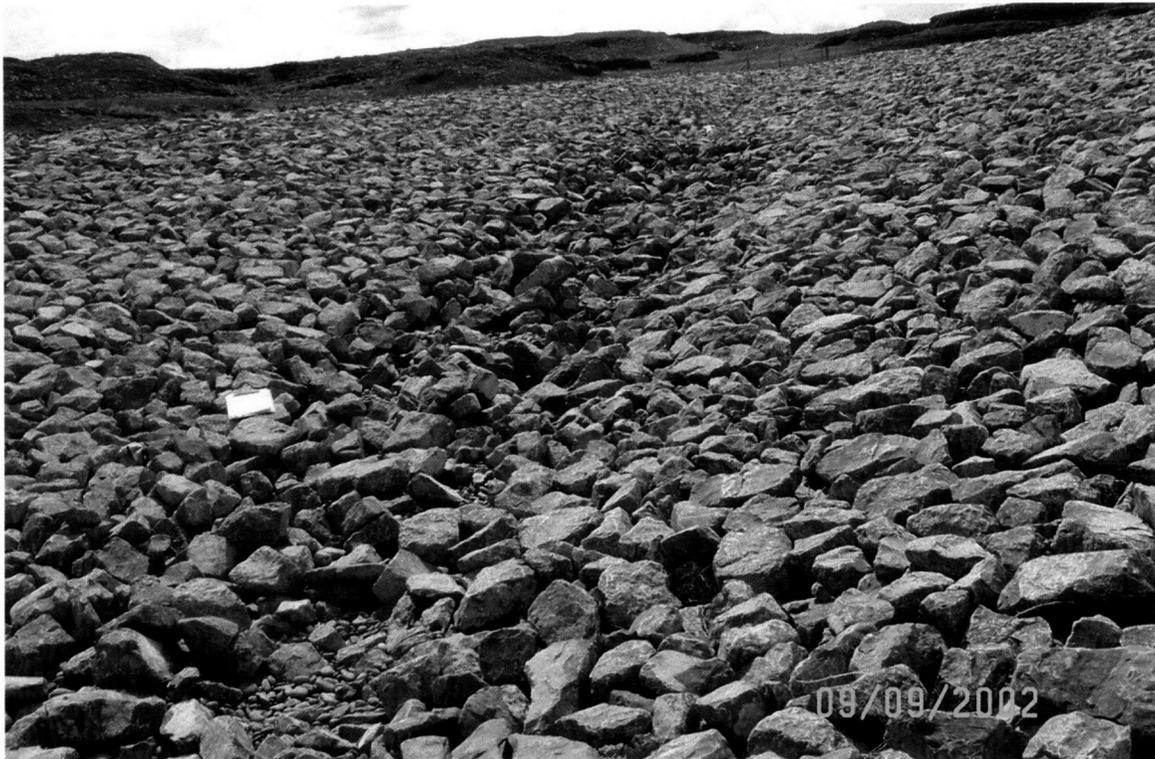
12A A severe storm passed through the Mexican Hat area on September 8, 2002, causing water from impervious areas south and west of the disposal cell to flow into the west diversion ditch. Municipal trash, tumbleweeds, and sediment were carried onto the site and became lodged in the security fence and diversion ditch riprap. Water depths in the ditch reached about 3 feet as indicated by the high water mark on the ditch sides. A 40-foot long by 3-foot wide section of

PL-4. Rock that moved in the south end of west ditch during storm event.
