Point Beach Nuclear Plant
SOCKET-WELD FAILURES IN
AUXILIARY FEEDWATER PUMP
RECIRCULATION PIPING

RCE 99-081, Revision 1

March 15, 2000

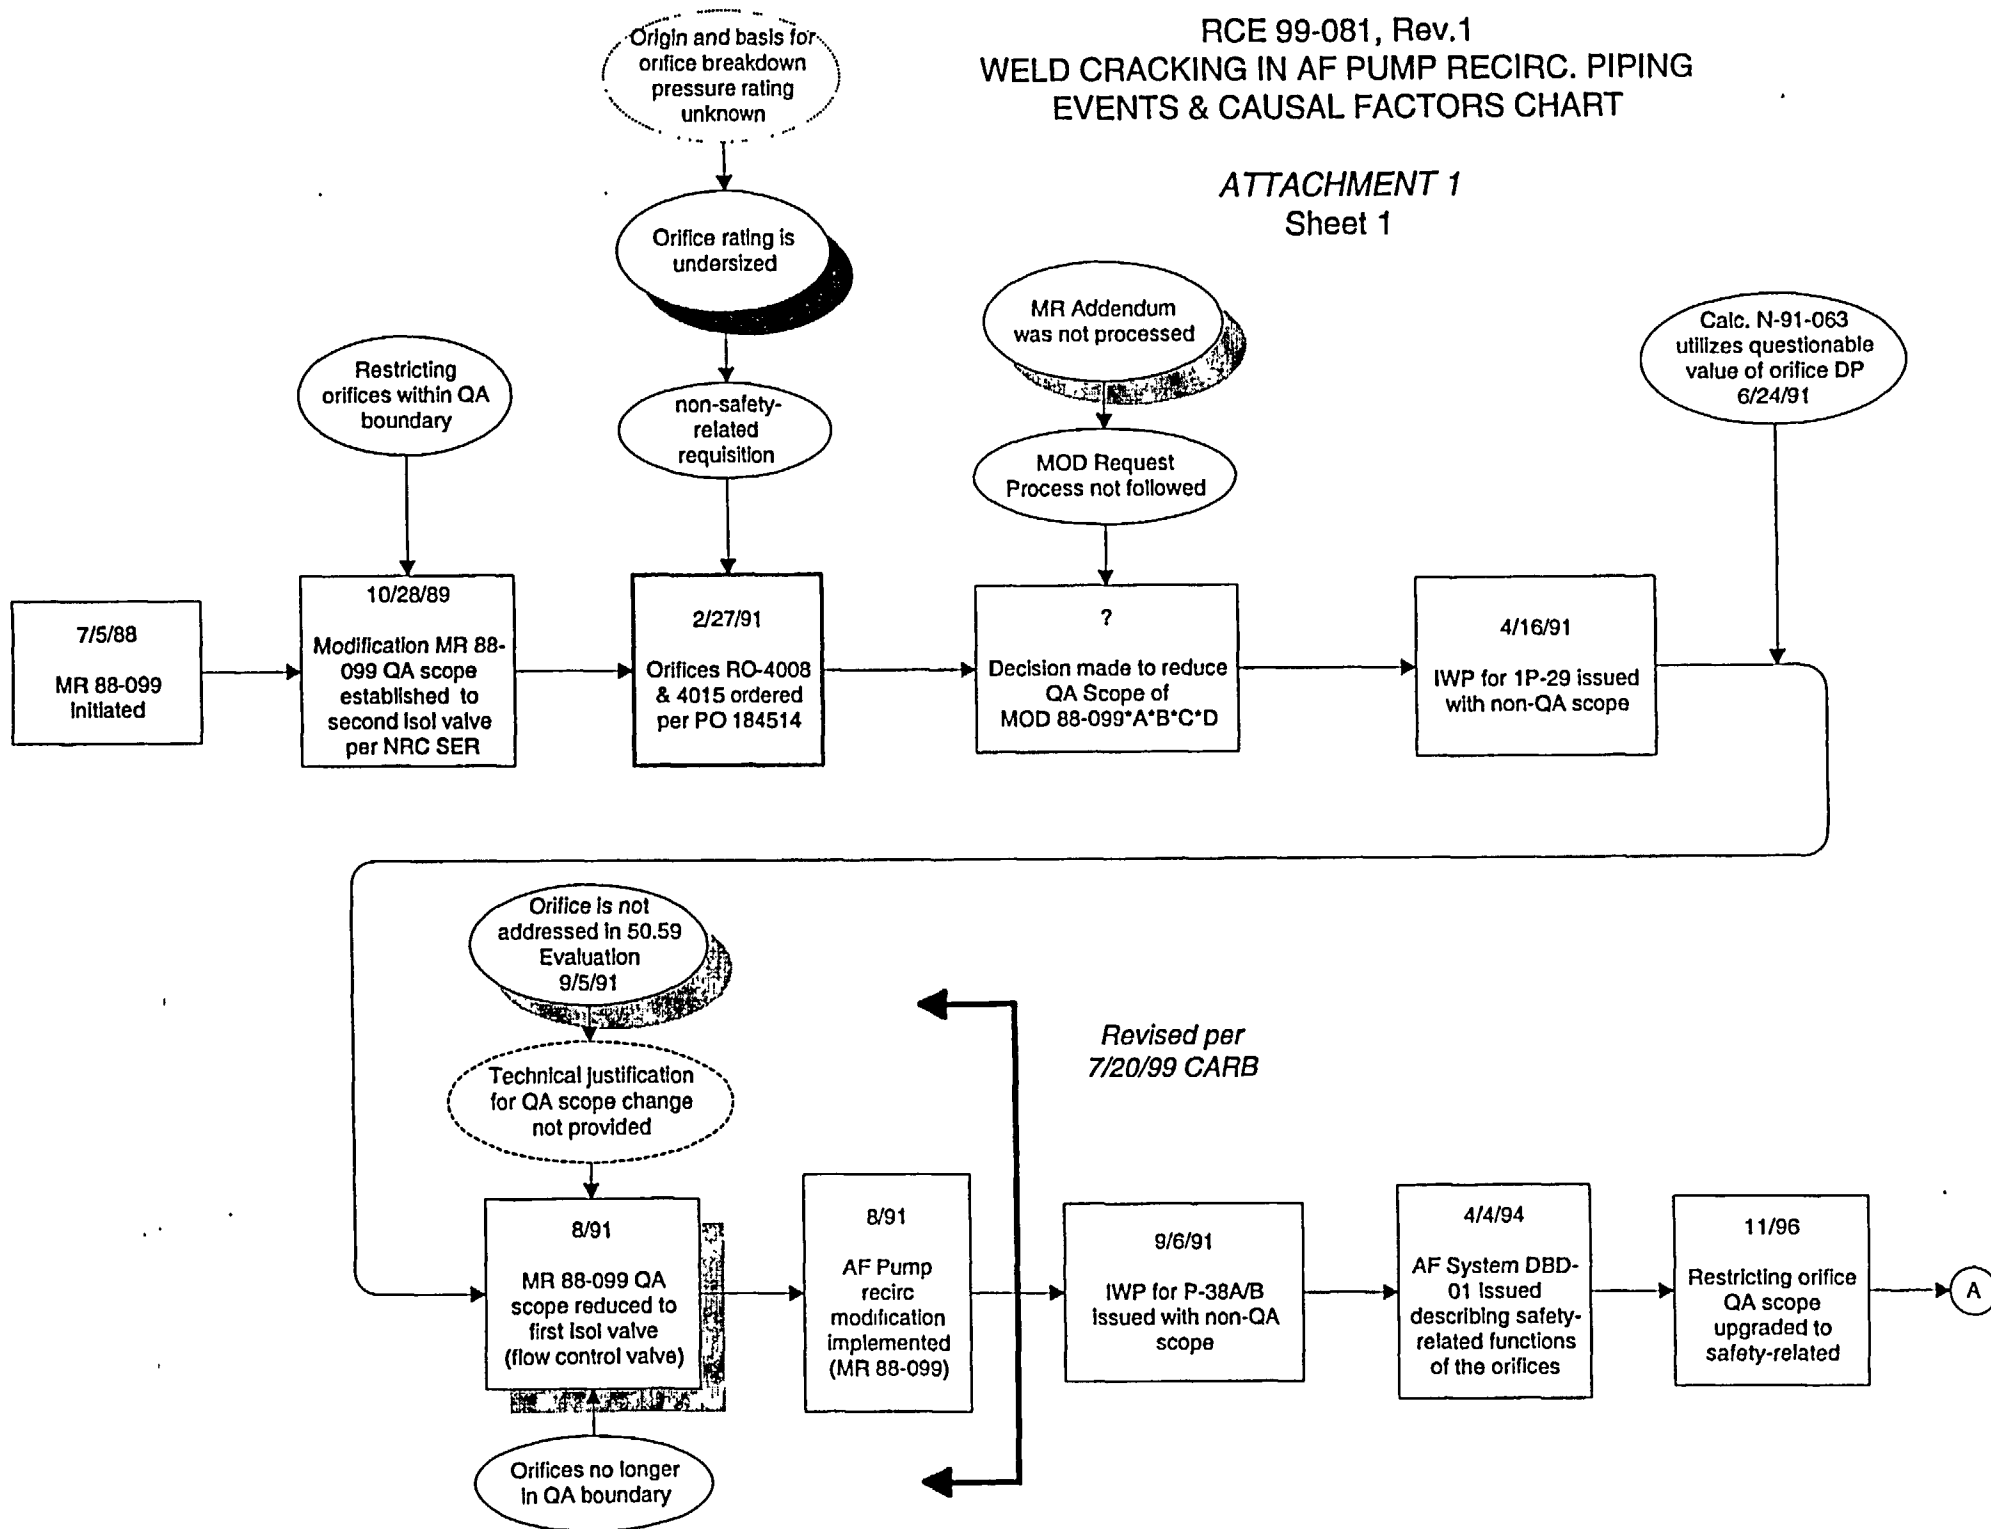
ATTACHMENT 1
 Sheet 1

RCE 99-081, Rev.1
 WELD CRACKING IN AF PUMP RECIRC. PIPING
 EVENTS & CAUSAL FACTORS CHART

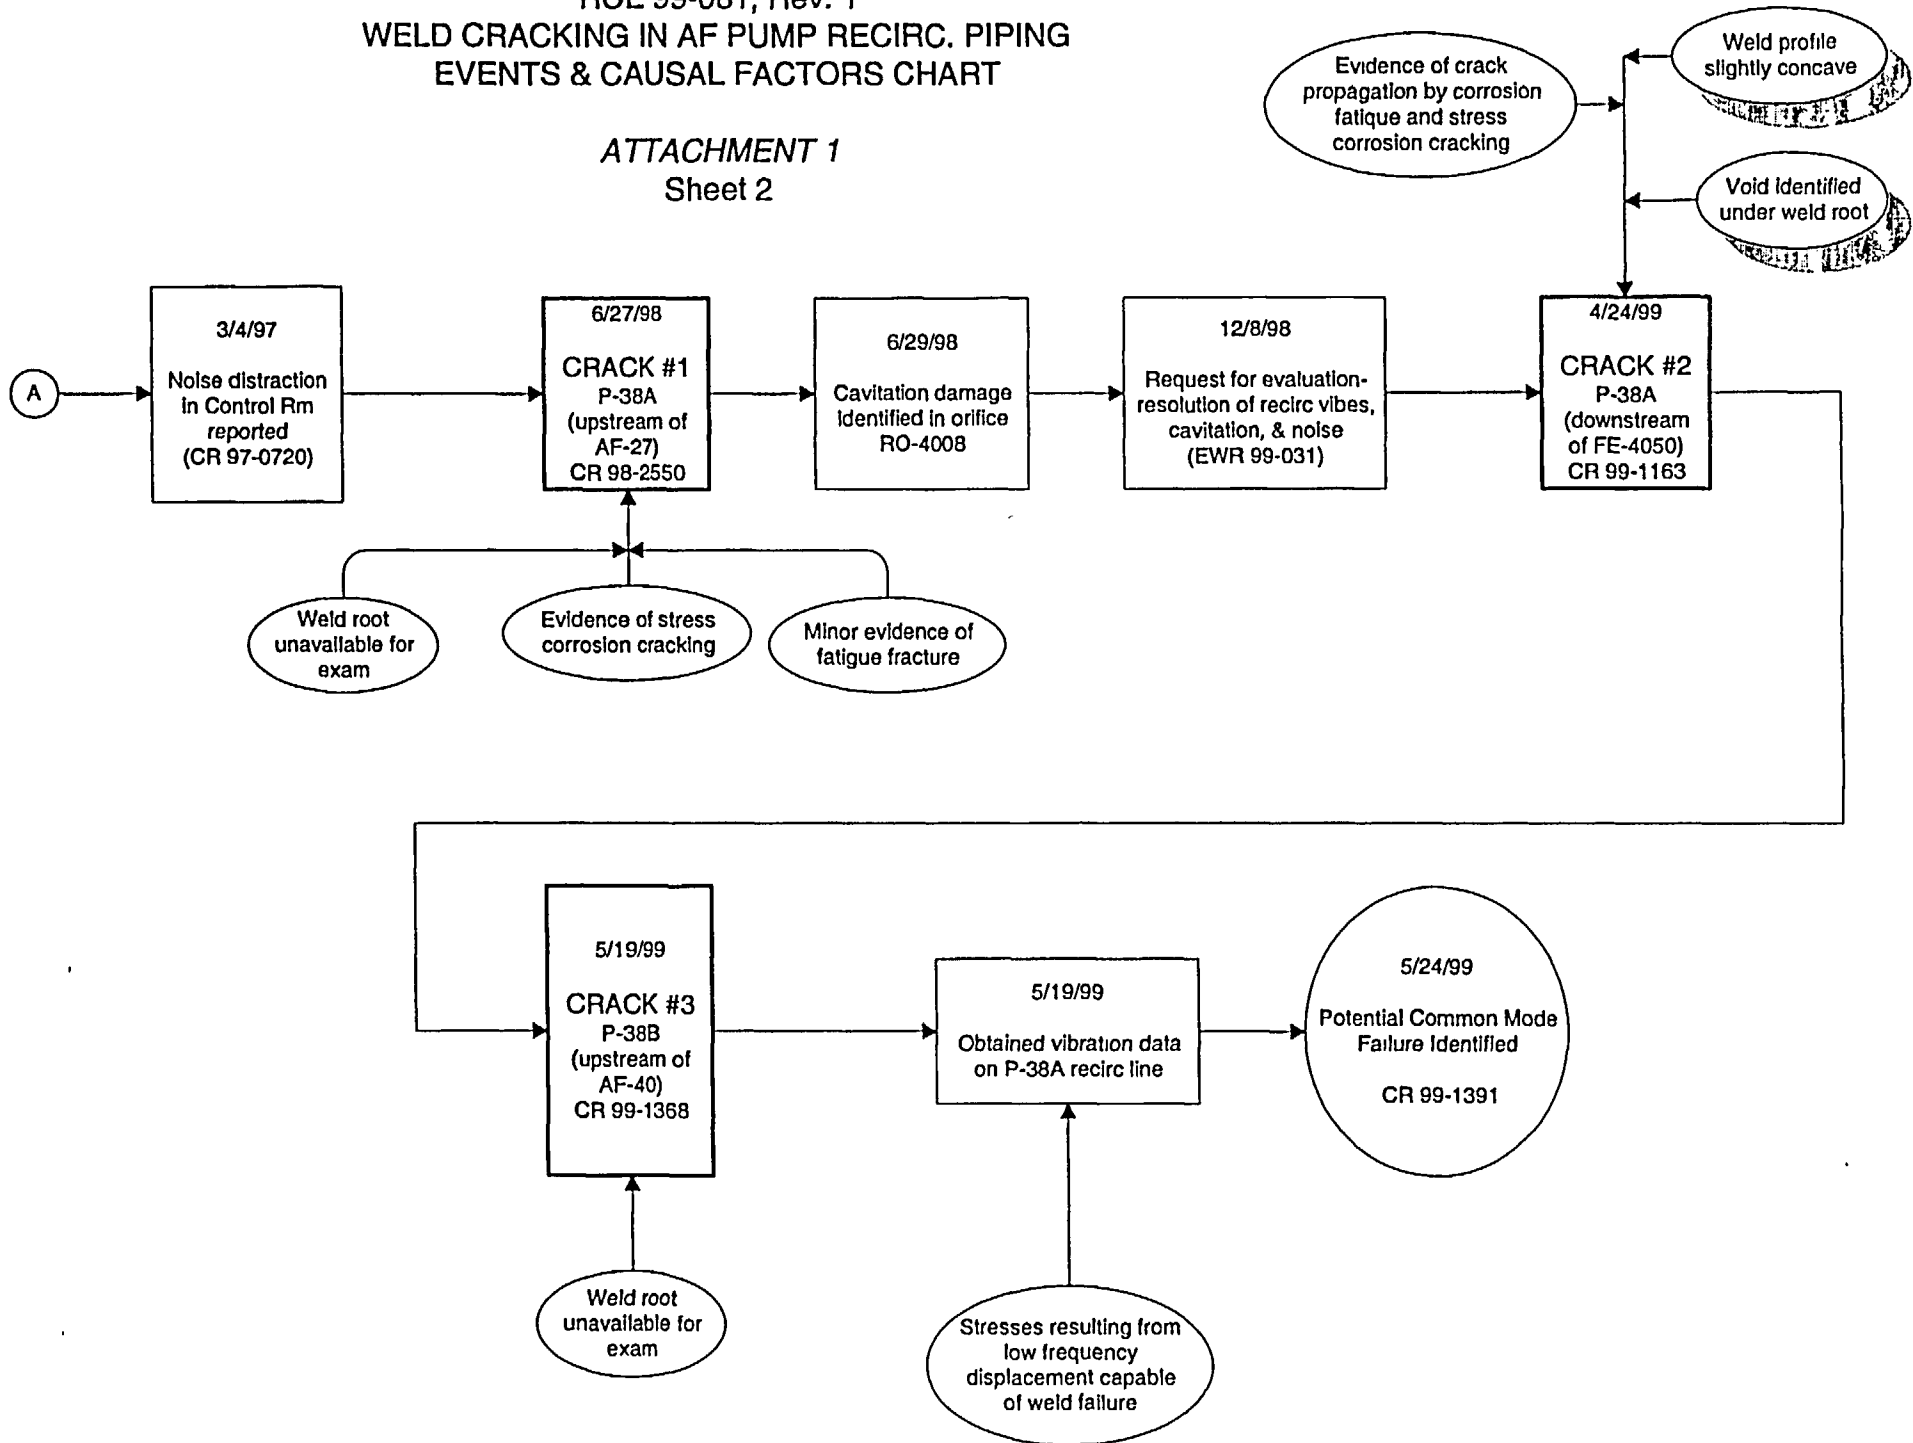
ATTACHMENT 1
 Sheet 2

RCE 99-081, Rev. 1
WELD CRACKING IN AF PUMP RECIRC. PIPING
EVENTS & CAUSAL FACTORS CHART

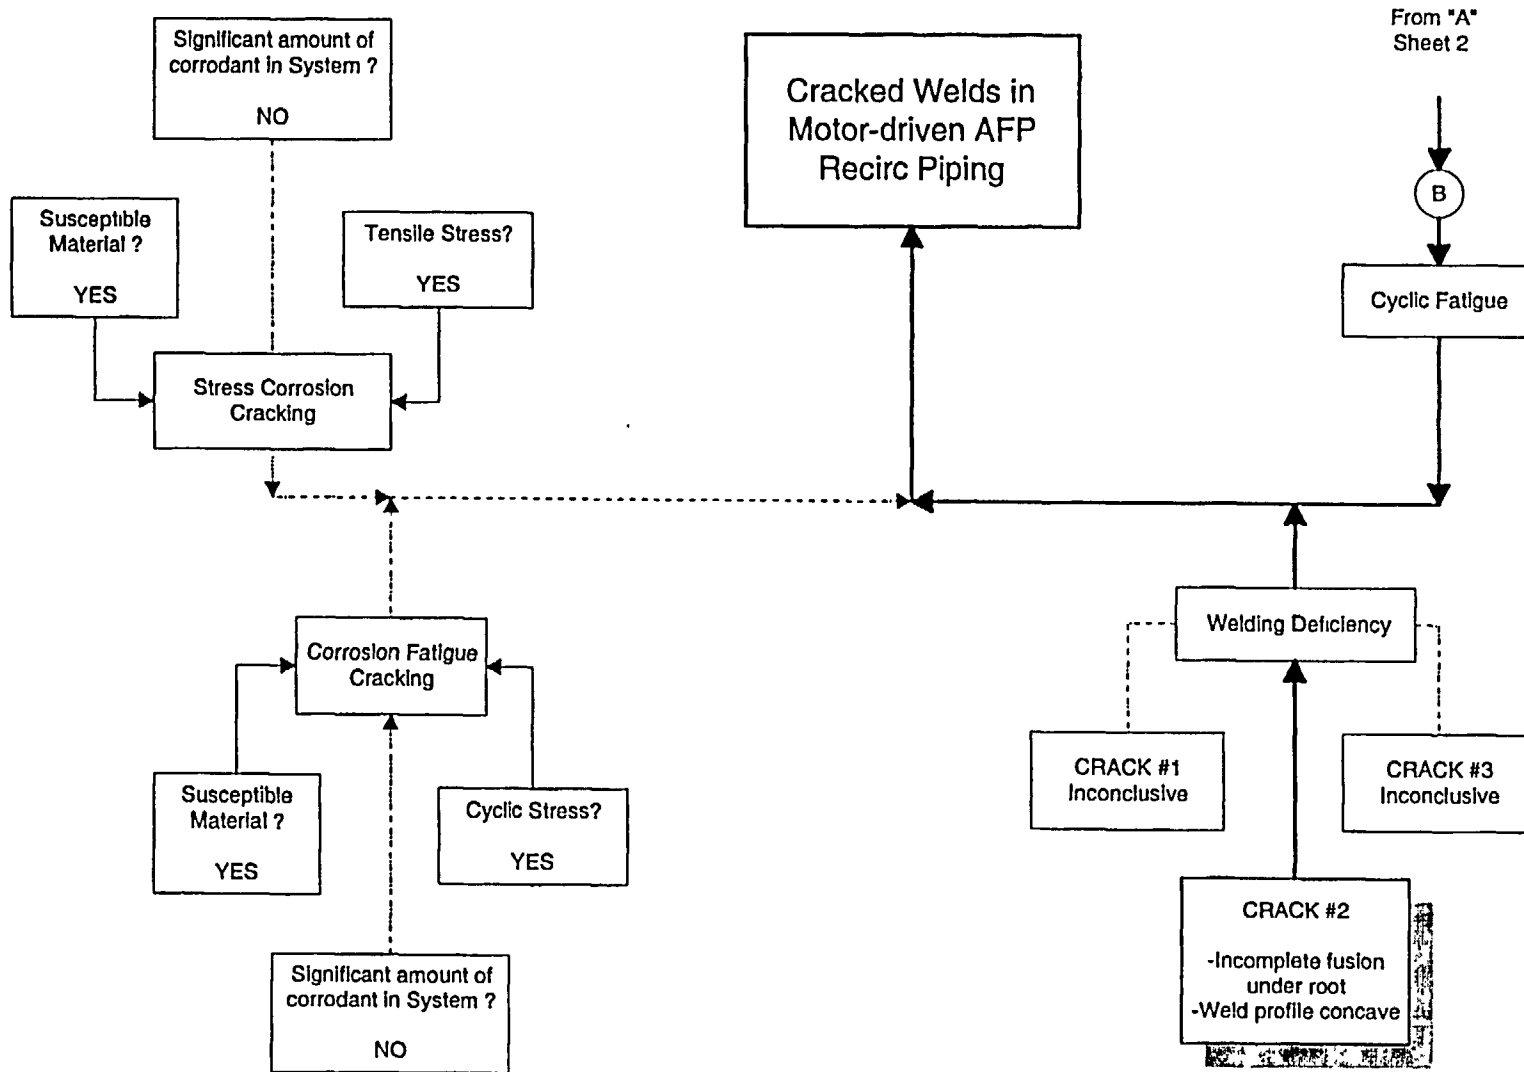
ATTACHMENT 2
Sheet 1

RCE 99-081, Rev. 1
WELD CRACKING FAILURE MODE DIAGRAM

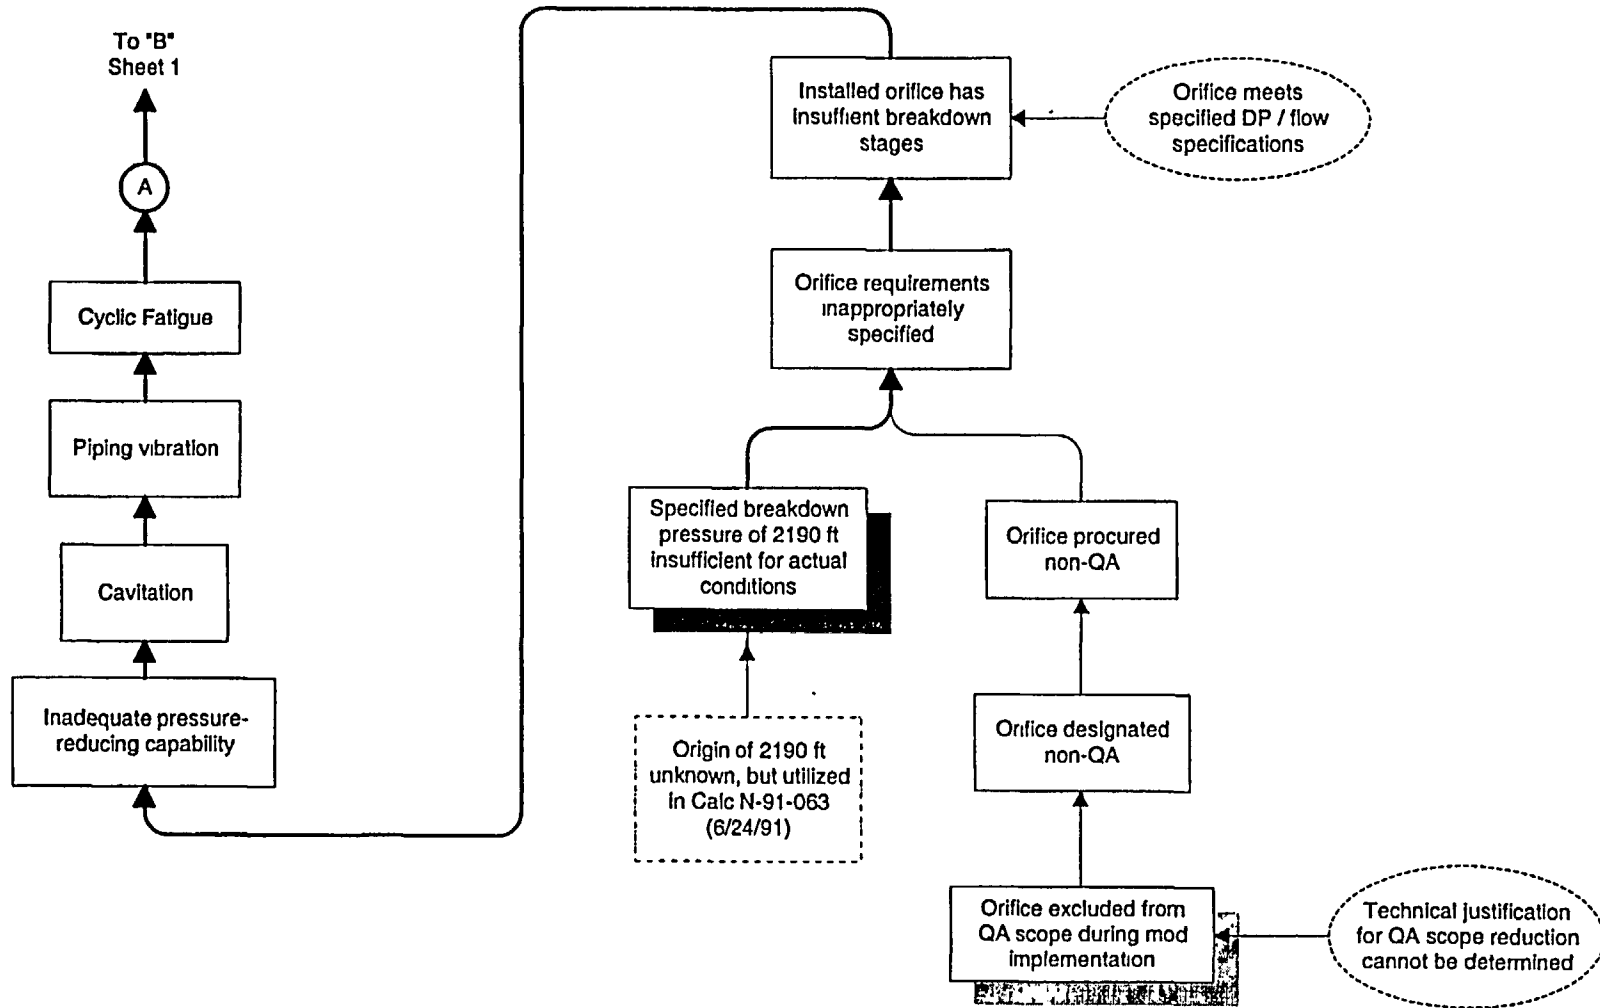
ATTACHMENT 2
Sheet 2

RCE 99-081, Rev. 1
WELD CRACKING FAILURE MODE DIAGRAM
